Devonport-Takapuna Local Board Workshop Programme

Devonport-Takapuna Local Board Workshop Record

KENNEDY PARK WWII TUNNEL

CONDITION ASSESSMENT
&
PROPOSED MAINTENANCE

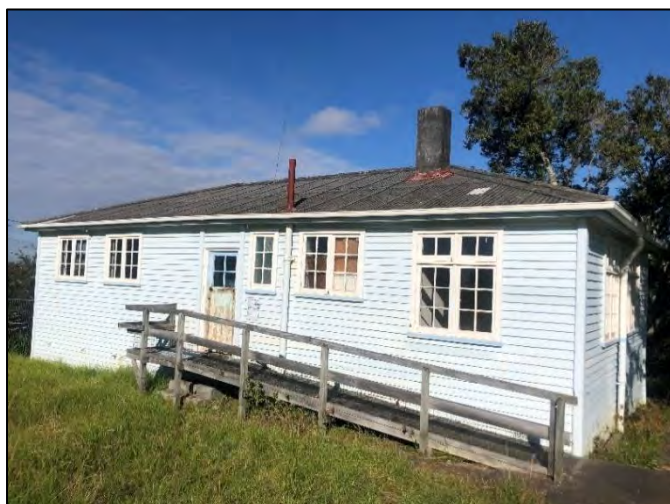
The asbestos cement roofing generally appears to be in reasonable condition with deterioration being consistent with its likely age. There is no evidence of leaks within the building originating from the roof. A separate report on the roof was commissioned by Auckland Council. The roof space in the building has since been cleared of asbestos particles and the underside of the sheets have been encapsulated. A certificate verifying that this work has taken place as been included in the appendices.

Rear side of building. Note corrugated asbestos cement roof and remnant of earlier lead flashing at the base of the chimney. Note also plastic spouting.

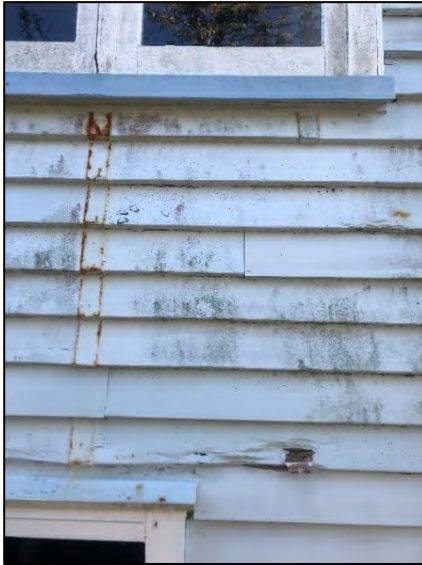
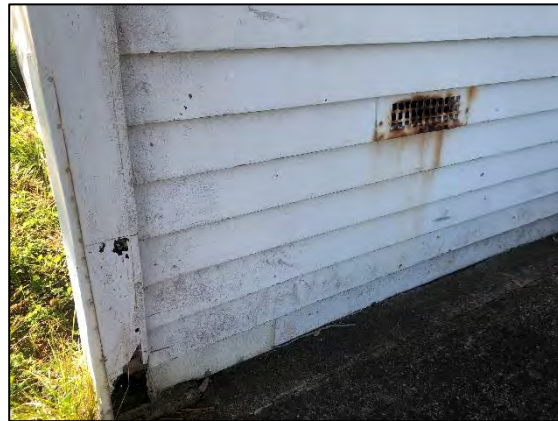
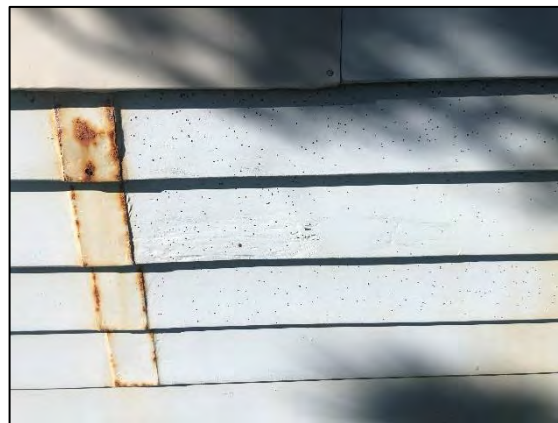
The weatherboards are in variable condition. The majority appear sound and it appears that some remedial work may have been carried out since the 2015 Conservation Plan was prepared. Nevertheless, some defects are still apparent including areas of decay and borer infestation. Some decay and evidence of water ingress which was not immediately apparent from the exterior became evident when areas of the internal linings were removed.

Decay is also evident in trim such as corner boxes and window facings. Other defects in the external cladding include rusting ventilation grilles and metal soakers over junctions between weatherboards.

Cladding defects included decayed weatherboards (left), rusting grilles and decayed corner boxes (top right) and rusting soakers (bottom right).

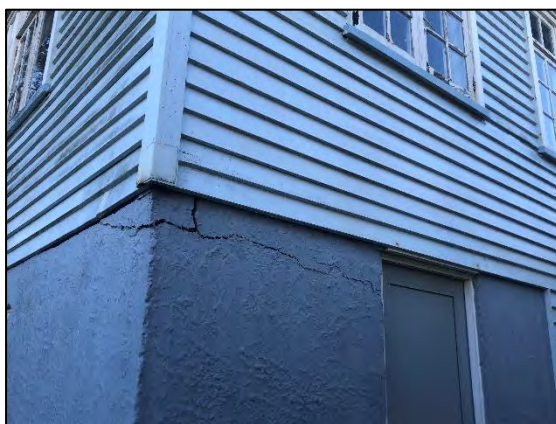
In the south corner of the building is a small basement that was constructed after the building was relocated in 1946 to provide space for a laundry. The outer wall comprises in situ concrete which has a substantial crack near the top of the wall. This could be the result of foundation settlement or rusting reinforcing within the concrete. Further movement appears to have occurred since the building was last surveyed in 2015.

Crack in foundation wall at south corner.

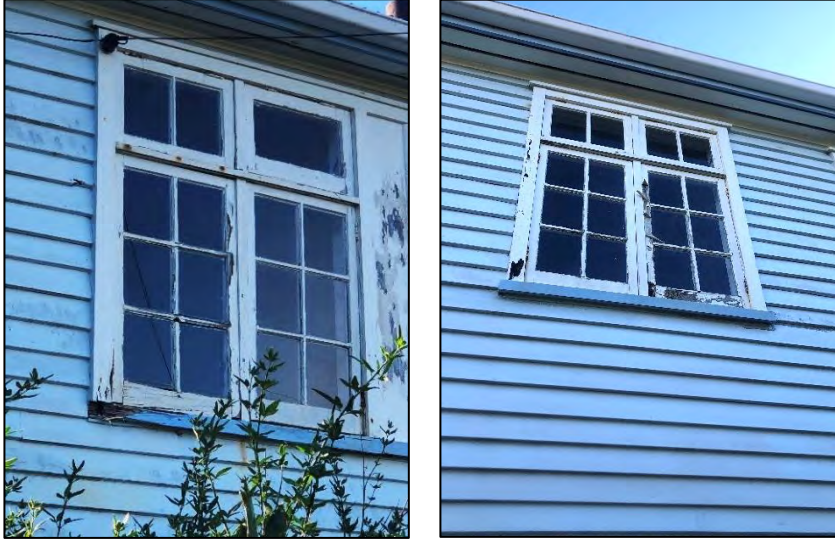
rusting hinges, cracked or missing putty and flaking paintwork. Some windows have previously been replaced but these are also showing signs of decay. The rear outer door is in poor condition. It appears to have been faced with a board to hide the decay. This has since been lost, leaving the door vulnerable to further decay. In the front porch, a timber sash was in poor condition and a pane of glass was missing.

Decay in window joinery, in sill and facing (left) and sash members (right).

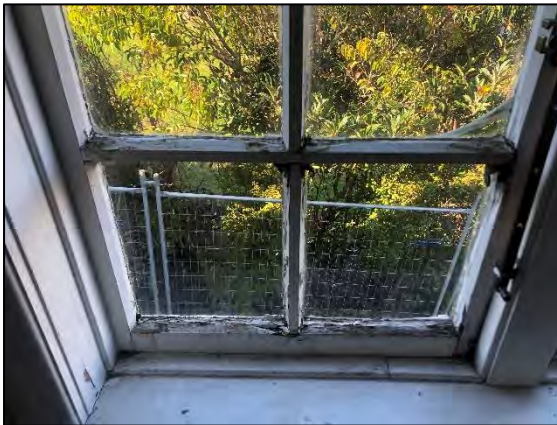
Decay apparent in replacement sash (left) and rear door (right).

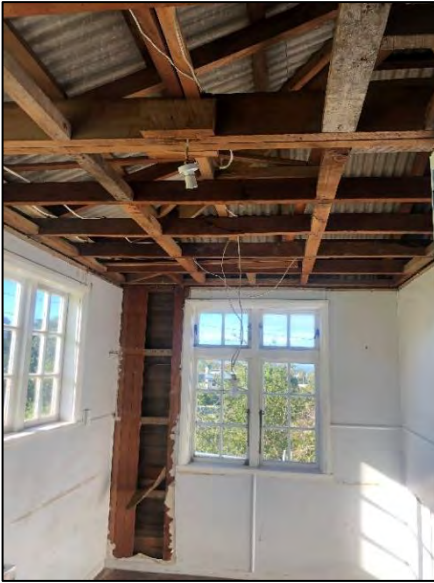
The original framing appears to have been augmented by recycled timber, essentially whatever was at hand, but possibly from some of the other buildings on the site that were demolished. Some of the additional timber is clearly *pinus radiata*. The additional framing may have been installed when the original corrugated steel roof was replaced with the current asbestos cement sheets in an effort to take the expected additional weight.

Areas of roof and ceiling framing. Note original timbers and later recycled material.

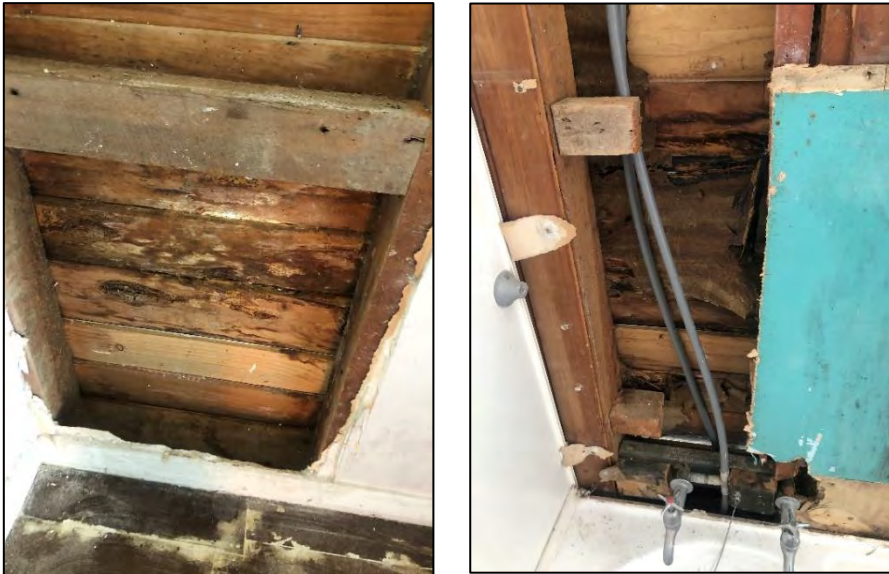
Areas of decayed weatherboards. The timber framing in these areas should be checked.

Wherever there is evidence of decayed weatherboards, the timber framing behind should be checked.

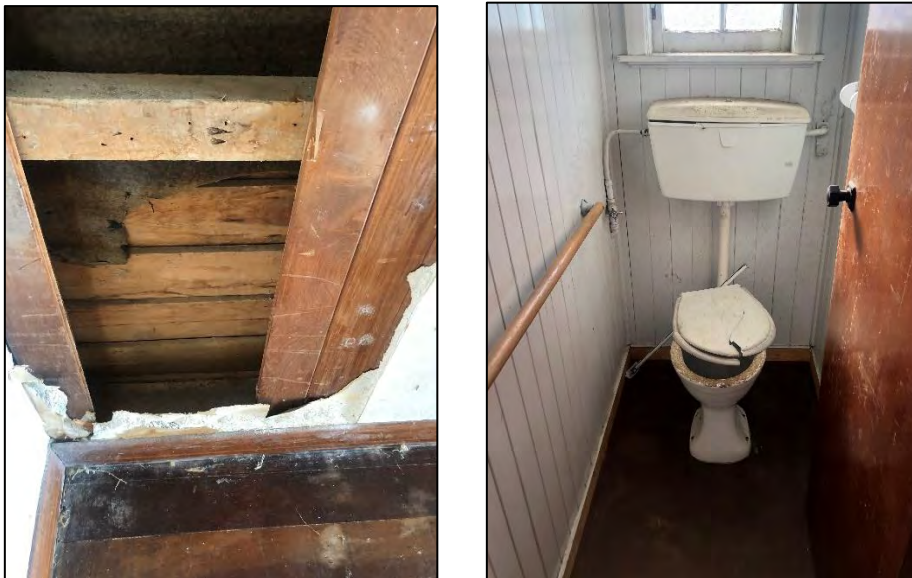
The walls generally comprise plasterboard over original tongue and groove boarding, likely to be rimu. Some cracks are visible in the plasterboard, suggesting the building may have settled over time. The bathroom has hardboard over the original boarding and laminated plastic wallboards have been fixed above the bath. Original tongue and groove lining, now with a paint finish, can be seen in the toilet compartment. Similar tongue and groove boarding can be seen in the wardrobes and cupboards. Borer is evident in some areas. Elsewhere, areas of the wall linings are now missing, following intrusive investigations that were carried out to determine the condition of the wall framing.

Area where plasterboard has been removed, exposing original tongue and groove linings (left) and toilet with tongue and groove boards still in place (right).

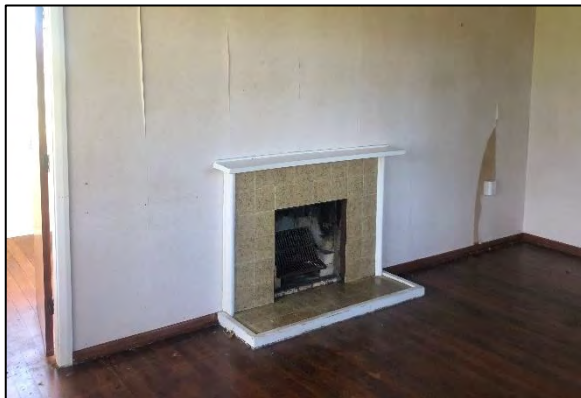
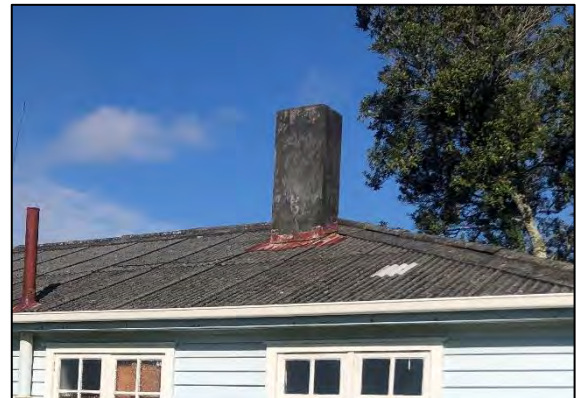
The chimney is visible in the subfloor area below the building and above the roof where it has a plaster finish. It appears to have been constructed from precast concrete sections but is probably unreinforced. The extent of the foundation below the chimney is unknown. The condition of the chimney should be checked by a structural engineer.

Fireplace (left) and chimney above the roof line.

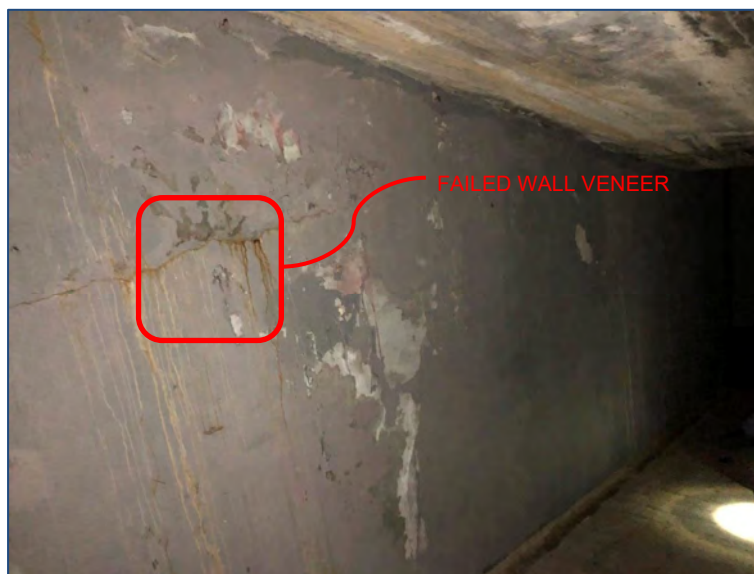
Figure 6: Southern Ramp Wall – Previous failed patch repairs

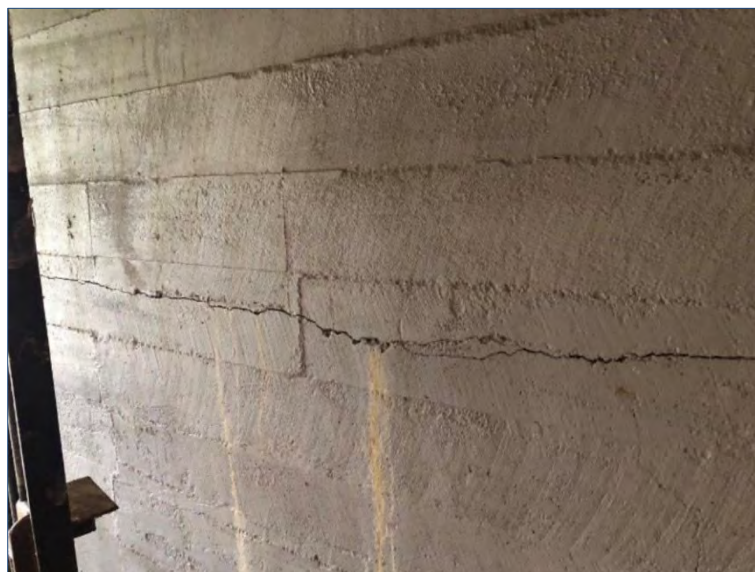
A significant horizontal crack was observed in the northern wall of the entrance tunnel, approximately 1400mm above the floor (undulating), and measuring up to approximately 3mm in width at its worst. The crack was observed along the entire length of the entrance tunnel up to the junction with the Gunnery Plotting Room where the tunnel ceiling steps up, albeit it was observed to be wider at the tunnel entrance gates. It was noted that the crack extends through a very significant vertical crack in the tunnel shaft at the abovementioned junction (further described below), indicating that it formed prior to vertical crack.

Figure 7: Horizontal cracking to western entrance tunnel

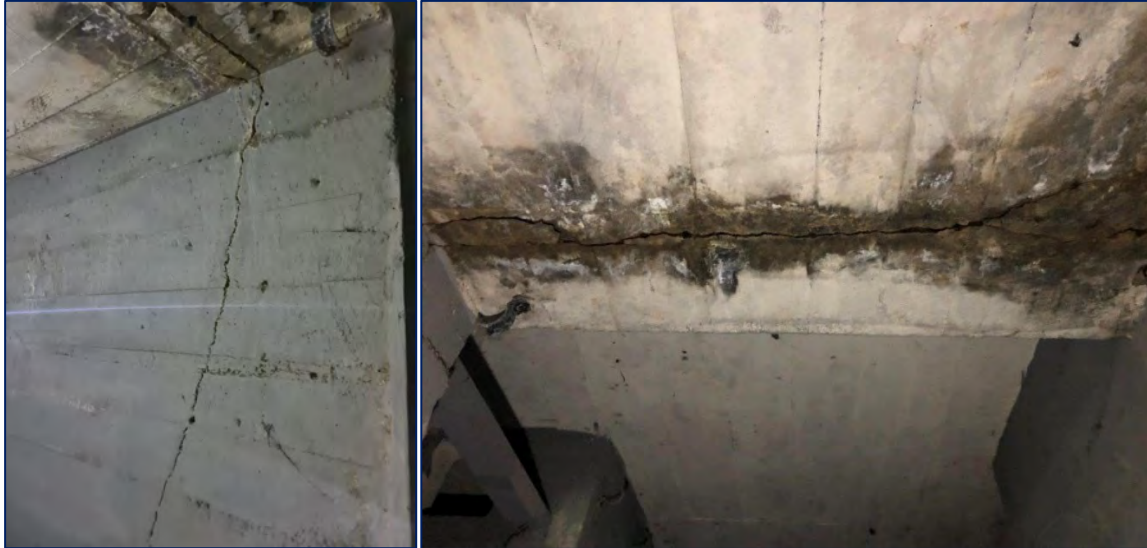
As mentioned above, a very significant vertical crack was observed around the tunnel shaft near the junction with the Gunnery Plotting Room, measuring in excess of 5mm in width, and extending around the entire concrete tunnel annulus, including the walls and ceiling. It is the most significant of the cracks observed anywhere throughout the tunnel network and appears to have formed via displacement or settlement within this section of the tunnel.

Figures 8&9: Vertical cracking around western entrance tunnel

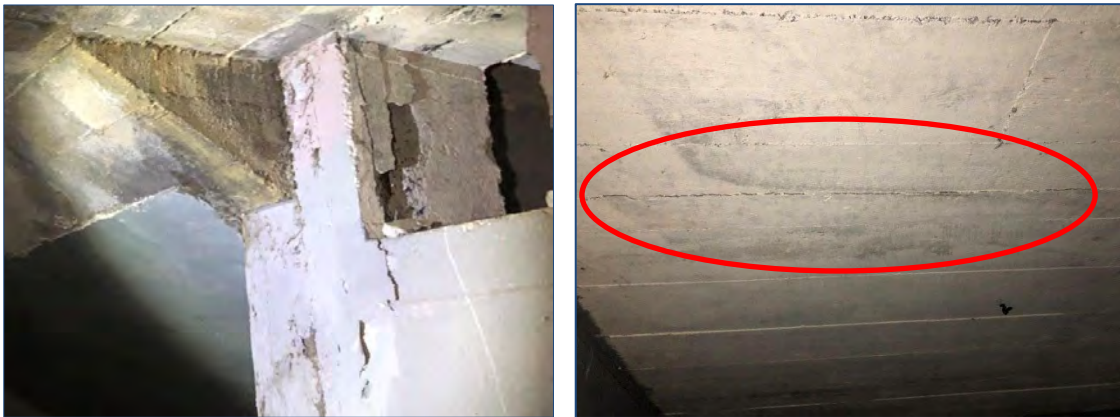
The Gunnery Plotting room exhibits at least one moderate crack through it's ceiling as well as cracking and spalling at the openings into the corridor. Given the longitudinal direction of the ceiling crack, it is considered likely to extend parallel to the primary reinforcing of the roof slab, suggesting that its cause is most likely corrosion or degradation related rather than load or flexural stress related.

Figures 10 & 11: Storage room corridor opening & ceiling crack

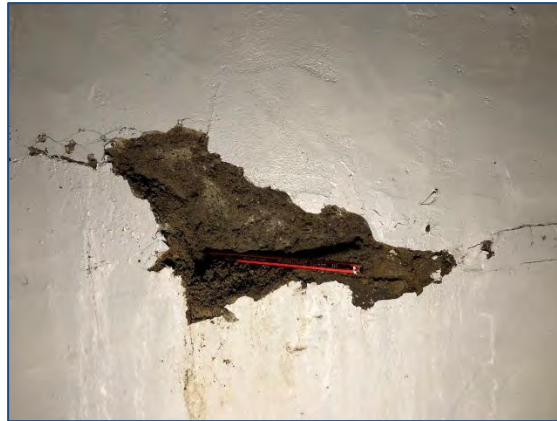
Figure 12: Damage to storage room walls

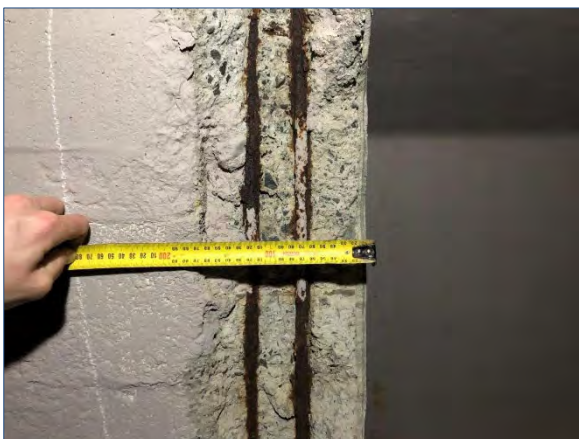
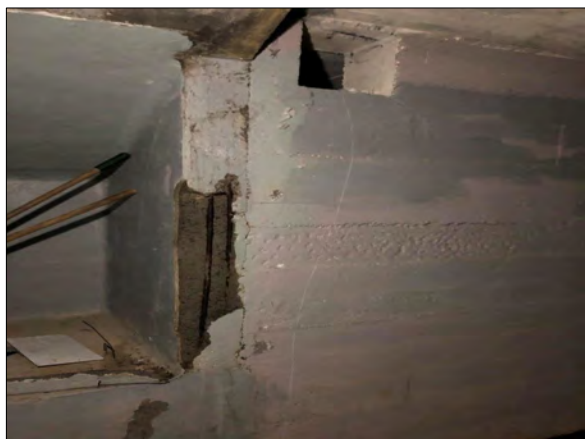
Figures 13 & 14: Damage to Ammunition Niche Corridor walls

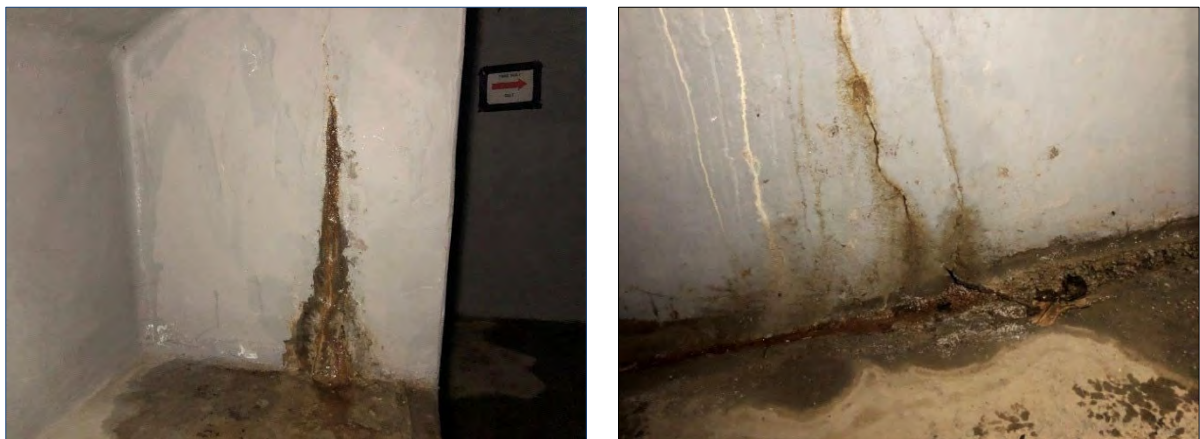
Figures 15 & 16: Corrosion staining through veneer coverings

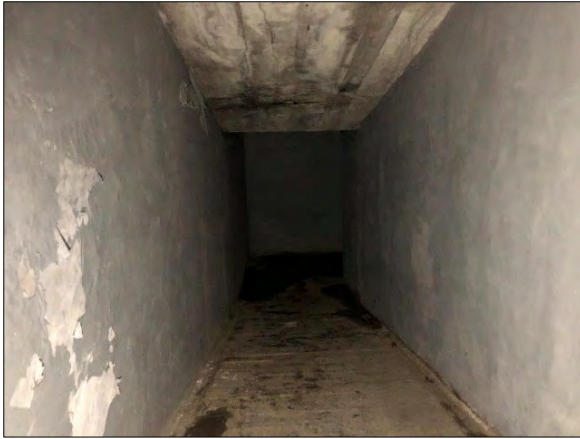
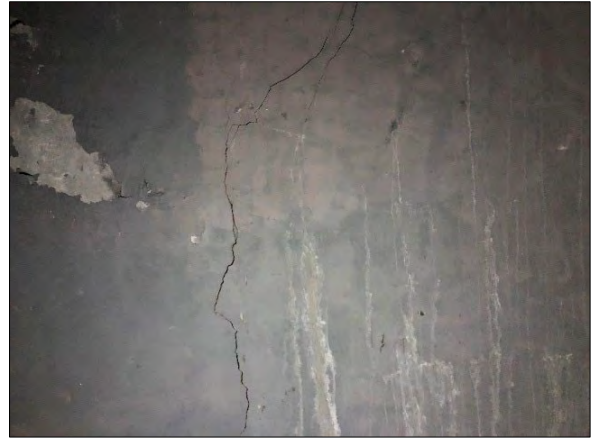
Figures 17 & 18: Failing veneer coverings to ramp walls

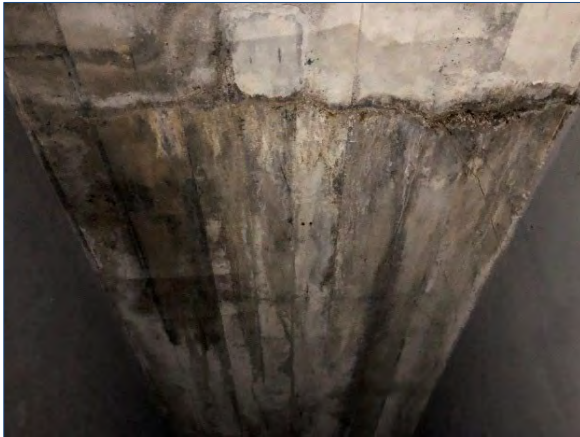
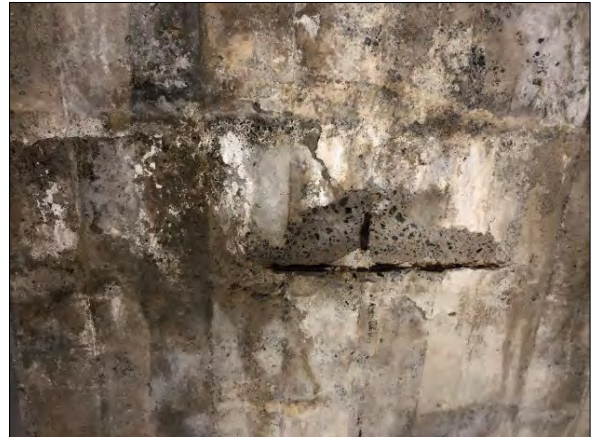
Figures 19 & 20: Water and corrosion staining, concrete spalls to ramp ceilings

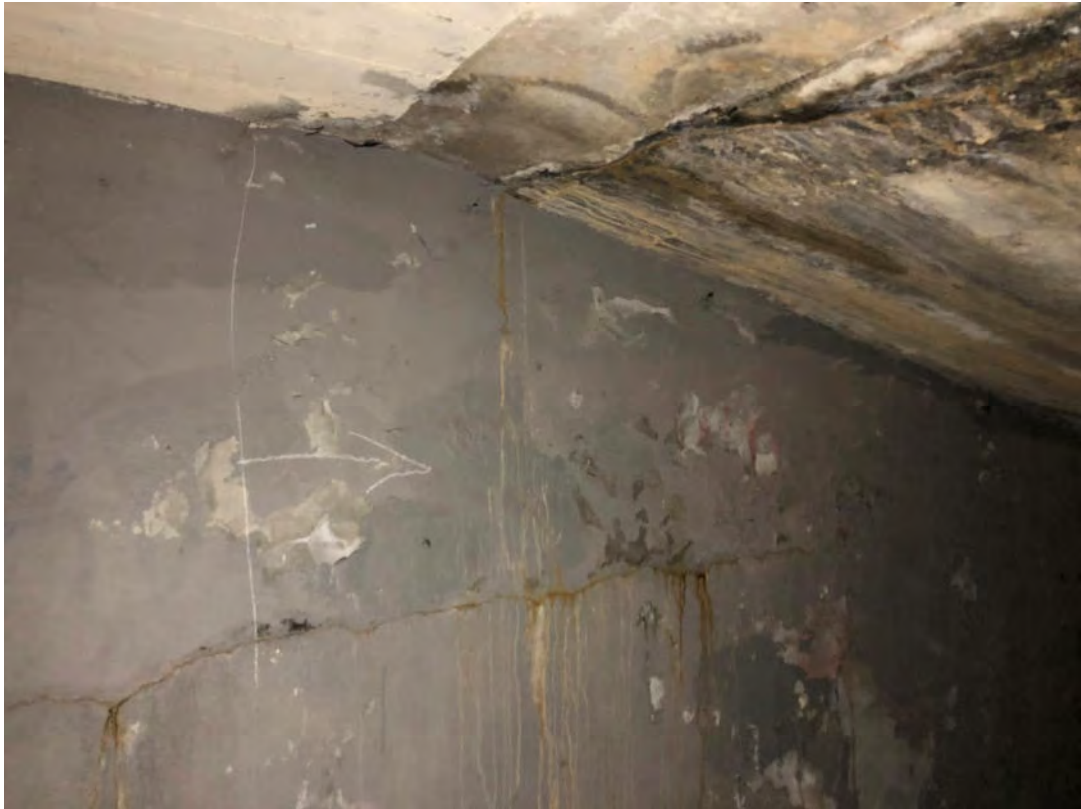
Photo 3: Failed wall repair

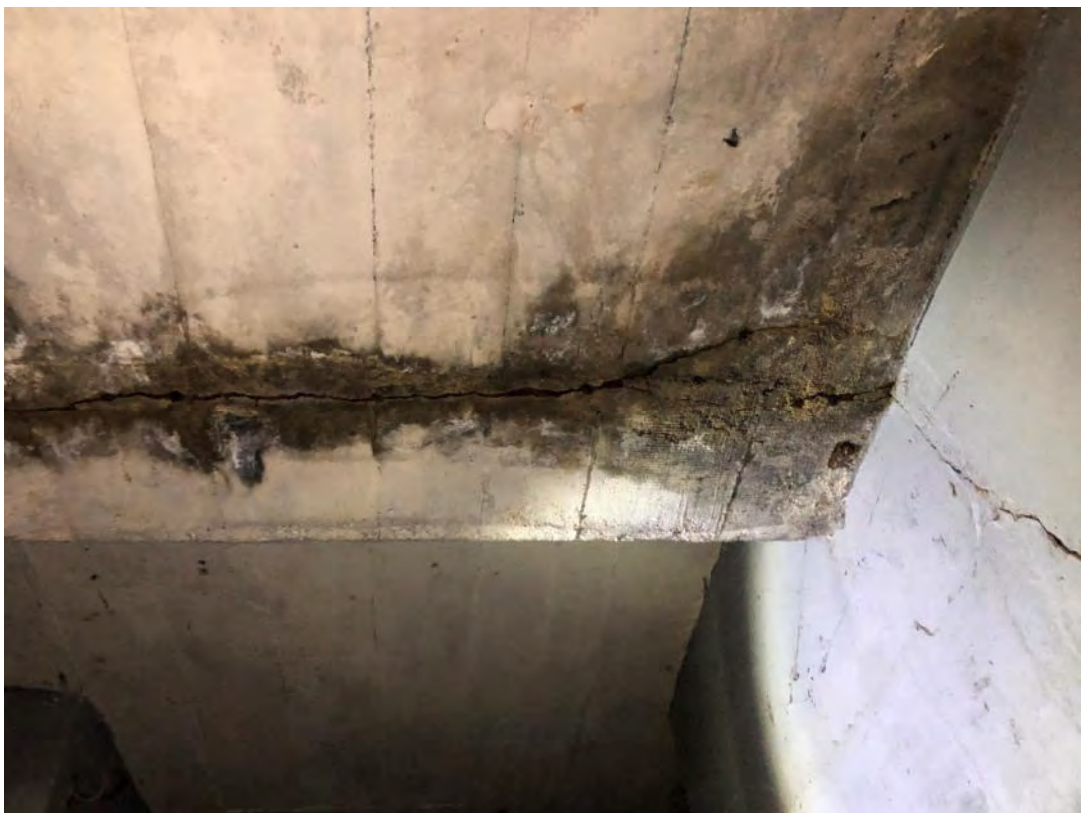
Photo 4: Large crack extending around soffit, walls and floor

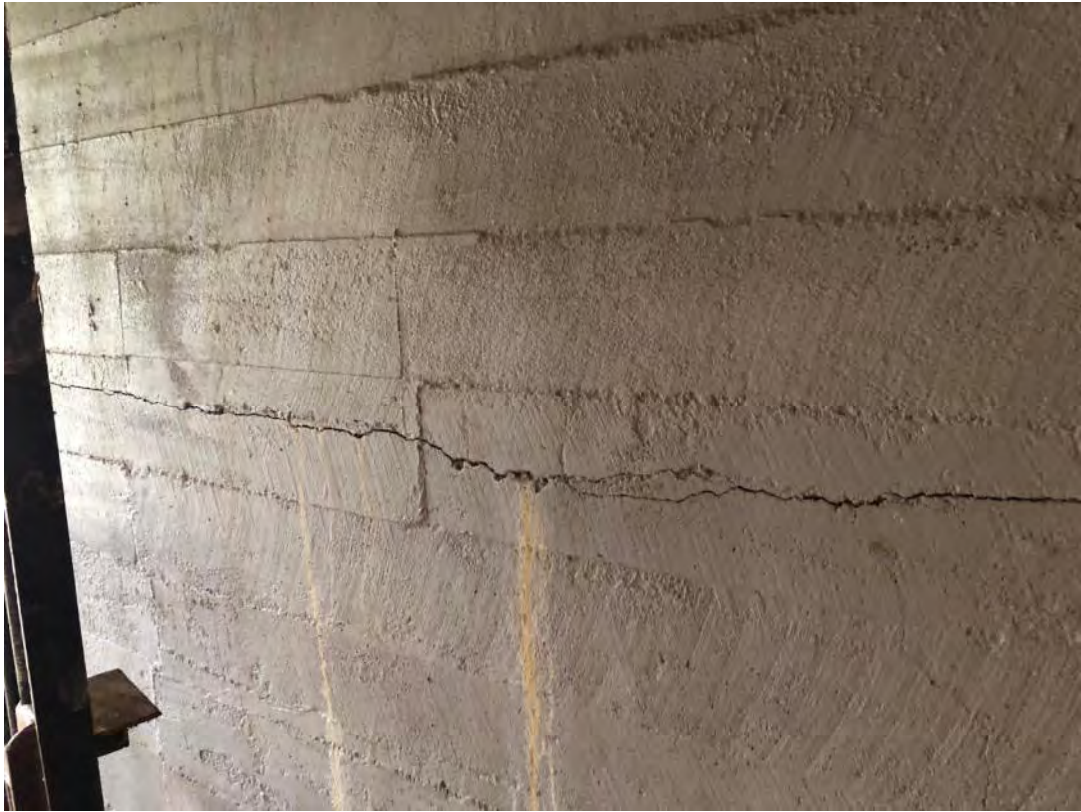
Photo 5: Horizontal crack along entire entrance wall

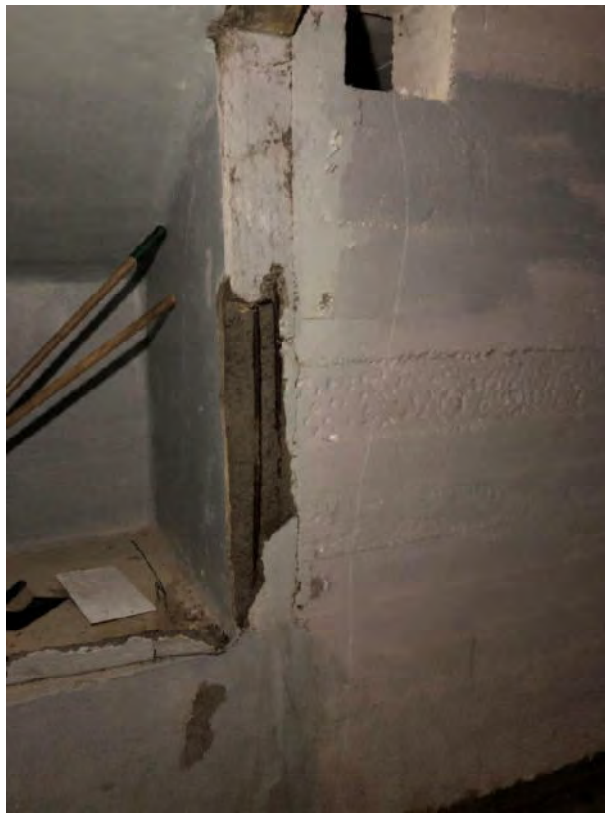
Photo 6: Spalled concrete to ammunition store

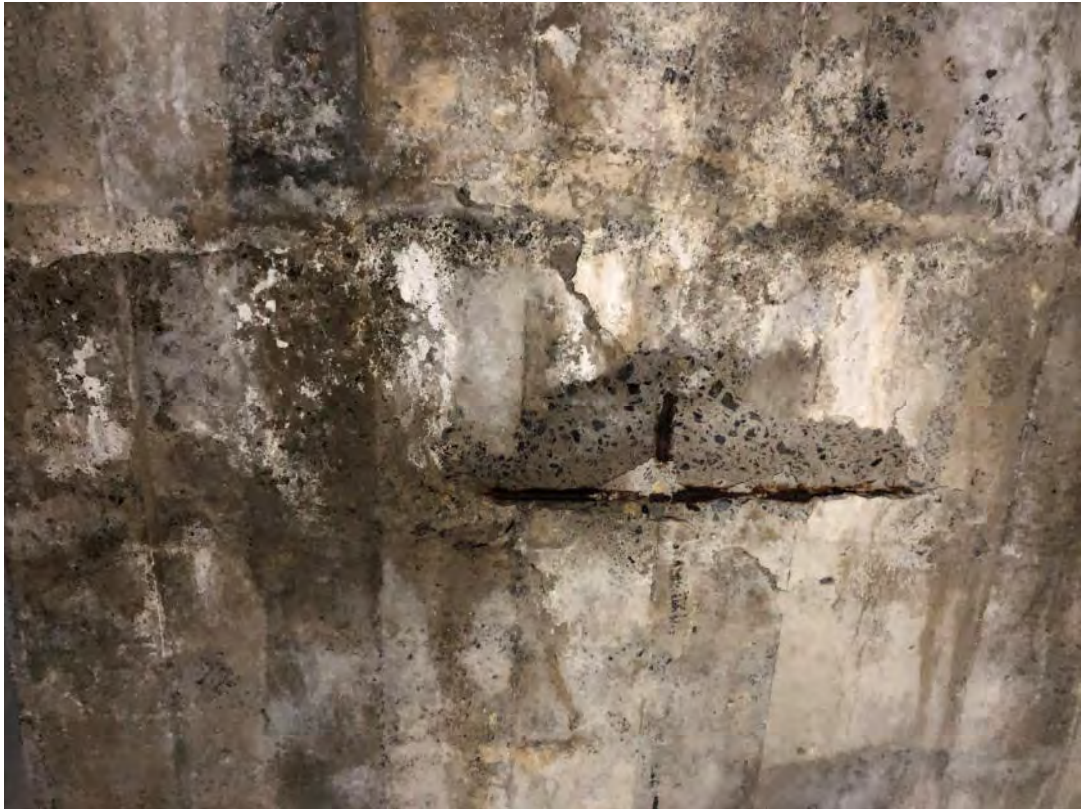
Photo 7: Exposed reinforcing with little cover

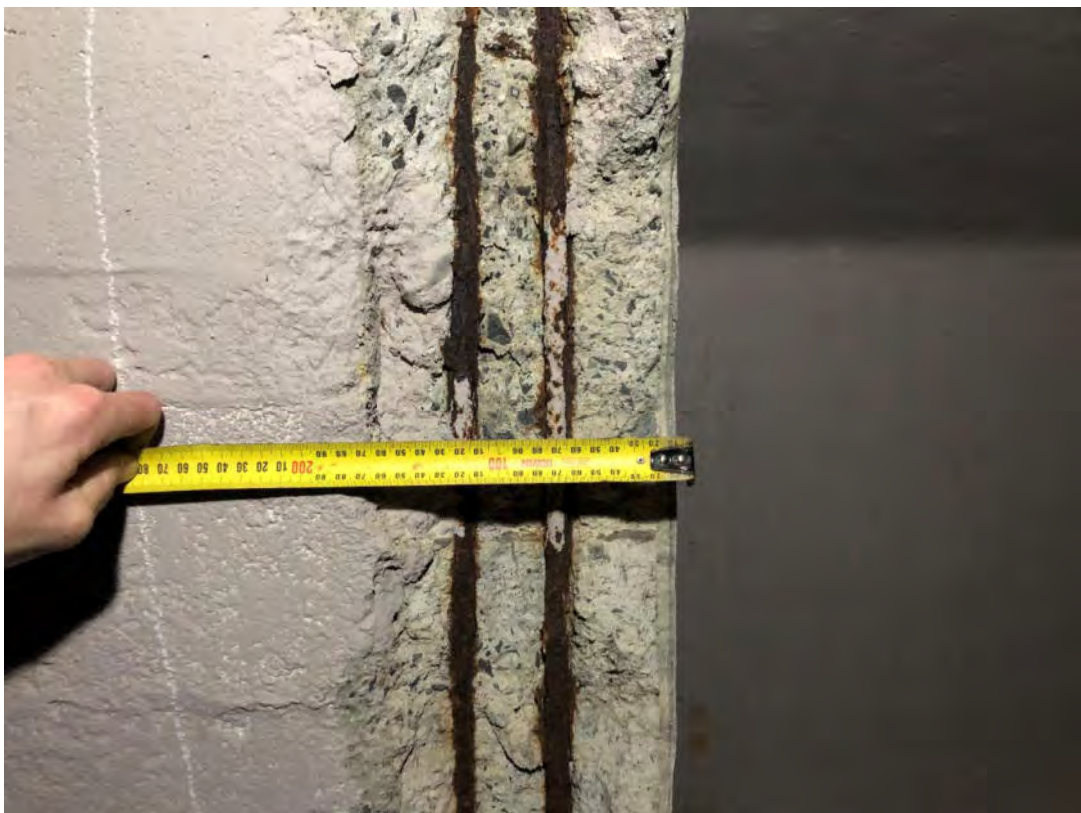
Photo 10: Spalled concrete exposing reinforcing
