Watercourse Assessment Report

Slippery Creek Catchment

Ingle, R., Rieger, A., Magee, J., Reeves, E., Macintosh, K., Lowe, M., Young, D.
Morphum Environmental Ltd

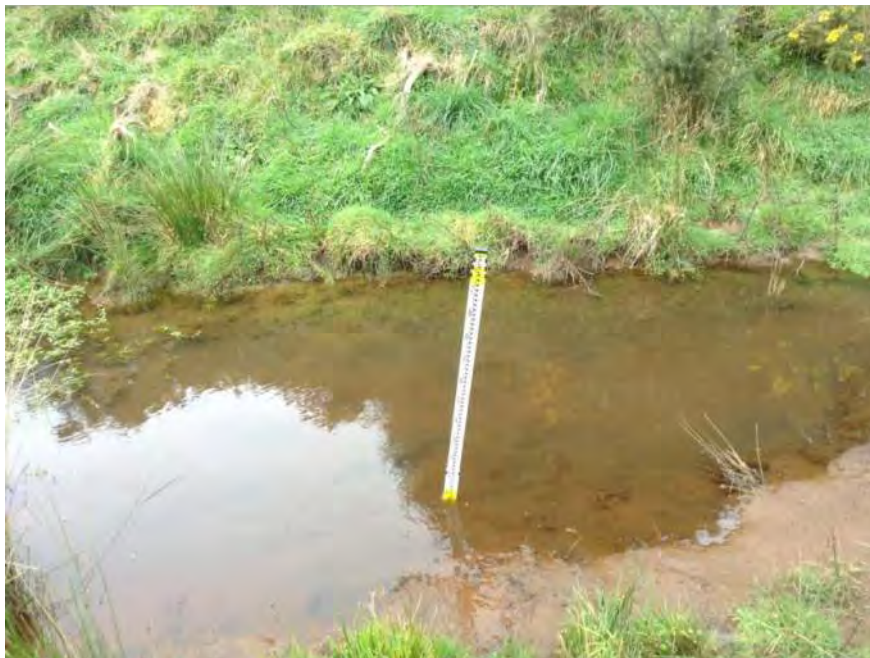
Figure 3: Unconsolidated fine sediment on HAY_TRIB6cl_2

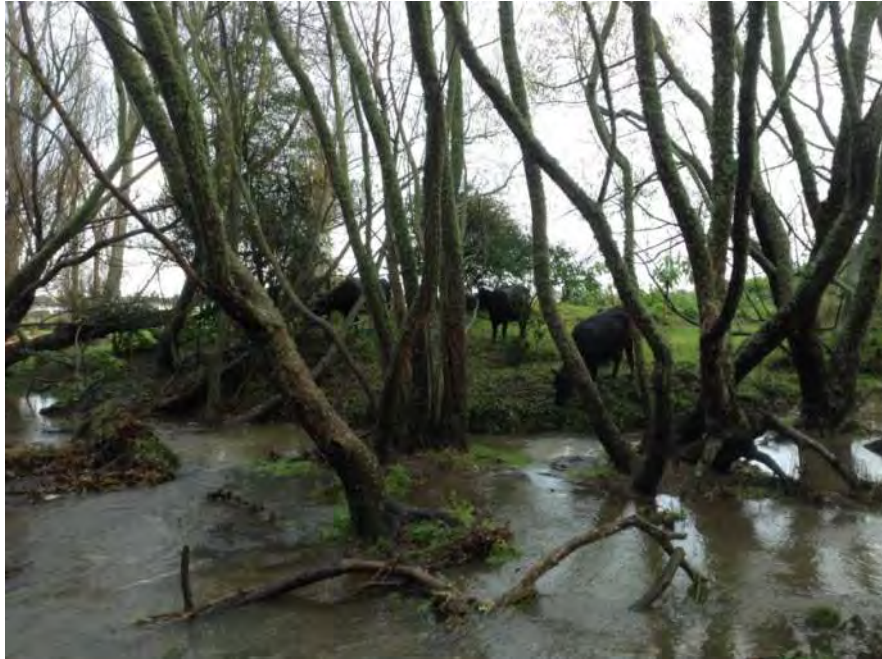
Figure 4: Reach modified by willows on SLI_MAIN_34

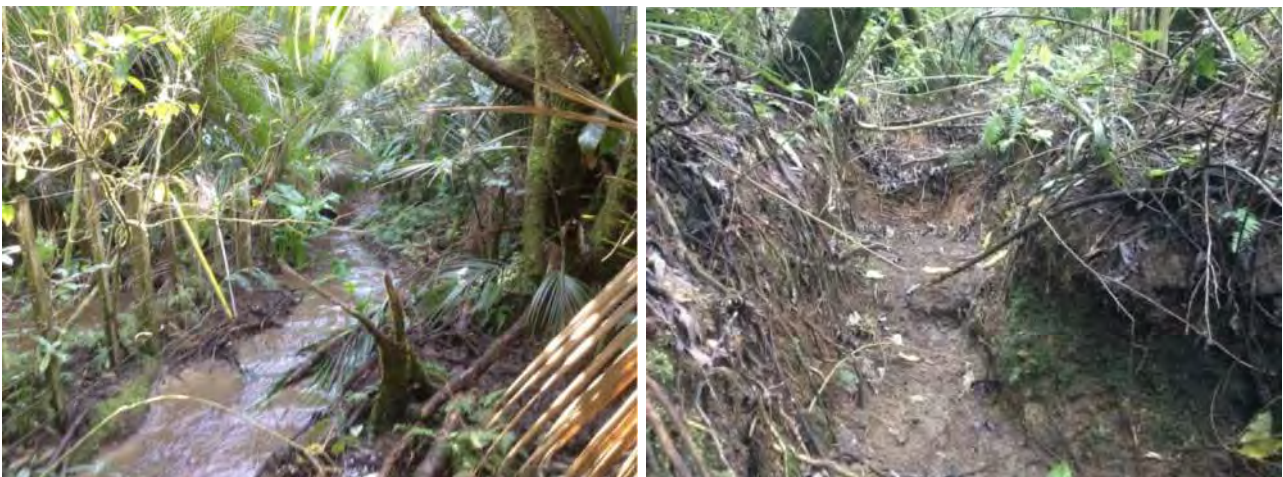
Tributary 10 was impacted by willows in the lowest reach, whilst the upper reaches (2-6) were actively down cutting and scour at the toe of the bank was evident. An online pond had been constructed which had completely diverted reach SLI_TRIB10_8 from the original channel through regenerating nikau forest (Figure 5). Banks had not yet fully formed at the new channel and the base was completely lined by willow root, with a layer of fine sediment trapped in the roots (Figure 5).

Figure 5: Newly formed channel lined by willow root (SLI_TRIB10_8) (left) and parallel original dry channel (right).

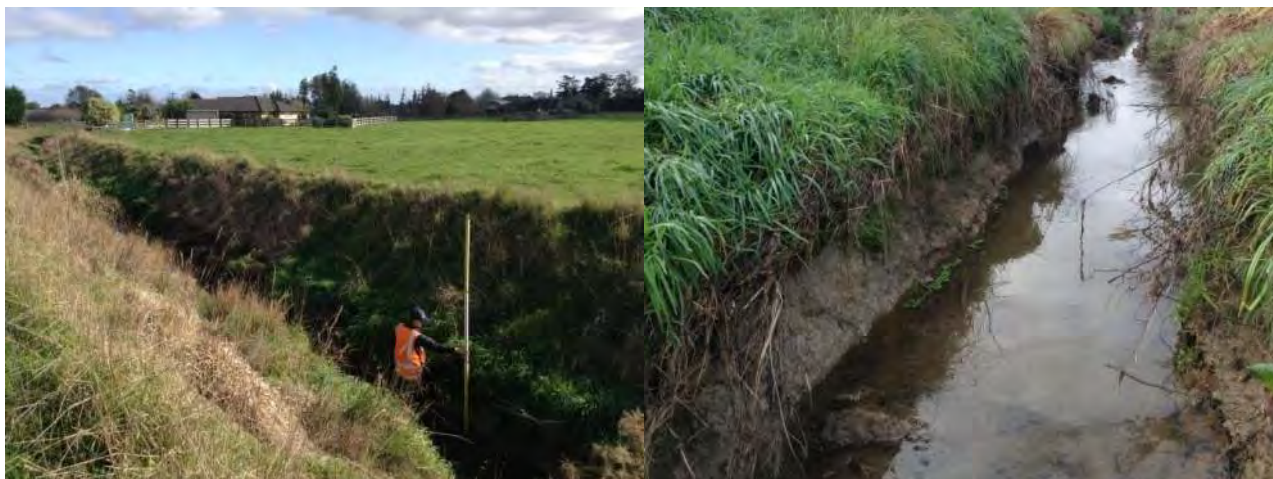
Figure 6: Representative reach of the main channel of WAI_TRIB2 with a close up of side cutting.

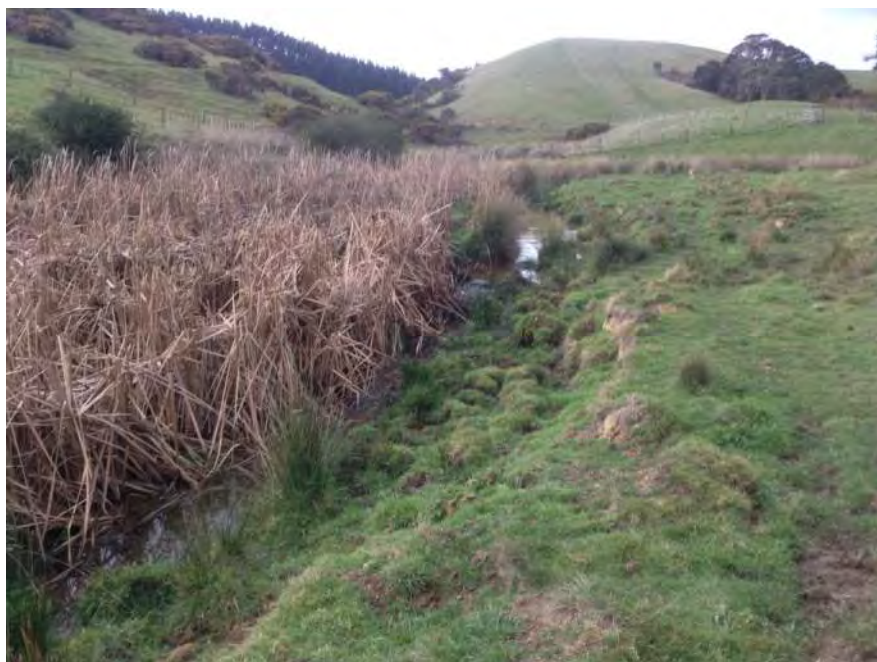
Figure 9: Channel on the TLB of HAY_TRIB6c_6 with raupo dominating the true right. Soil castings can be seen on the TLB. Photo facing upstream.

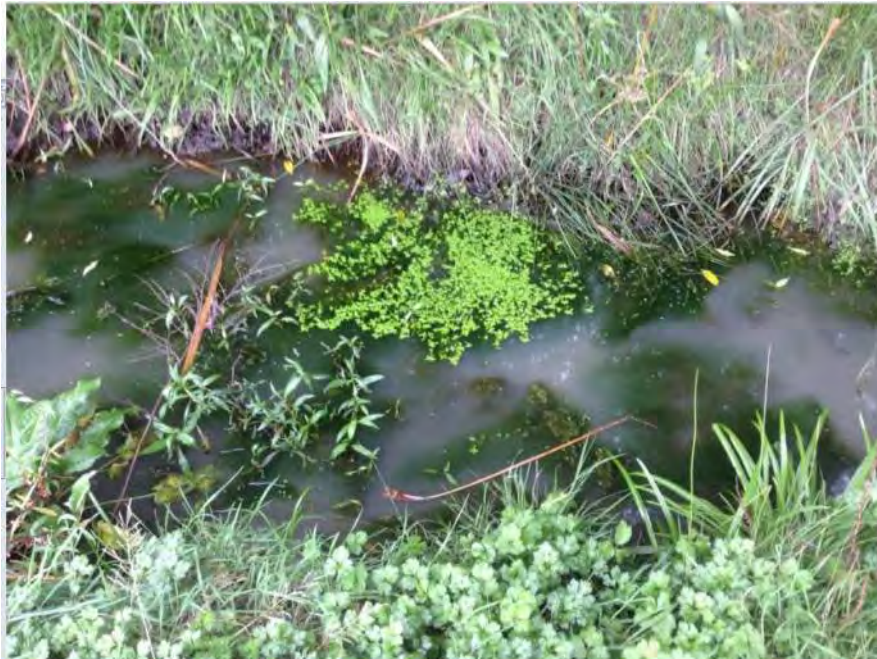
High turbidity with opaque, cloudy water was observed on several reaches including SLI_TRIB4_FORK2 at Graham Tagg Park and SLI_TRIB5a_1 at the railway corridor.

Figure 10: High turbidity, and abundant green filamentous periphyton at SLI_TRIB4_FORK2_3

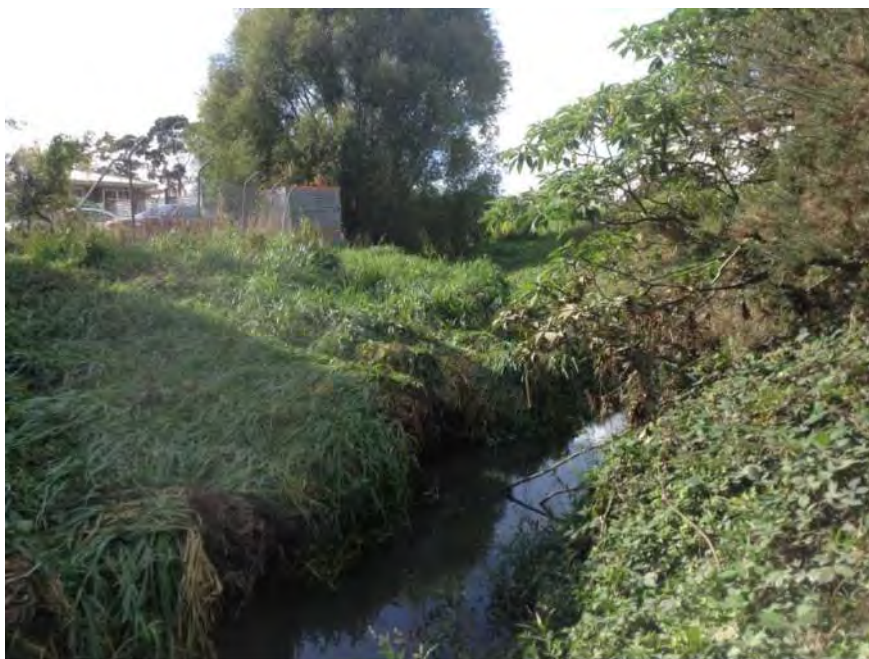
Figure 11: Representative photo of Croskery drain facing upstream. Flattened *Glyceria* in floodplain on TRB, blackberry and woolly nightshade exotic scrub on TLB.

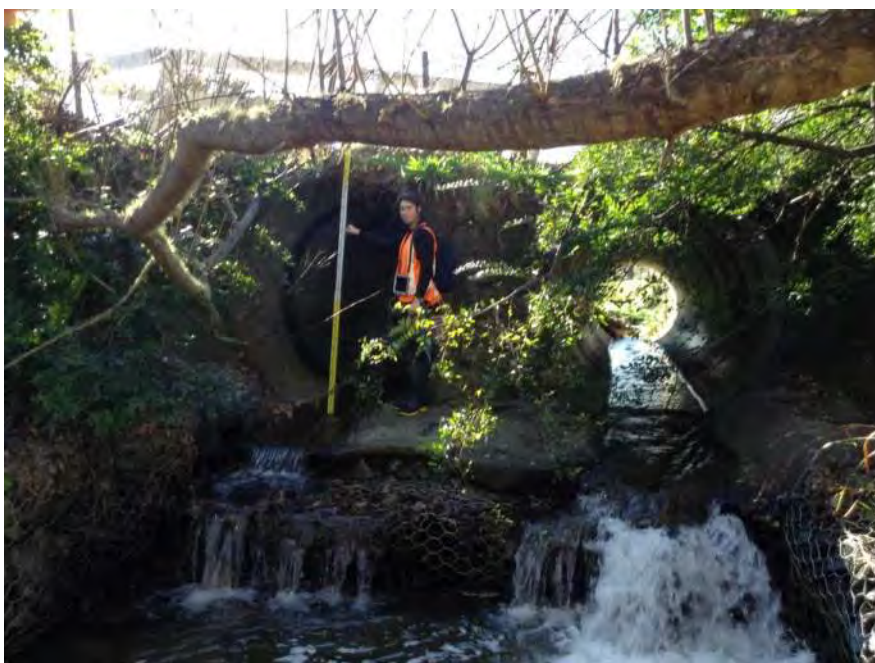
A concrete apron (UNK_237) was recorded as being a complete barrier to swimmers on Symonds Stream (SYM_MAIN_19) as is it breaking up in places and the gabion baskets are beginning to slump into the stream (Figure 20). However, 26 common bully, which are typically considered to be poor climbers, were observed immediately upstream of this culvert at SC7.

Figure 20: Concrete apron at the outlet (UNK_237) on Symonds Stream (SYM_MAIN_19).

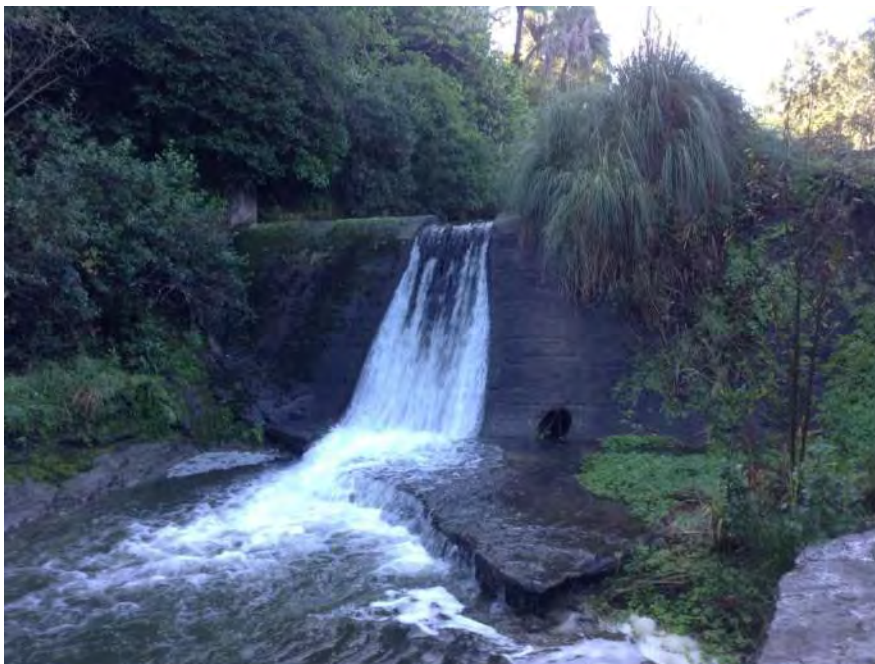
Two dams were recorded as miscellaneous points on Hays Stream. One dam (HAY_MAIN_20; Figure 21) was recorded as being a complete barrier to all fish species whilst the other (HAY_TRIB6c_10) was a complete barrier to swimming species due to the drop at the broken apron and 5 m high spillway. However, six common bully, which are typically considered to be poor climbers, were captured upstream of this dam at SC2. Three weirs (HAY_TRIB6_1, WAI_TRIB2_25, SYM_MAIN_FORK2_13) were recorded as being complete barriers to swimming species.

Figure 21: Old dam infrastructure at HAY_MAIN_20 with broken concrete apron

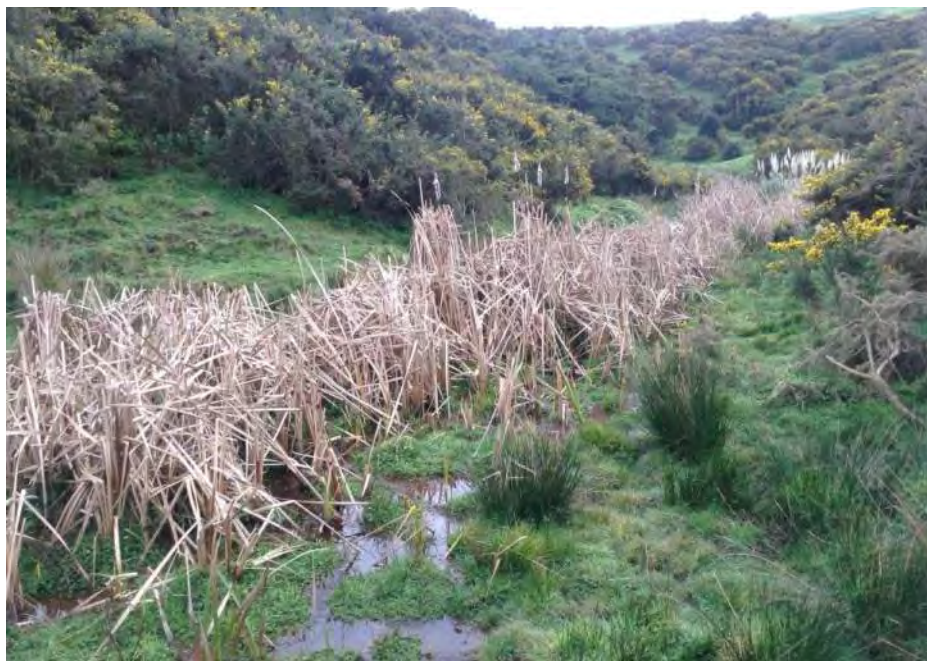
Figure 24: Riverine headwater raupo wetland (UNK_077) with no defined channel and pugging from stock on both banks (HAY_TRIB6cl1_1).

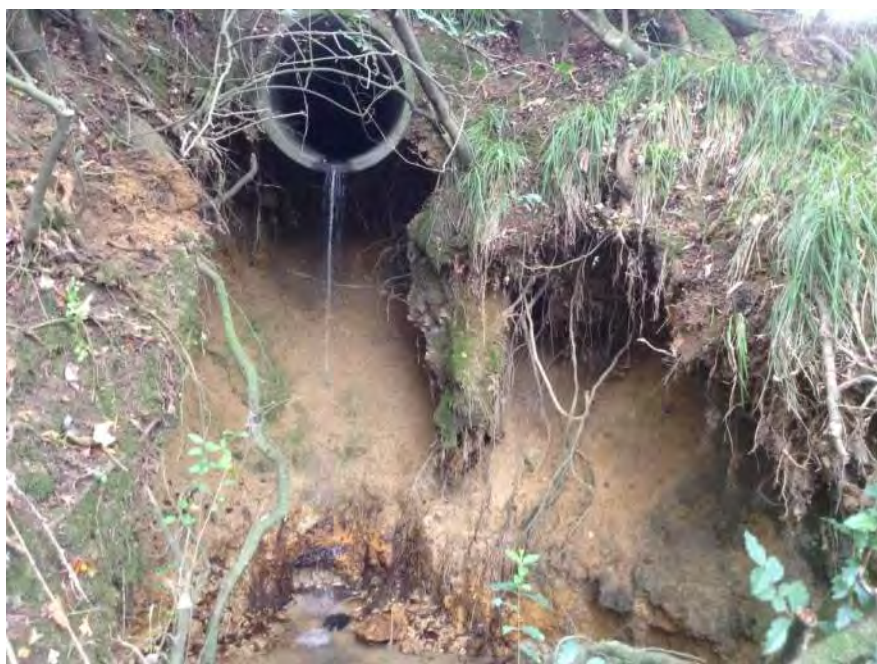
Figure 27: Severe erosion on HAY_MAIN_9 associated with asset: 1115574

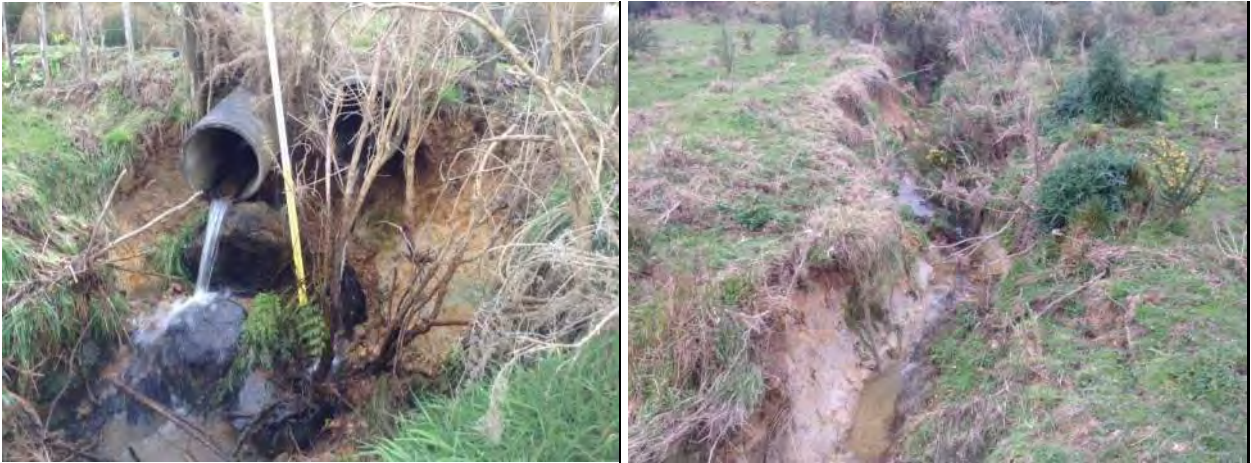
Figure 28: High velocity discharge from wetland UNK_ 117 causing severe erosion downstream (SYM_TRIB2_10) (outlets UNK_379, UNK_380)

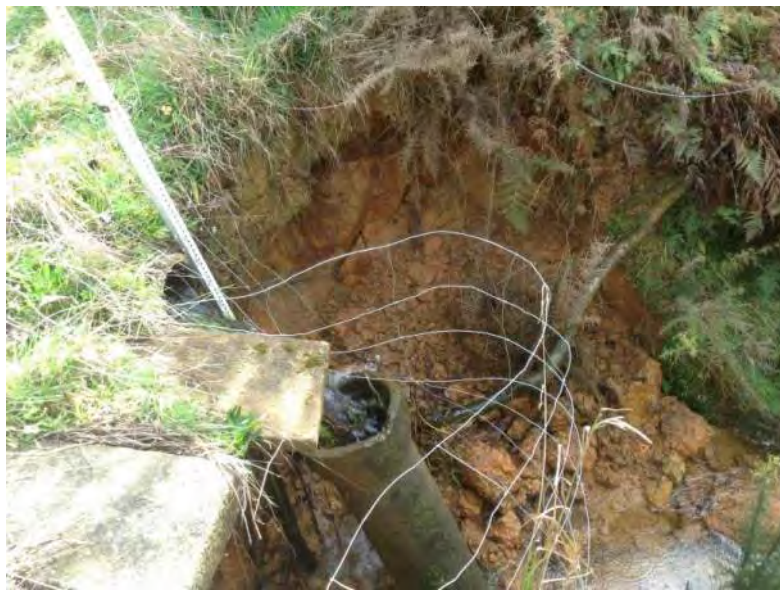
Figure 29: Severe erosion and culvert failure at HAY_TRIB6fl_2 (pond UNK_49, outlet UNK_581)

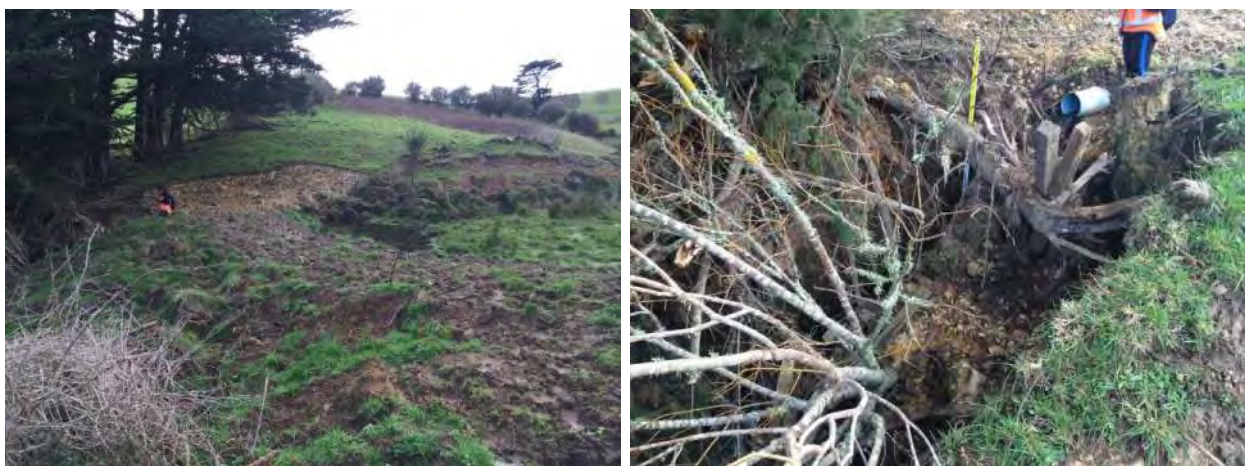
Figure 30: Recently installed culvert at HAY_TRIB6c_10 (wetland UNK_29, outlet UNK_414). A mature pine and the original concrete culvert had slipped.

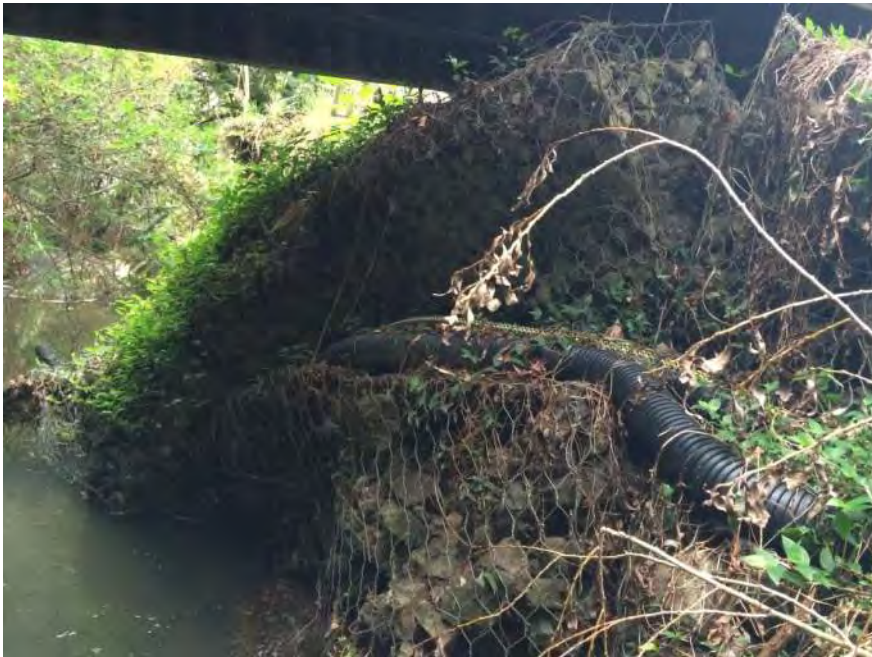
Figure 31: Poor condition bank lining on WAI_MAIN_15 under shared driveway.

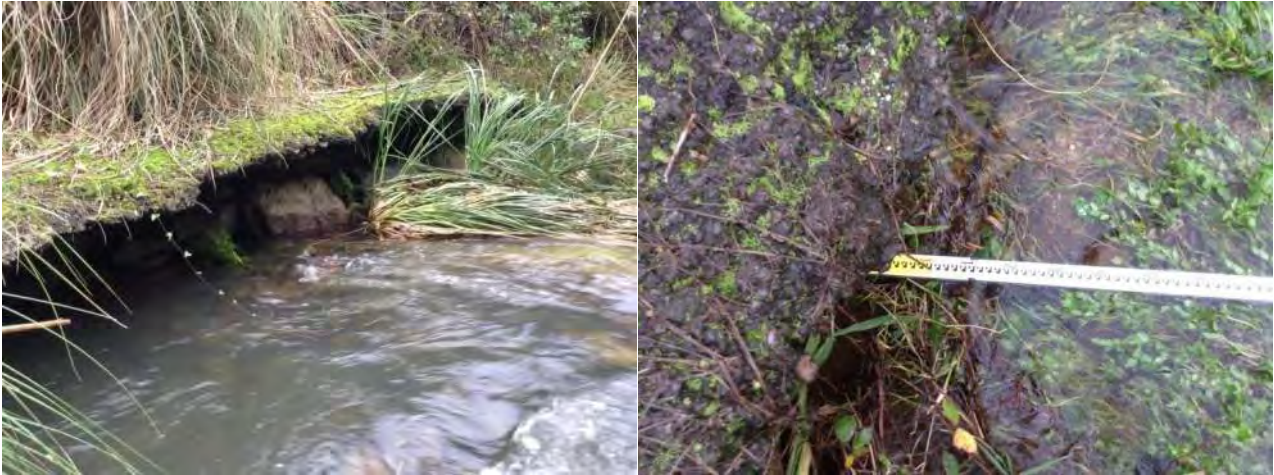
Figure 32: Undercut bank lining on HAY_MAIN_29

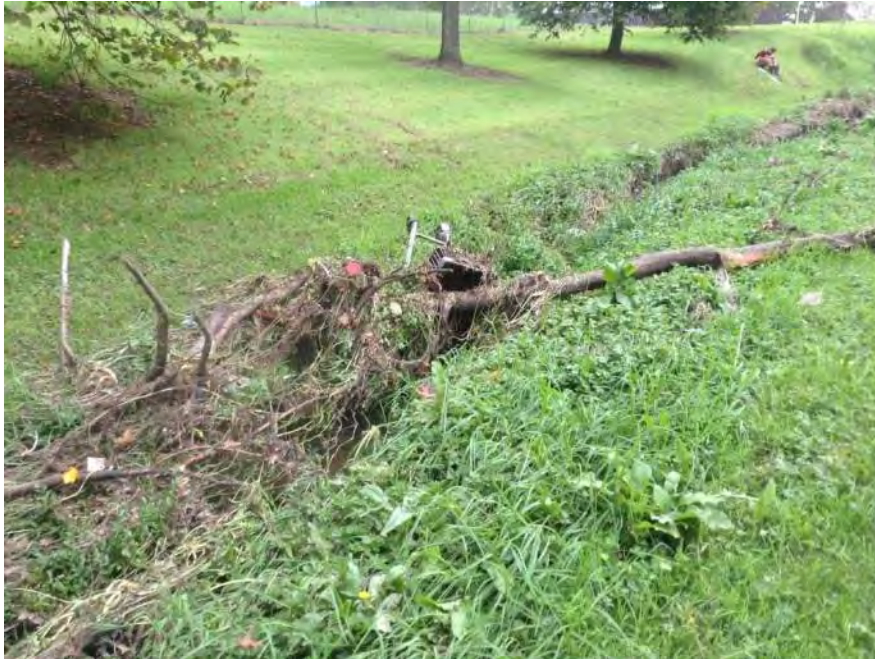
Figure 36: Debris jam obstructing flood flow caused by a shopping trolley on SLI_MAIN_31 at Keri Downs Park

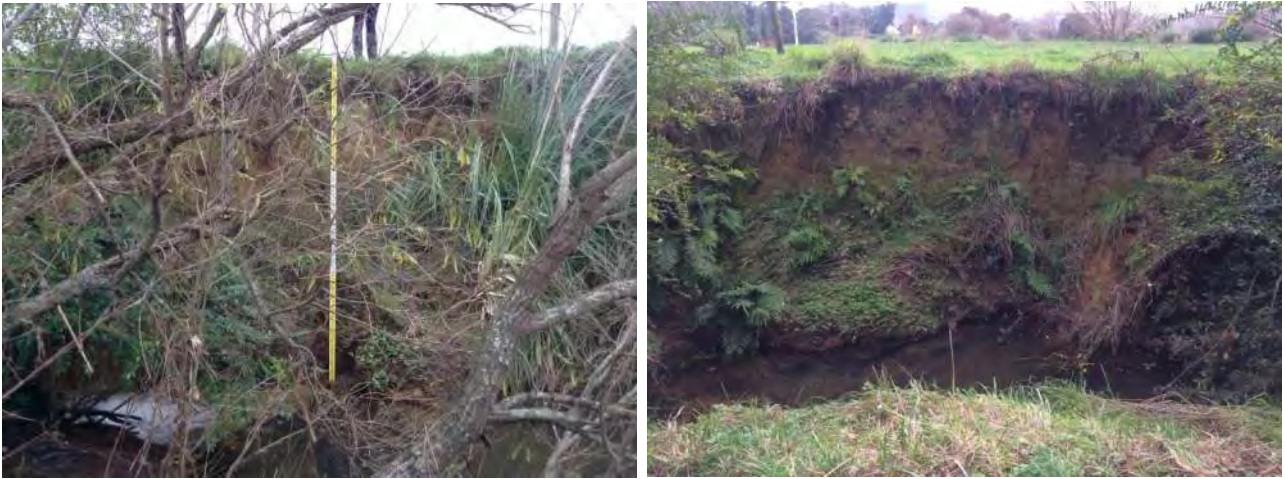
Nine landslides or slips were assessed within the reaches of SYM_MAIN_4 to SYM_MAIN_9 (Figure 37).

Figure 37: Land slips on SYM_MAIN_5 and SYM_MAIN_9

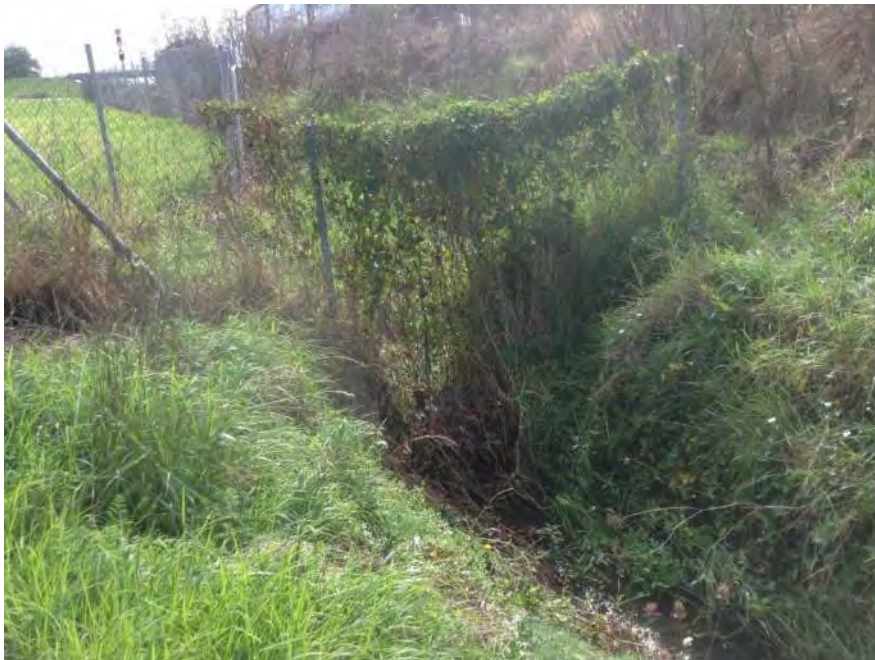
Figure 38: Wire mesh fence with debris build up potentially restricting flow on SLI_TRIB5_7

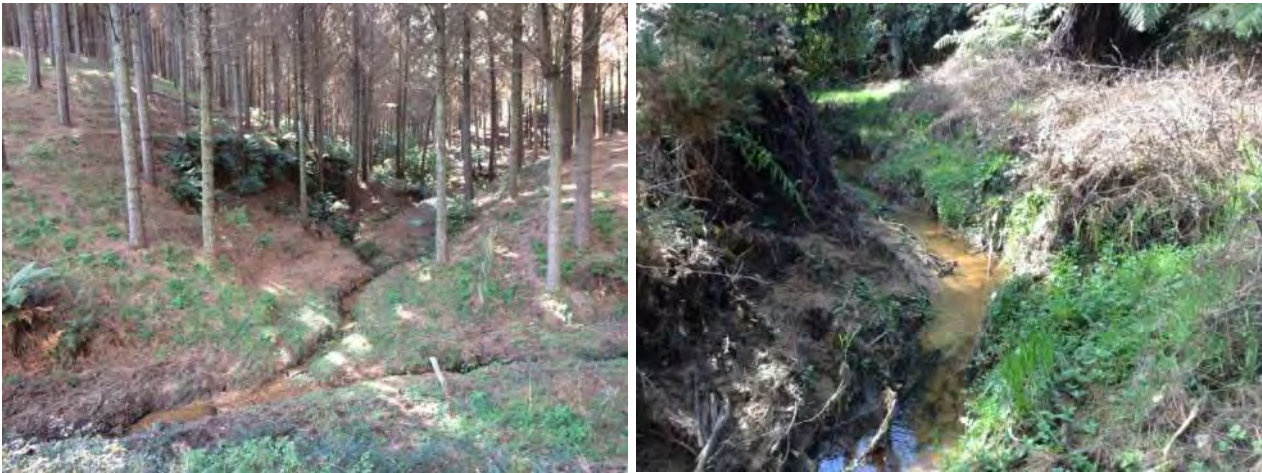
Figure 40: Mature pine plantation at the confluence of SYM_MAIN_FORK2_TRIB7_1 and SYM_MAIN_FORK2_16 and sediment and pine needle deposition in the floodplain and channel immediately downstream on SYM_MAIN_FORK2_14

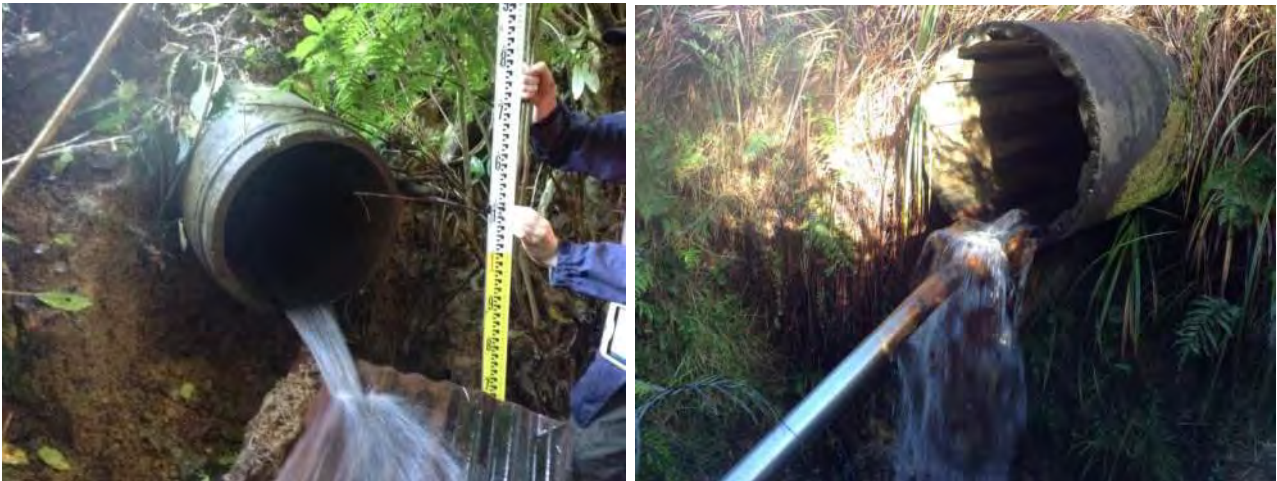
Figure 42: Upper culvert UNK_093 showing corrugated iron sheeting covering the lower culvert (right) and perched culvert UNK_092 (right) both on HAY_TRIB5_5.

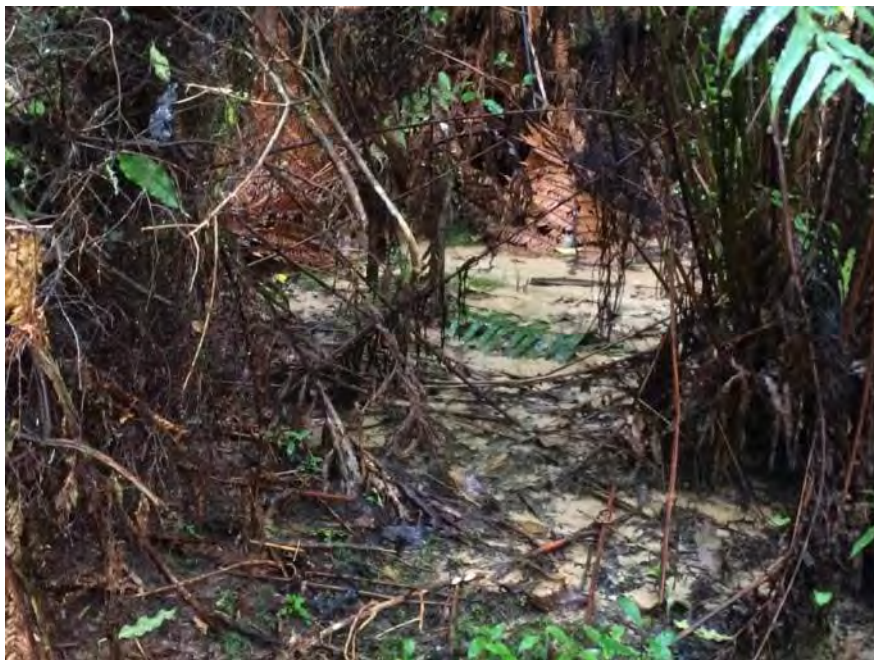
Figure 43: Sediment deposition on HAY_TRIB6i_5

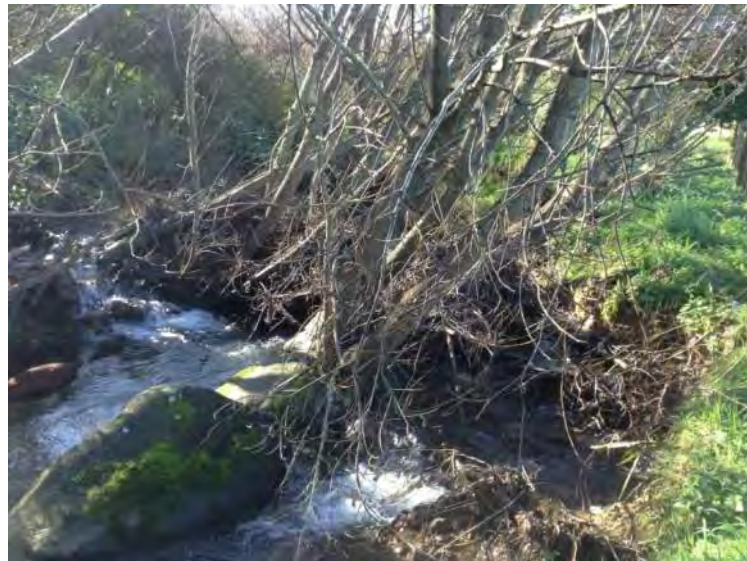
Willow instream on WAI_MAIN_12

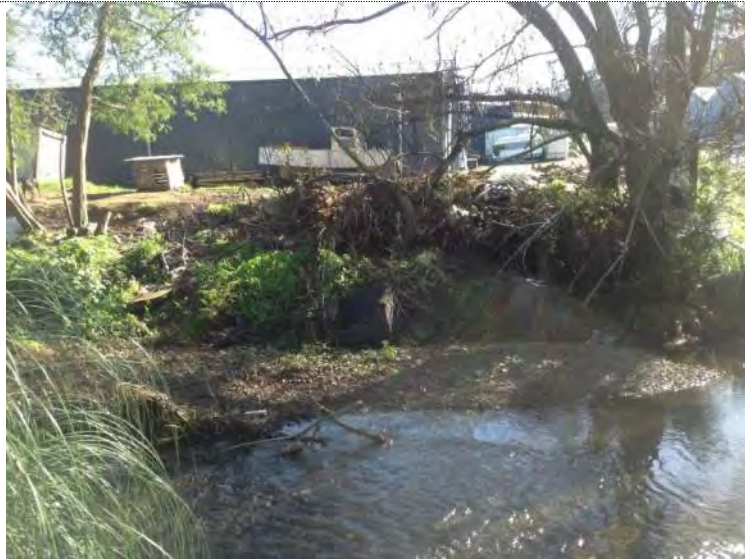
Rubbish dumping on HAY_MAIN_12

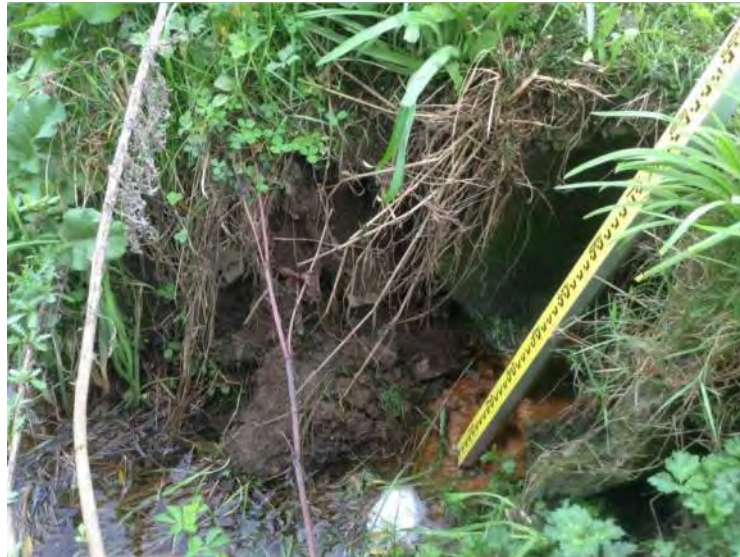
Erosion protection and structural repair required at outlet Asset ID 1115547

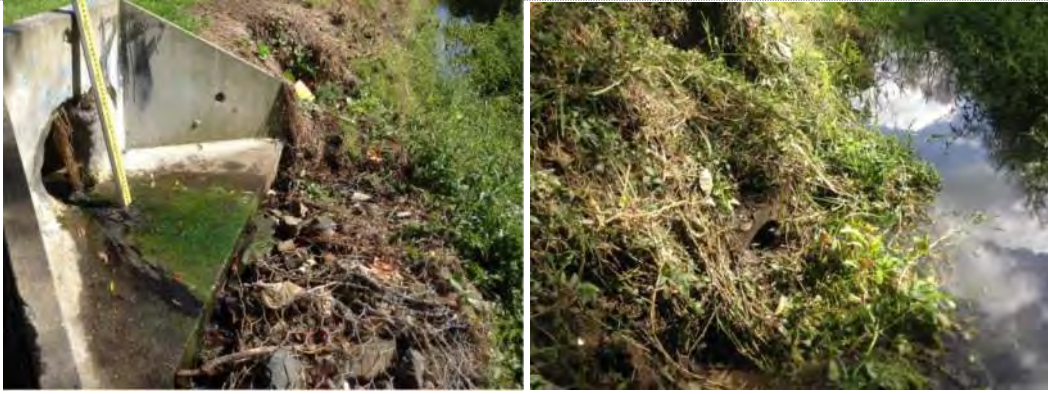
Sewage fungus at Asset 1135579. Poor condition structure separated from pipe (Asset ID 1116832)

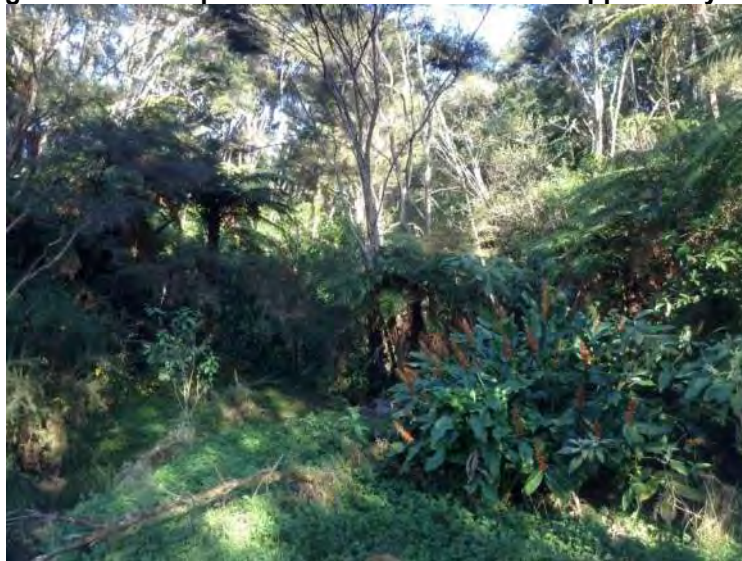
Edge effects evident upstream of driveway crossing over Tributary 3 of Symonds Stream
