**Residential New Build Construction Waste Audit Summary
(Whenuapai Site)**

Auckland Council Waste Planning Team

19th September 2023:

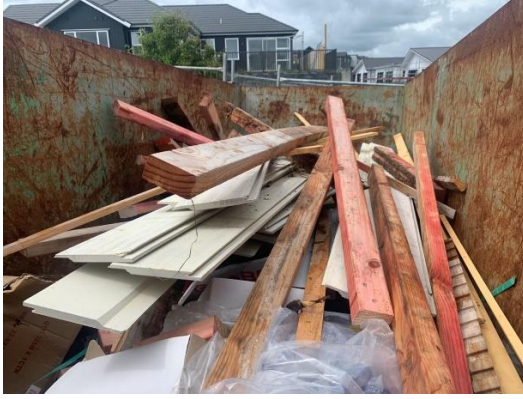
FIGURE 2: SECOND SKIP FILLING UP ON SITE DURING CLADDING STAGE.

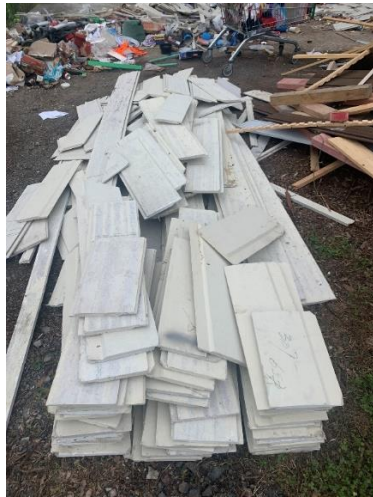
FIGURE 6: SORTED LENGTHS OF FIBRE CEMENT BOARD.

The largest waste stream by weight was the cement board cladding (Hardiplank) at 990kg. This stream was particularly high which was likely a combination of the density of the boards as well as the pitched roof design with the boards being laid vertically (meaning a large proportion of offcuts). Cement board is not typically able to be recycled in New Zealand although overseas it is commonly able to be crushed and used as a base course blend.

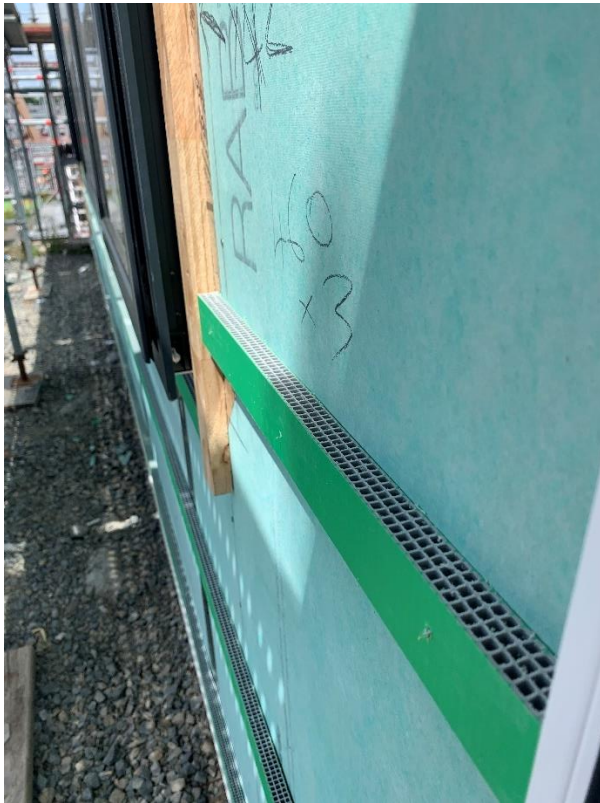
A delay with the supply of the Abodo cladding supply meant that RAB (Rigid Air Barrier) board was required over that section of framing which created additional waste. The James Hardie RAB board product is unable to be recycled so those offcuts plus the PVC plastic cavity battens used would become landfill. Total weight of the offcuts was 5kg so relatively insignificant. Worth noting that the GIB Weatherside RAB board has a gypsum core which is able to be recovered although that was not used on this project.

FIGURE 12: RAB BOARD WITH HORIZONTAL PVC CAVITY BATTEN (PRIOR TO ABODO VERTICAL CLADDING).

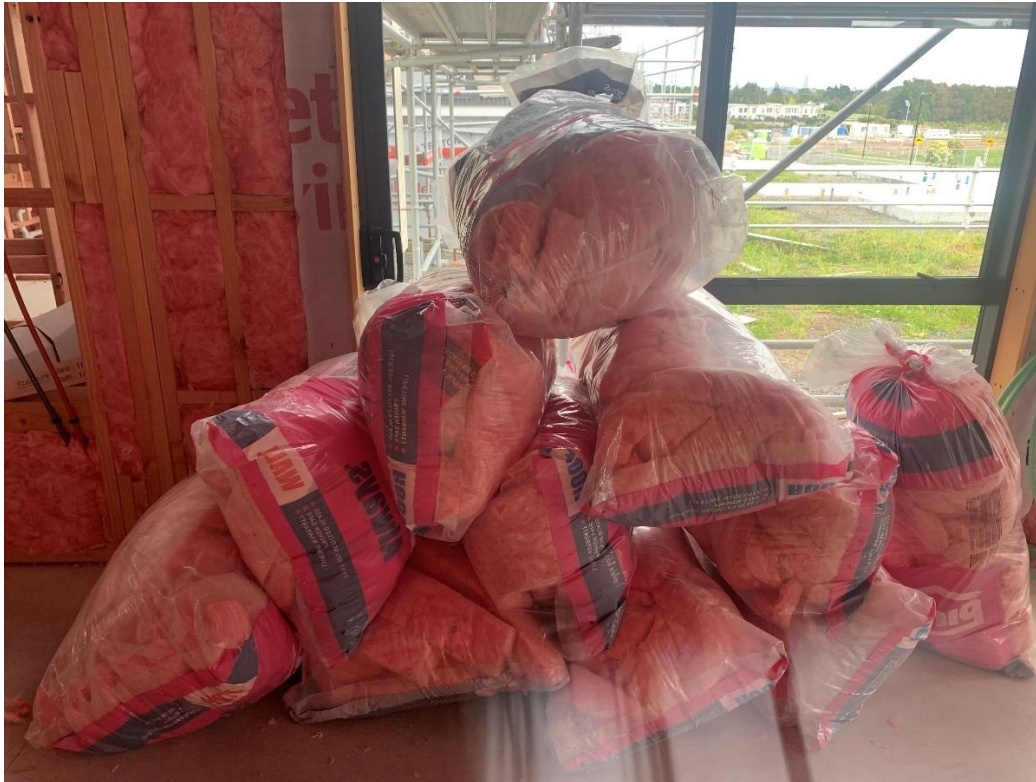
Project managers on site had made the assumption that the leftover insulation was being recycled as it was bagged up and removed by the installers. In practice though it was just the plastic bags that were recycled as the insulation waste is not recyclable. Normally this waste would just end up in a skip bin on site or back at the installers/ distribution site.

As the installers had bagged this as a separate waste stream, we were able to weigh easily and then sold the off cuts via Trade Me on \$1 reserve. The offcuts sold for \$11.50 but saved 49 kg or 1.5m³ of waste to landfill. Prior to listing on Trade Me these were offered to the Community Recycling Centre at the transfer station who declined them as they did not think they would sell.

FIGURE 13: BAGGED INSULATION OFFCUTS READY FOR COLLECTION.

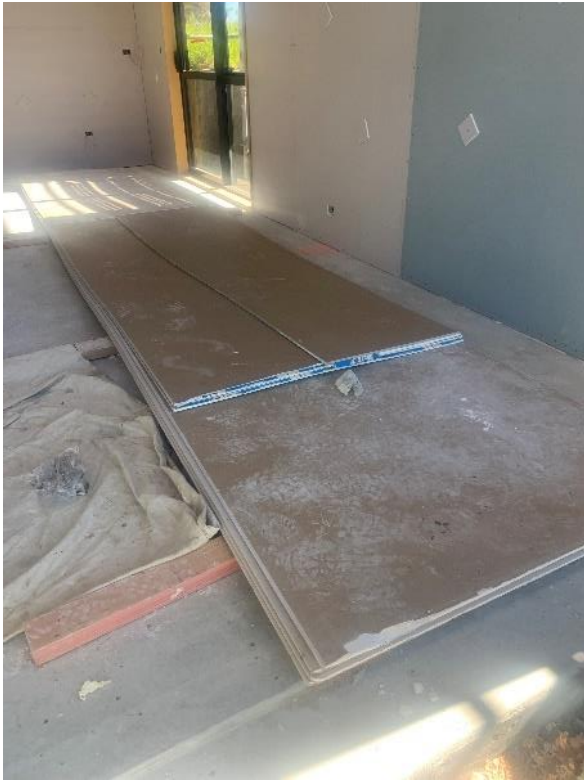
The plasterboard waste largely lined up with the expected quantity of waste based on the order (see below). The slightly higher than expected weight of 869kg is likely due to the pitched roof design. Plasterboard waste was around 25 % of the total build waste so a very significant component. There were several full sheets left over also but they were not included in the audit total as they were moved along to the next house in the development. The Developers process is to keep moving the leftover sheets along each build in the street and then to adjust the order to suit for the final house. Again this is an example of some of the efficiencies able to be achieved by developers building at scale.

FIGURE 15: FULL SHEETS OF PLASTERBOARD LEFT OVER TO BE TRANSFERRED TO THE NEXT HOUSE IN THE DEVELOPMENT.

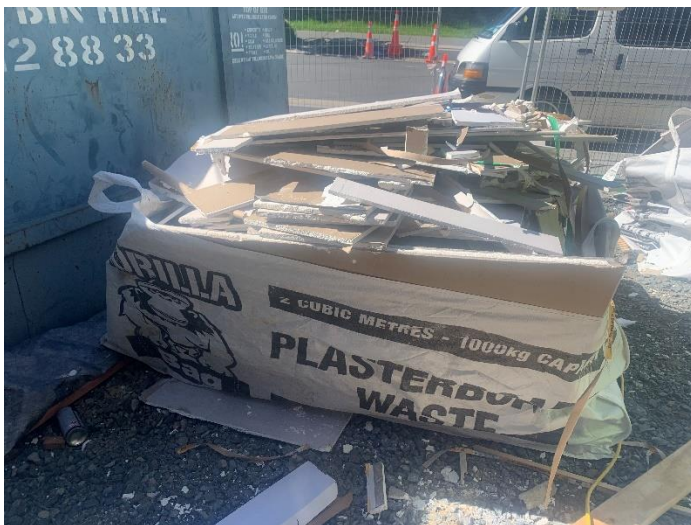
FIGURE 16: 2M3 PLASTERBOARD WASTE BAG READY FOR COLLECTION.

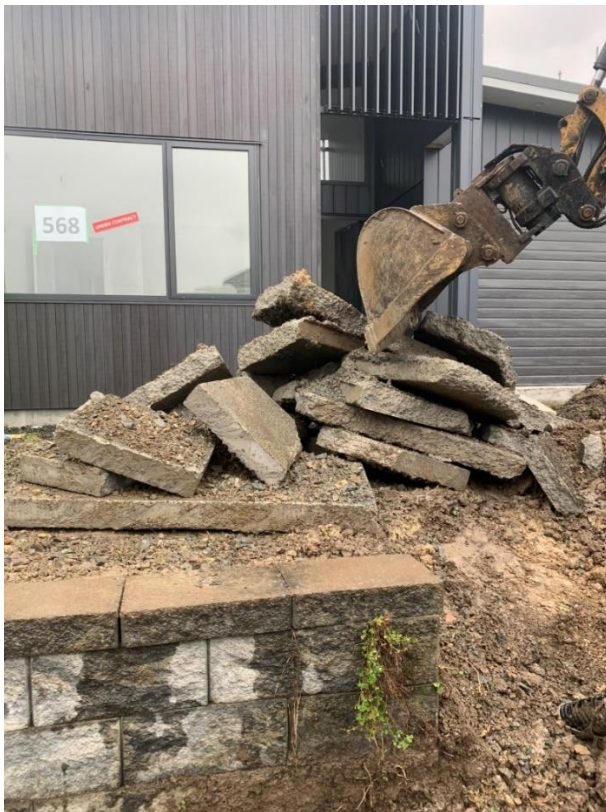
For this site there was 4200 kg of concrete from the footpath cut and then 23940 kg of spoil removed for the driveway cut. Most of the spoil removed was actually Gap65 metal that had been brought on to the site in preparation for the build. Once the driveway/ vehicle crossing are down to correct level then new metal is brought in for the base course.

Although the concrete is being crushed for reuse and spoil is cleanfilled, it is far from ideal use of resources and warrants further exploration due to the sheer scale in comparison to the build waste (28160 kg of concrete/ spoil vs 3679 kg of building waste).

FIGURE 17: CONCRETE FOOTPATH CUT AND STACKED READY FOR DISPOSAL PRIOR TO VEHICLE CROSSING INSTALLATION.
