20 QUESTIONS ON WATER

Q1 - What is the Howick Local Board's role and the Governing Body role in environmental services and water-related matters?

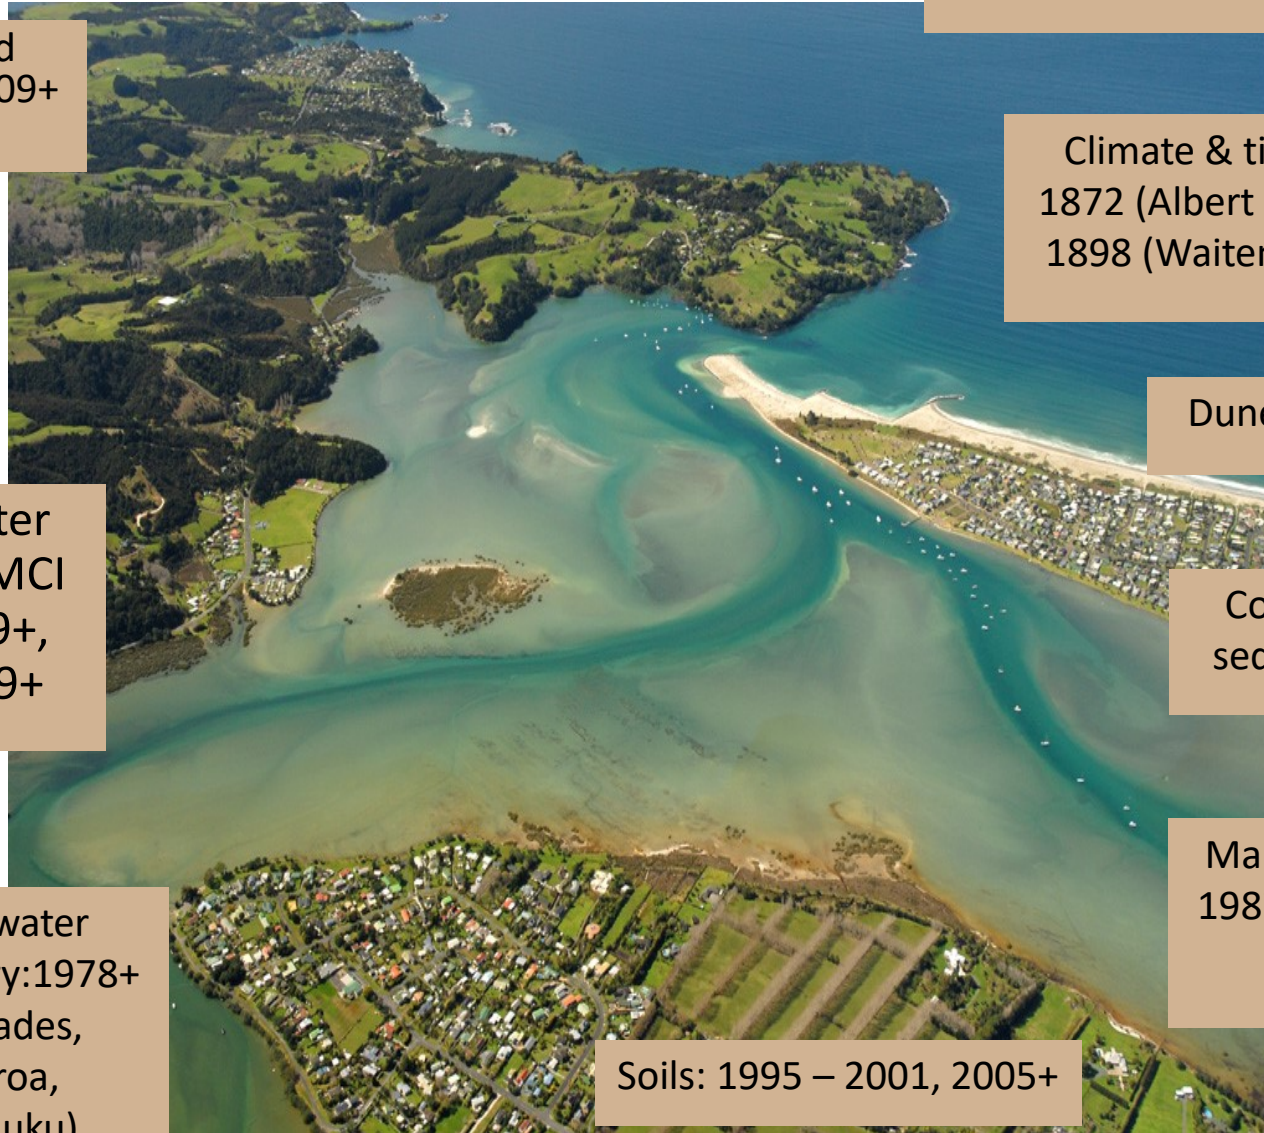
Q2 & Q3 cont – Environmental monitoring

Forests and wetlands: 2009+

Air Quality: 1993+

Climate & tides: 1872 (Albert Park), 1898 (Waitemata)

Dunelands: 2018+

Freshwater Ecology. MCI etc. 1999+, SEV 2009+

Contaminants in sediments: 1998+

Marine ecology: 1987+ (Manukau Harbour)

Freshwater Chemistry: 1978+ (Cascades, Wairoa, Opunuku)

Soils: 1995 – 2001, 2005+

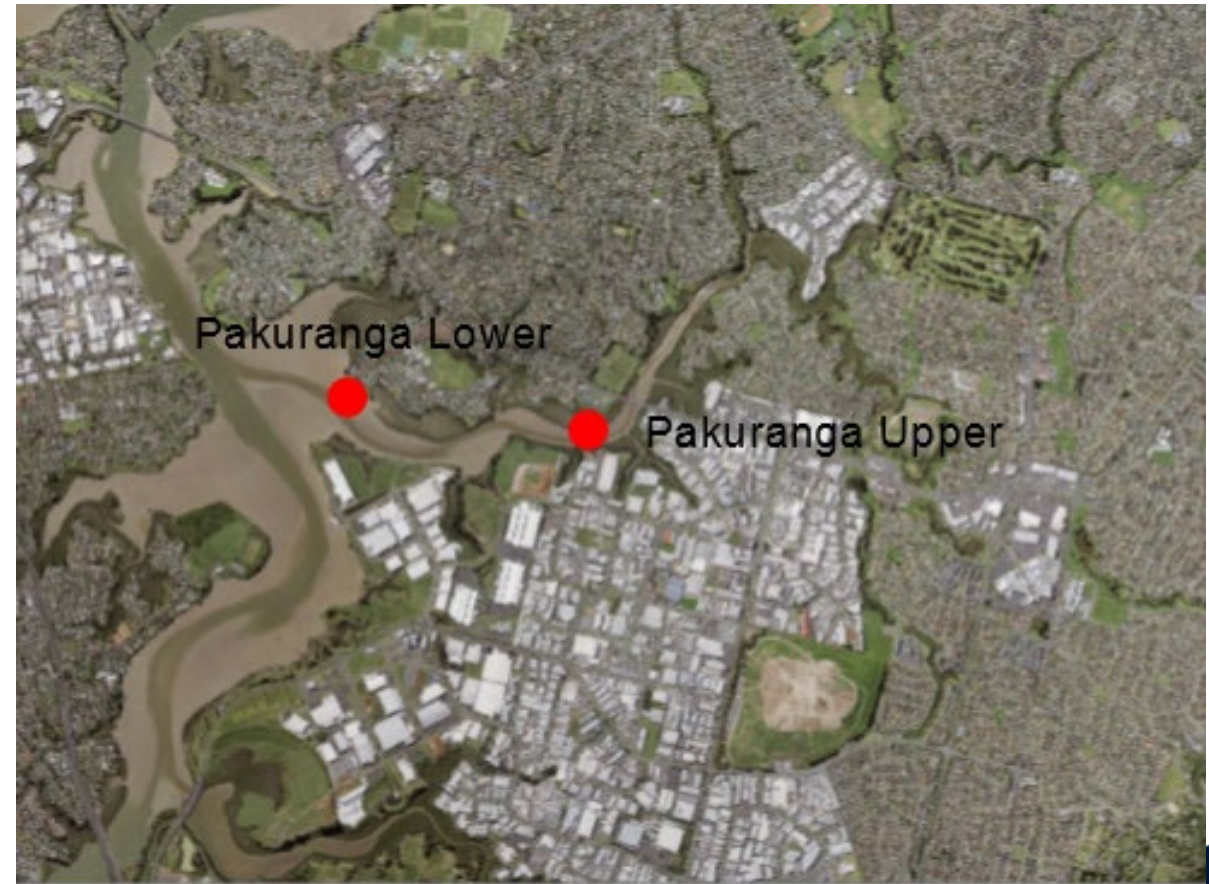
Q2 & Q3 cont – Sediment Contaminants

- 12 sites within the Tamaki Estuary – two within the Howick Local Board
- Pakuranga Lower and Pakuranga Upper sampled biannually since 1998.
- contaminant concentrations are assessed using conservative limits set in the Environmental Response Criteria (ERC)
- **Green** conditions reflect a low level of impact , **Amber** a moderate impact and **Red** are sites where concentrations are likely to have caused significant degradation
- similar results at both sites - elevated Zinc levels associated with urban and industrialised areas
- contaminant concentrations provide an indication of the potential effects of contaminants on benthic ecology.

ERC				Site Details	Comments
	Copper	Lead	Zinc	PAH		
Pakuranga Upper	Green	Green	Red	Green	Muddy SZ site. Mangrove encroachment. Urban catchment.	18 year monitoring period. No major changes over time. Cu & Pb possibly decreasing. Mud content variable.
Pakuranga Lower	Green	Green	Red	Green	Muddy SZ site. Urban catchment.

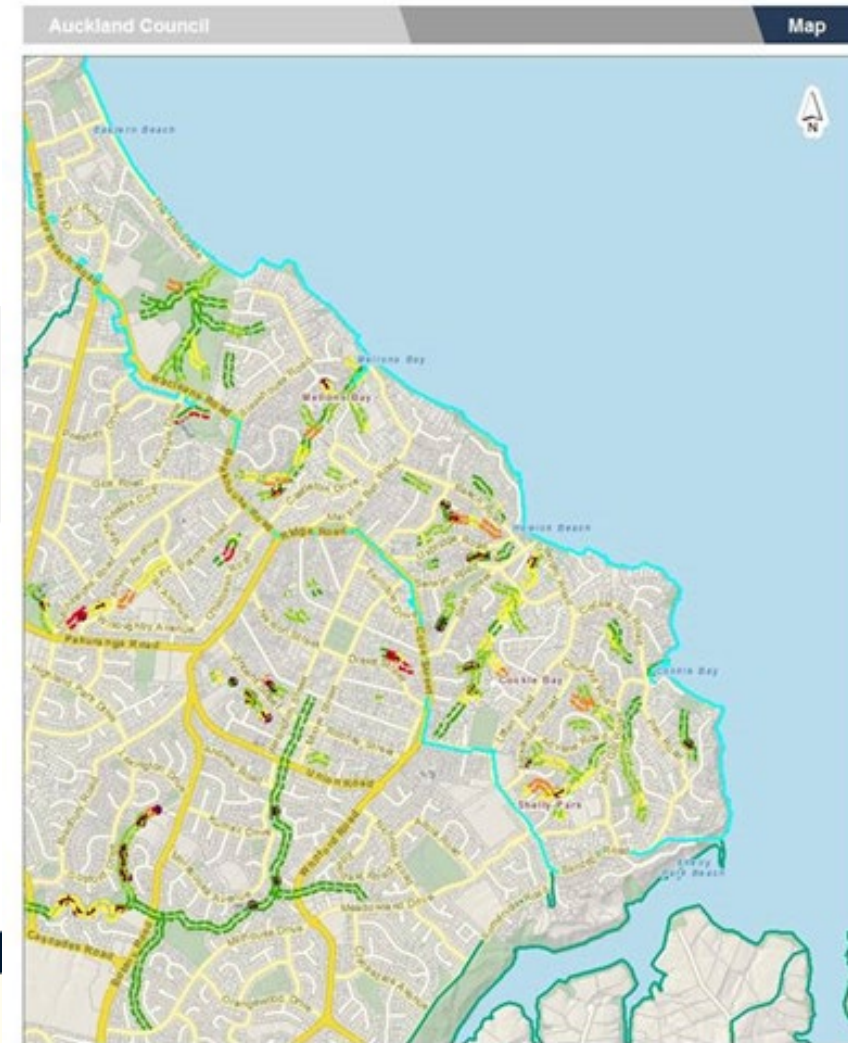
Q4 – What are some facts and figures on Howick waterways? (most particularly Cockle Bay, Howick and Mellons Bay beaches?)

- 13 km stream assessed

0%	≤20%	20-40%	40-60%	≥60%
Erosion Scarring (% of total stream length) (length of stream (m))	30% 3,934	41% 5,364	21% 2,722	8% 1,080	- -

Erosion	Excellent	Good	Fair	Poor
Overall Stability Index (% of total stream length)	none Scores ≤13	0.13 Scores 14-23	0.93 Scores 24 -32	0.45 Scores ≥33
	Percentage of the No. of reaches with >60% erosion scarring		Total No. Erosion hotspots	
	0		16

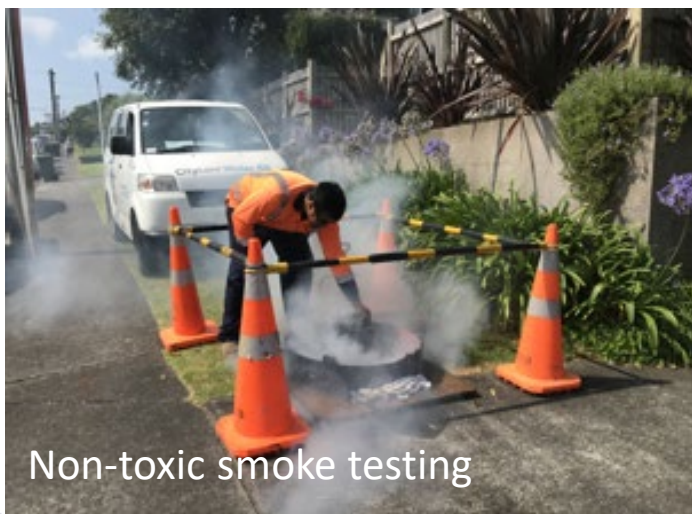
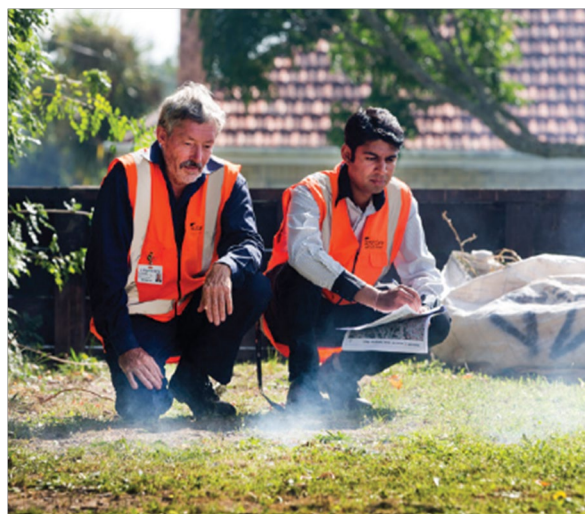
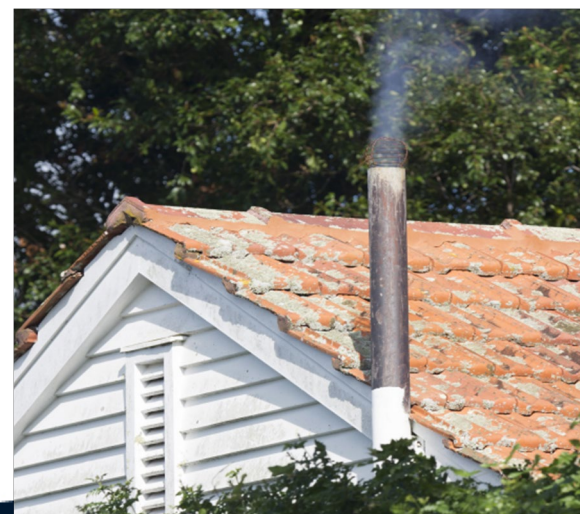
Case Study: Investigation of overflow incident at 41R Meadowland Drive , Howick (Howick Tennis & Softball Club)

Summary of investigation findings:

- private drainage issues:
 - ineffective gully traps found on private wastewater pipes from the club's buildings
 - toilet building had no gully trap at all
 - Effective external gully traps help keep overflows outside of buildings.
- public wastewater network issues:
 - inspections found partially blocked wastewater pipe - lose pieces of concrete, debris and fats which would have reduced capacity of the pipes during heavy rainfall
 - the connecting wastewater network has been cleaned
 - source of concrete has not been identified.

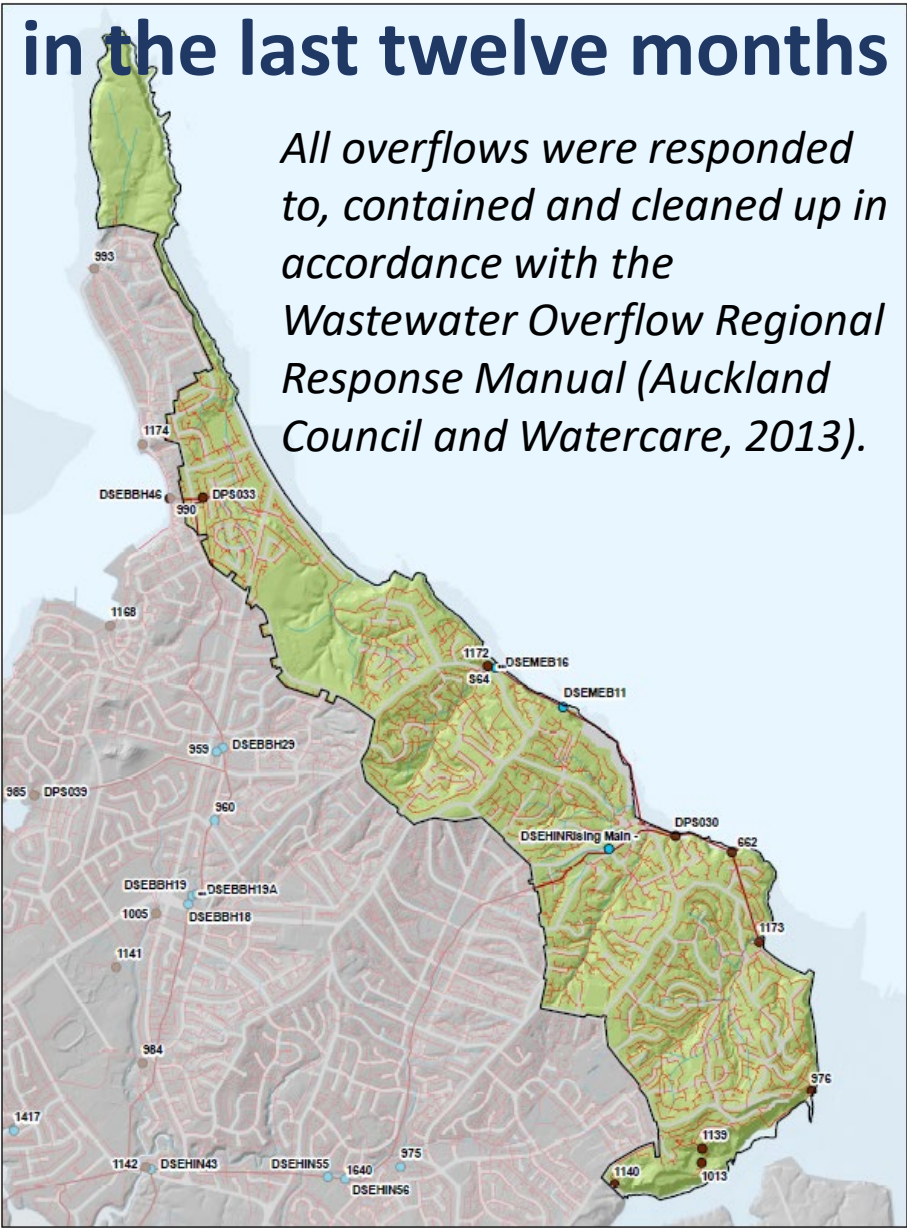
All overflows were responded to, contained and cleaned up in accordance with the Wastewater Overflow Regional Response Manual (Auckland Council and Watercare, 2013).

3rd party damage	Broken Pipe	Fat	Foreign Object	Rags	Roots	Rubbish	Surcharging	Unknown	Total
2015-2016			6			21	1		9	37
2016-2017		5	7	2		7		14	15	50
2017-2018		2	6	2		18	4	3	10	45
2018-2019	1	4	4	1	2	12	2	13	6	45
2019-2020		1	9	1	3	14	1	2	12	43
Grand Total	1	12	32	6	5	72	8	32	52	220

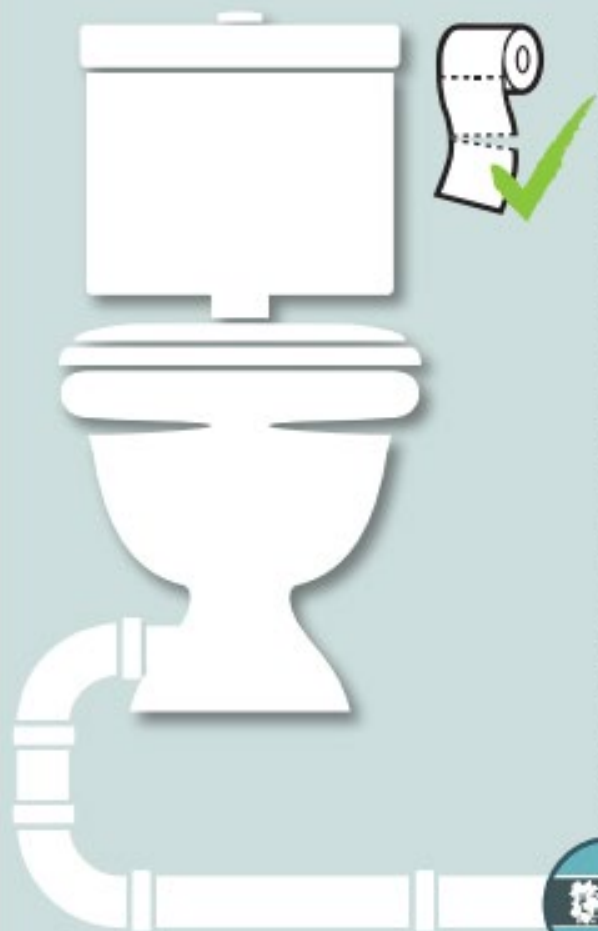
Small items can cause big problems for your toilet.

These items don't break down in water or within the wastewater network like toilet paper does. Instead, they form large clumps that block pipes and cause overflows.

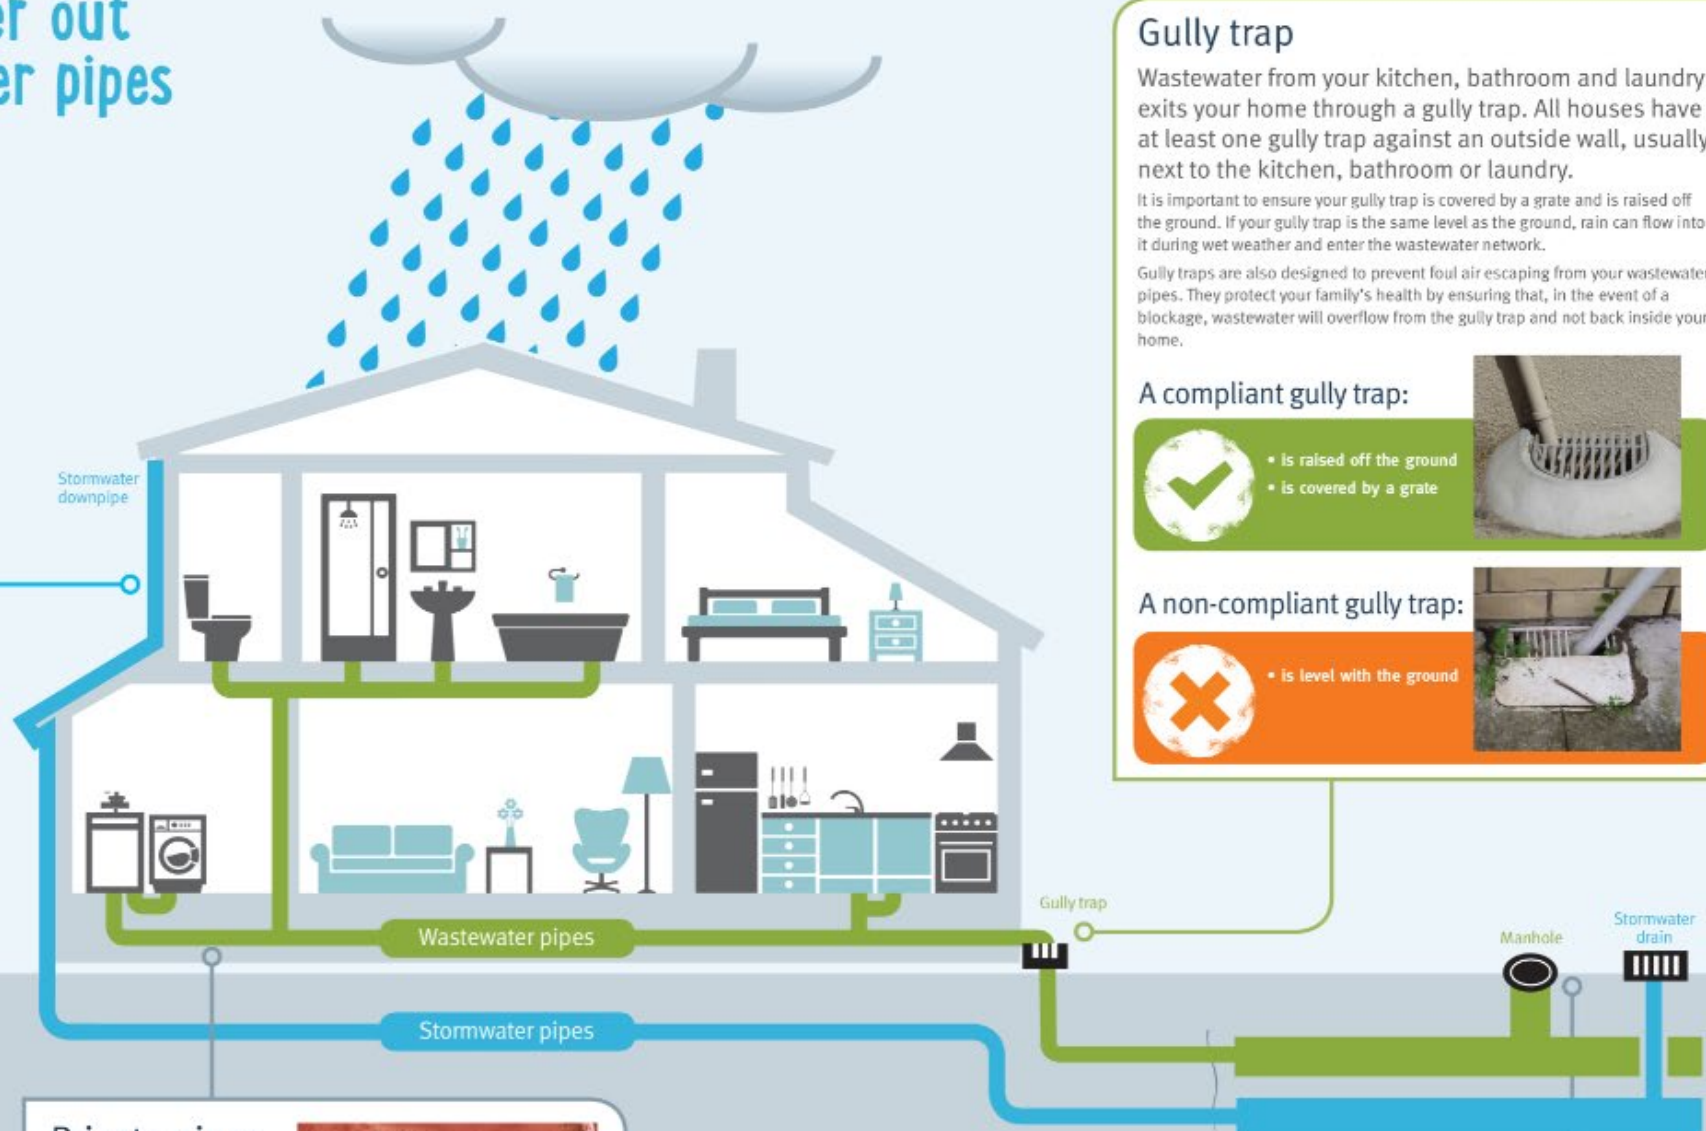
Keeping stormwater out of your wastewater pipes

Downpipes

A downpipe collects rainfall (stormwater) from the roof and should connect to the stormwater network only.

A compliant downpipe:

- is separate from a gully trap
- connects to the stormwater pipes on your property

A non-compliant downpipe:

- is connected to a gully trap, so stormwater will enter wastewater pipes
