# DAVID NATHAN PARK AND HOMESTEAD

## CONSERVATION PLAN

# David Nathan Park and Homestead Manurewa, Auckland

Prepared by  
Matthews & Matthews Architects Ltd  
P O Box 108 166 Symonds Street,  
Auckland

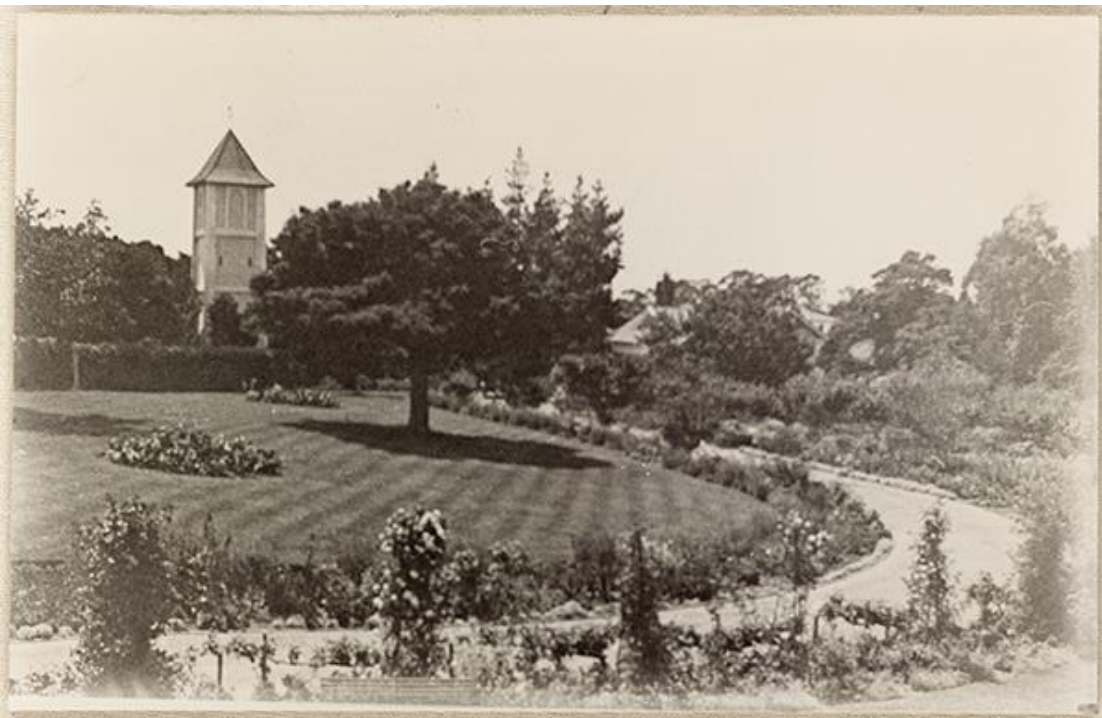
*The water tower at 'The Hill', the Nathan family's residence in Hill Road, Manurewa, ca 1935. This structure was designed by architect D.B. Patterson in the style of an old Norman Church tower. Manurewa Historical Society, Auckland Libraries, Footprints 06244.*

In addition to the new house, the family commissioned Patterson to design a new water tower, based on a post-card image of a Norman Church tower.<sup>68</sup> Built within the remnant forest, the tower was constructed of concrete and its roof was capped with a weathervane featuring a kiwi.

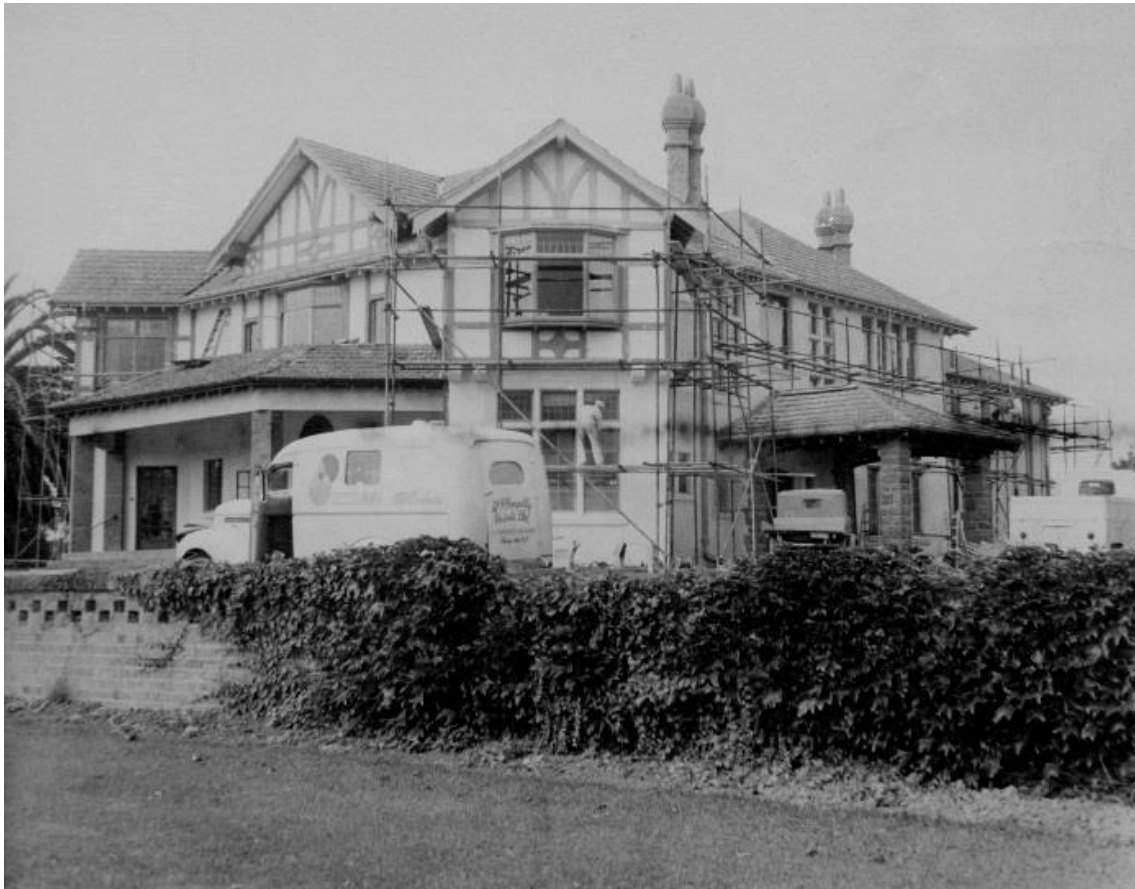
*Figure 9: Nathan Homestead getting a "facelift" in March 1964. Murray Freer, Stuff Ltd, Auckland Libraries, Footprints 00076.*

In the 1930s the brick wall framed the stairs leading to the north garden. (Footprints 06237) The walls here were extended sometime prior to 1964 when photographs show the extended wall covered in a creeper. (Footprints 00076) In 2016 the deteriorated brick wall to north of the homestead was dismantled and reconstructed. (Property File)	Moderate
20	Brick wall close to west side of homestead

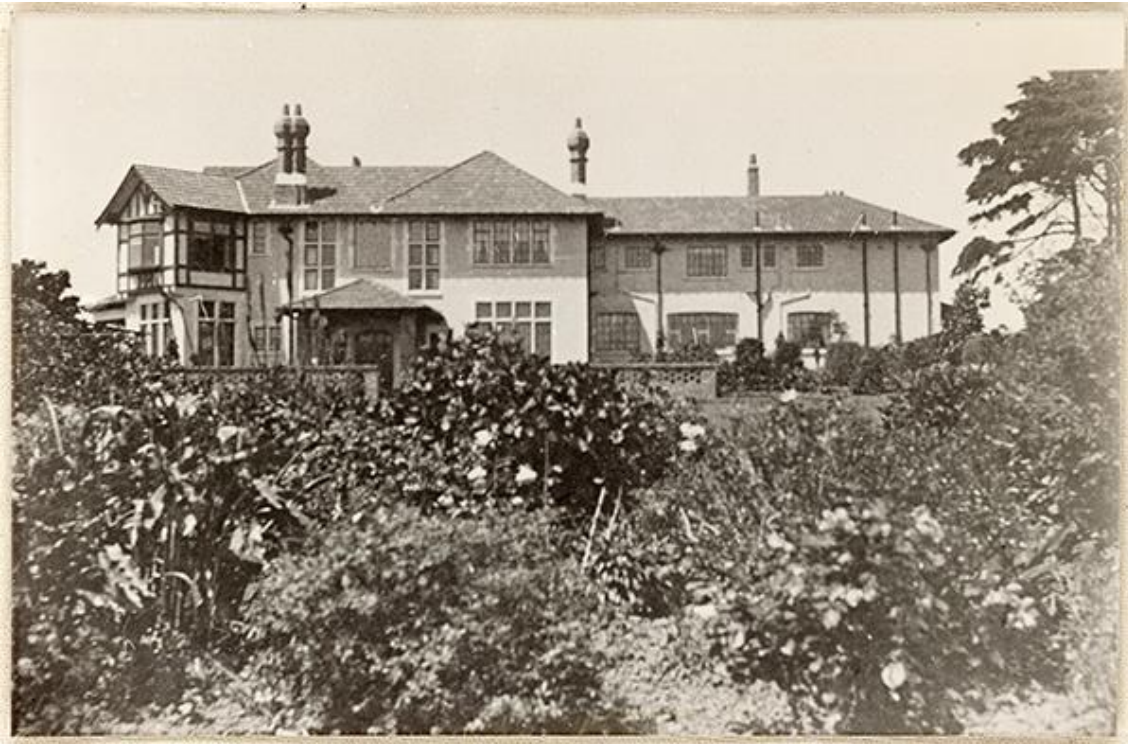
*Figure 10: View of the 'The Hill', the Nathan family's residence in Hill Road, Manurewa, ca 1935. This is the western side of the house as seen approaching along the driveway. Manurewa Historical Society, Auckland Libraries, Footprints 06236.*

The house is constructed of cavity brickwork, with a brushed render finish, and has half-timbered bays to the upper level on the north and east sides. The hipped and gabled roof is clad with terracotta tiles and there are four tall brick chimneys. The half-timbered bay on the east side is flanked by generous enclosed sleeping balconies at the upper level, clad with terracotta shingles. Verandahs on the north and east sides have tiled concrete floors and brick piers. Aluminium joinery has generally replaced the original steel windows. A portico, supported on stone piers, protects the main entrance on the west side. The southern service wing is plainly detailed. A recessed porch at the south end provided access to the service wing.

Brick wall to the east side of the lawn are evident in a photo dated c. 1935 Footprints 06236. The wall appears to have been reconstructed using modern bricks. Walls to the north and south appear to be evident in 1959 aerial. The middle section of the south wall was rebuilt in 2017. Note- The walls are significant as Nathan Family era features. The work repairing original fabric where done poorly, can have an impact on values, but the walls/	Moderate

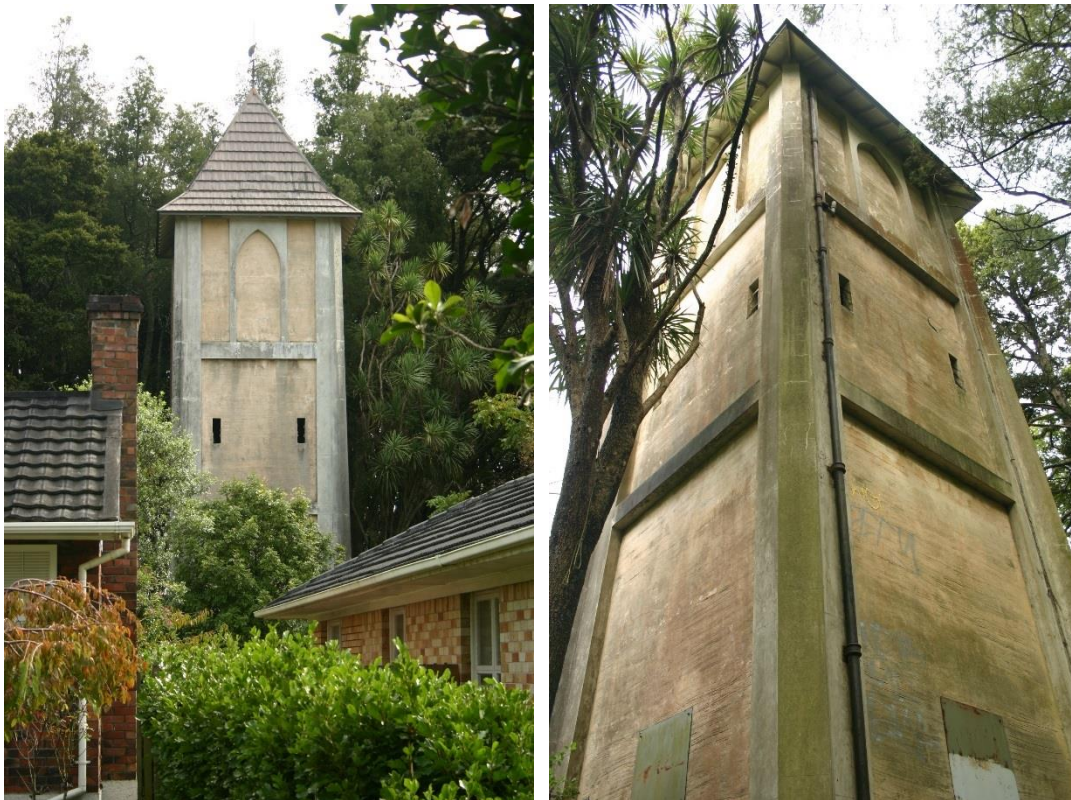
Figure 14: Views towards the water tower. Photos Matthews & Matthews Architects Ltd 2008

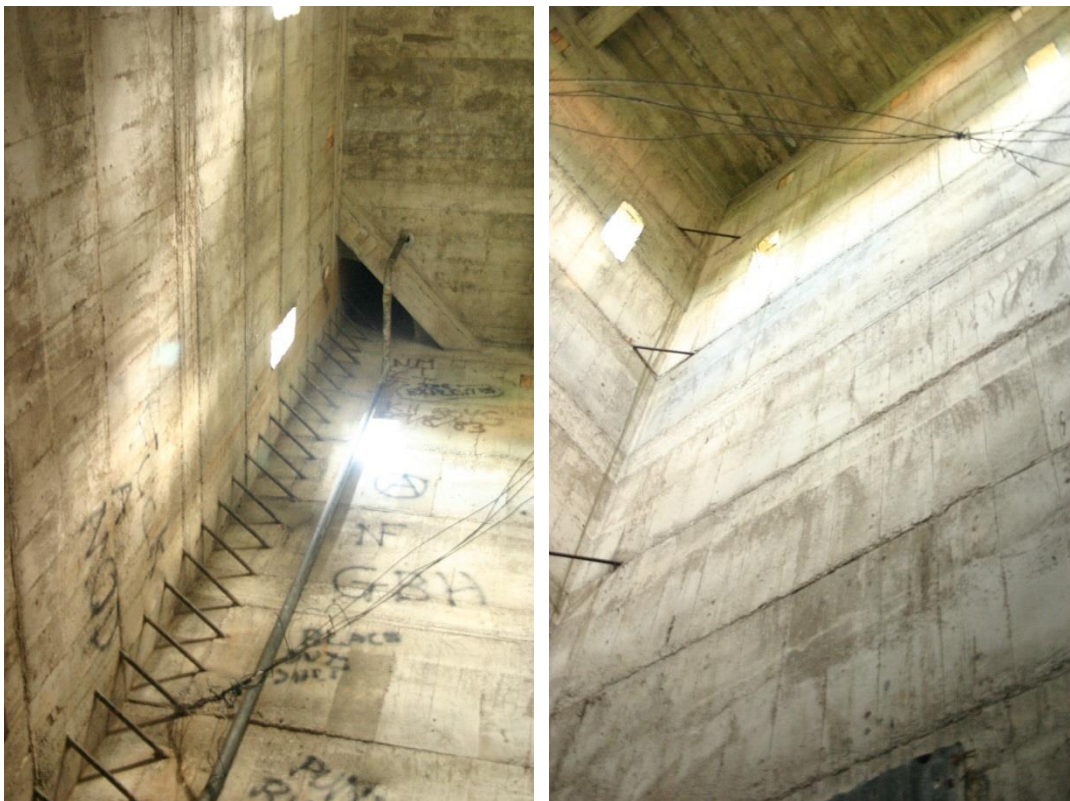
Figure 15: Views inside the tower, looking up towards the tank. Matthews & Matthews Architects Ltd 2008

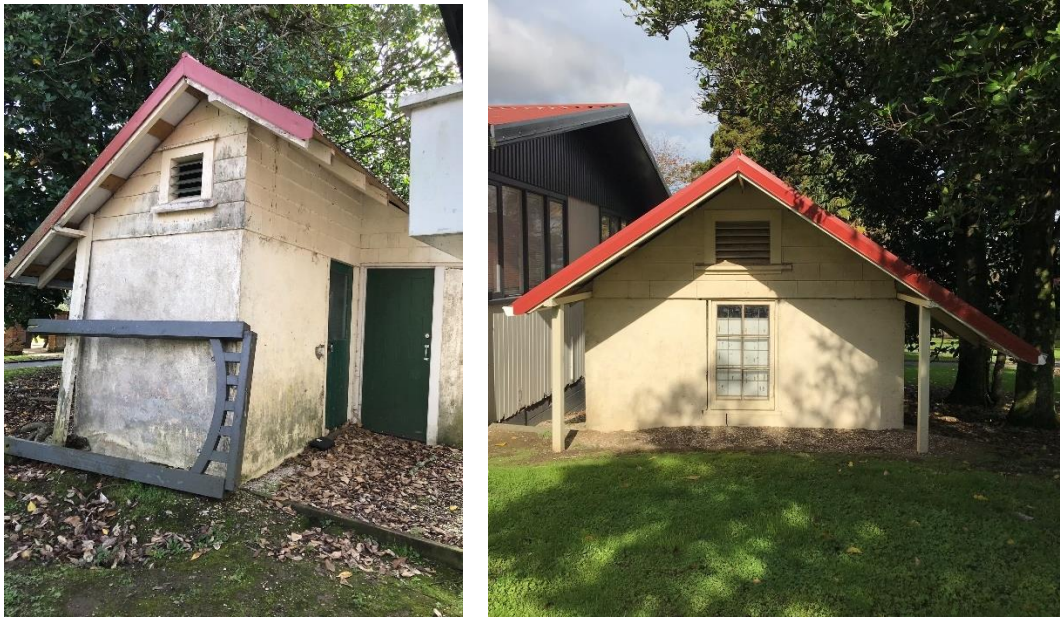
Figure 17: Views of the Dairy. Matthews & Matthews Architects Ltd 2018.

The small building located to the south west of the existing Nathan Homestead is believed to have been built as the dairy around a similar time to the original house on the property in 1910.<sup>130</sup> Dairies were used for making butter. An Assessment of Cultural Heritage Value report by Dave Pearson Architects notes that *Brett's Colonists' Guide and Cyclopedia of Useful Knowledge* commented that a dairy 'for convenience should be detached, dry and airy. A south or south-eastern aspect is best in this country and the building should be shaded by trees to protect it from the sun and keep as cool as possible in summer.'<sup>131</sup> Dairies often had a lofty ceiling and a concrete floor to keep a cool temperature and were sometimes partly dug into a slope.

In the assessment, Dave Pearson notes that the building has many of these characteristics. It has a roof with generous eaves overhang to shelter the brick walls and has a concrete floor. The building appears to have been built in stages. The northern section believed to be the earliest and measures 3 x 3 metres. The south section measures 2.5 x 2 metres. The walls are constructed with a single skin of brickwork, plastered on both sides. The existing roof is corrugated iron. The gabled roof extends past the walls at the north end and is supported on posts. The gable ends are clad in timber shingles and have louvered vents to allow cross ventilation.

Dating from c.1910s, the small building is thought to be the earliest structure on the property and is a reminder of the farming activity and food production on the property. It is the only surviving out-building that formed part of the complex of buildings and glass houses that were located to the south of the existing house.

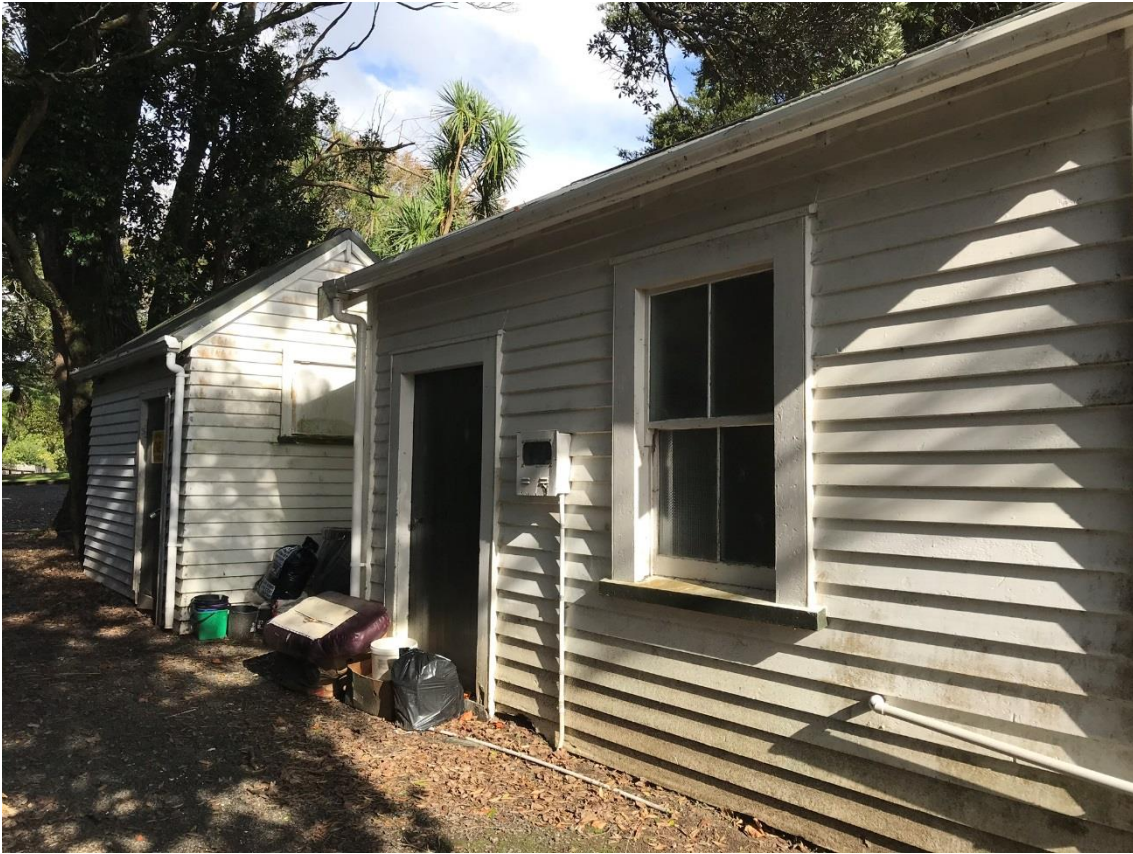
*Figure 19: View to east side of the timber sheds located to north east of the tennis court. Matthews & Matthews Architects Ltd 2018.*

The north shed is clad with timber weatherboards, with boxed corners and has a corrugated iron roof. The inside has painted hardboard linings to its walls and ceiling. The shed has a concrete floor. It has a door and casement windows on the west side, and a door and double hung sash window on the east side, and a fixed window on the north end.

The south shed has timber weatherboards with galvanised soakers at the corners. It has a gabled corrugated iron roof. It has doors on its south and east side, and a window on the north side. Inside, the building has timber sarking beneath the iron roof. In the north west corner is a concrete plinth and pipework, which may possibly be associated with a water bore. It has been noted that the area of the farm north of the sheds may have been used for farming pigs, based on a photograph in the Nathan Homestead.

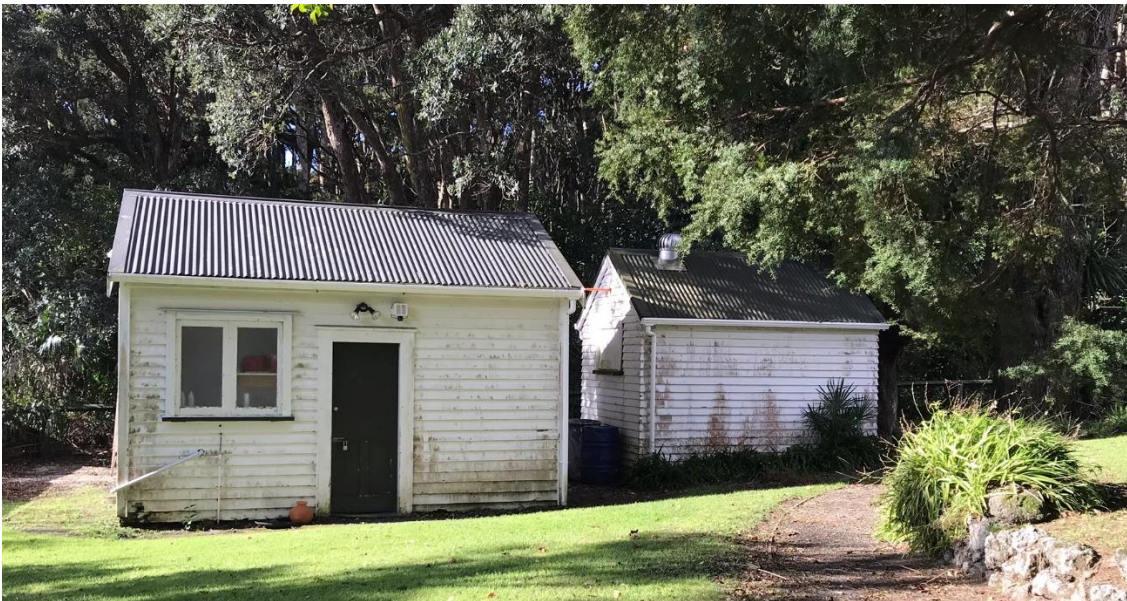
*Figure 20: View to west side of the timber sheds. Matthews & Matthews Architects Ltd 2018.*

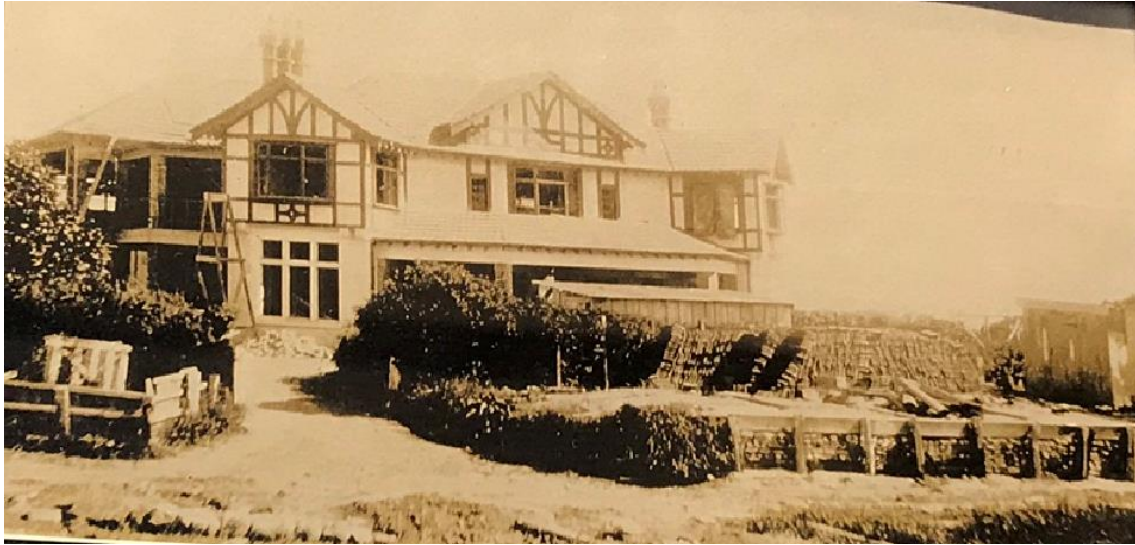
*Figure 23: View towards the north side of the house c.1925, showing what appear to be changes being made to form the terrace in front of the house. Photo displayed in the Nathan Homestead from Dennis Nathan's family album.*

The terraced lawn to the north of the house appears to have been formed or more formally edged at a similar time to the existing house. Historic photos show a change in level being formed. Initially the red brick walls did not extend right along this change in level. There were brick walls framing the stairs, with a grassed bank to either side.

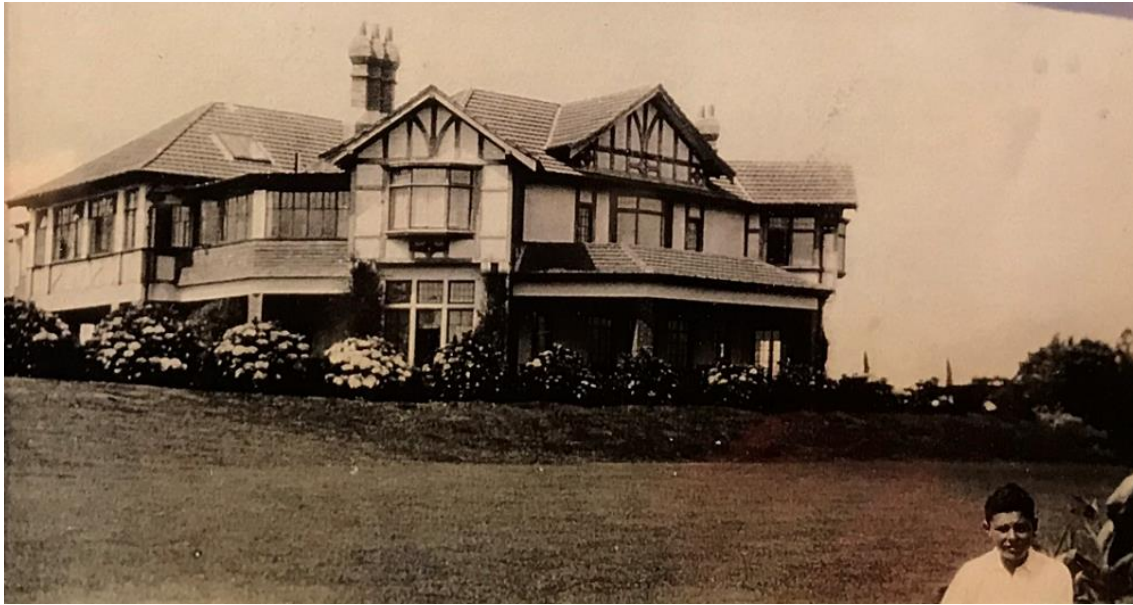
*Figure 25: View towards the north and east sides of the house. At this stage a grassed bank, lined with hydrangeas edges the change in level from the drive to the lower lawn. Photo displayed in the Nathan Homestead from Dennis Nathan's family album.*

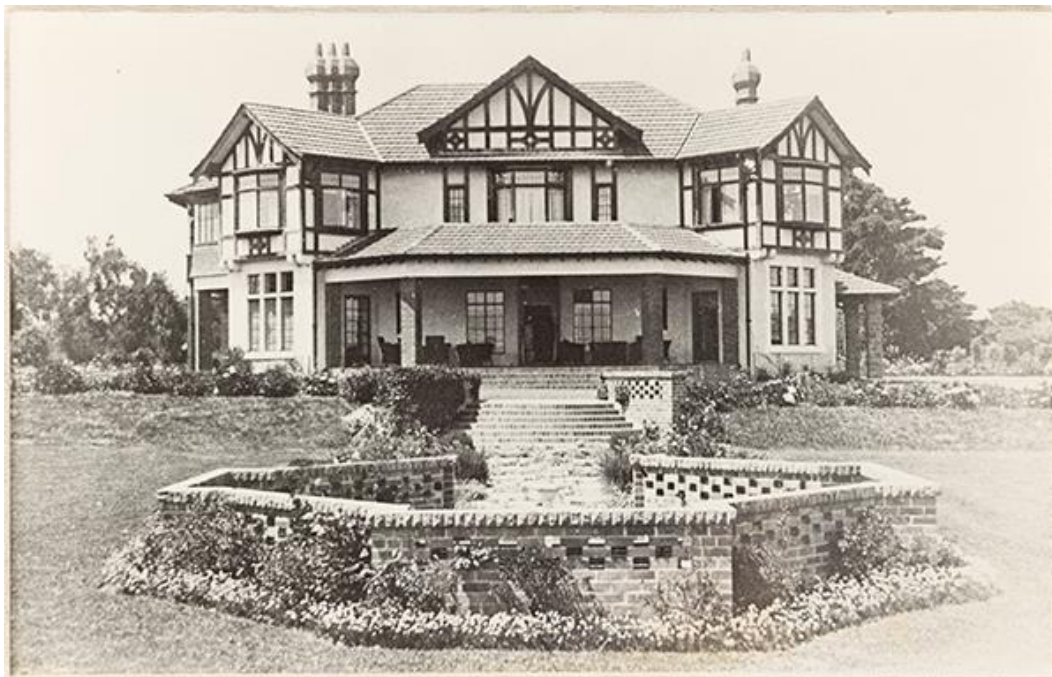
*Figure 28: View of the walled garden looking back towards the homestead, c. 1935. Manurewa Historical Society, Auckland Libraries, Footprints 06237. The brick wall did not yet extend to either side at the top of the steps, where a planted bank appears to be evident. A sun dial was located in the centre of the walled garden, with open views back to the house.*

To the north of the house, the brick walls initially enclosed the octagonal garden feature and framed the stairs. They did not extend to either side of the stairs along the edge of the drive as they do now. There was a planted and grassed bank instead along this edge. (Refer Footprints 06237).

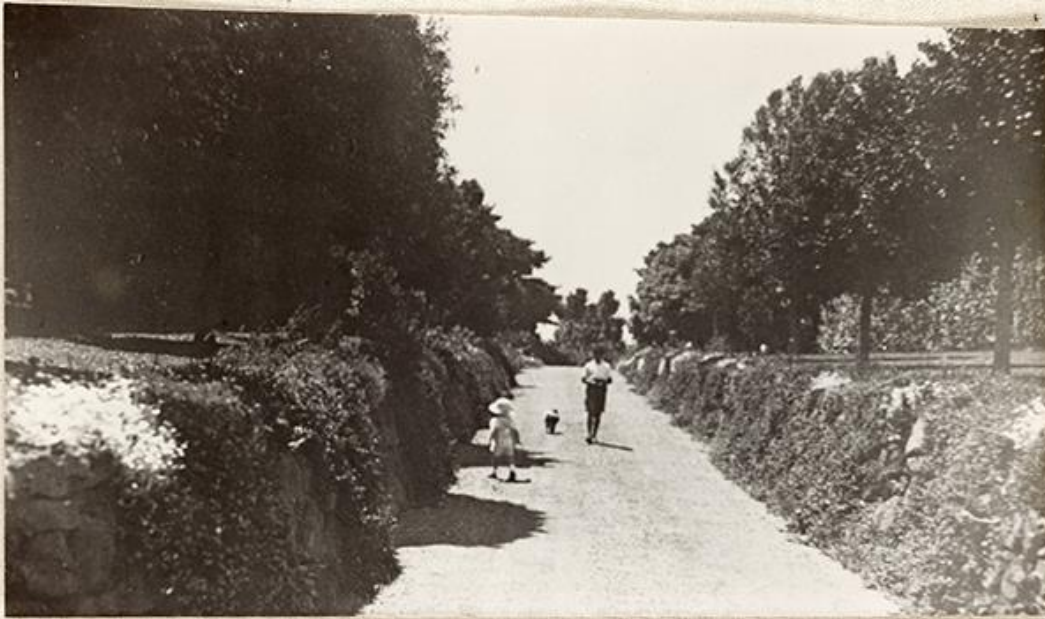
*Figure 34: View of the entrance to the west driveway c.1935. The drive was edged on both sides by stone retaining walls, and a row of trees. Manurewa Historical Society, Auckland Libraries, Footprints 06239.*

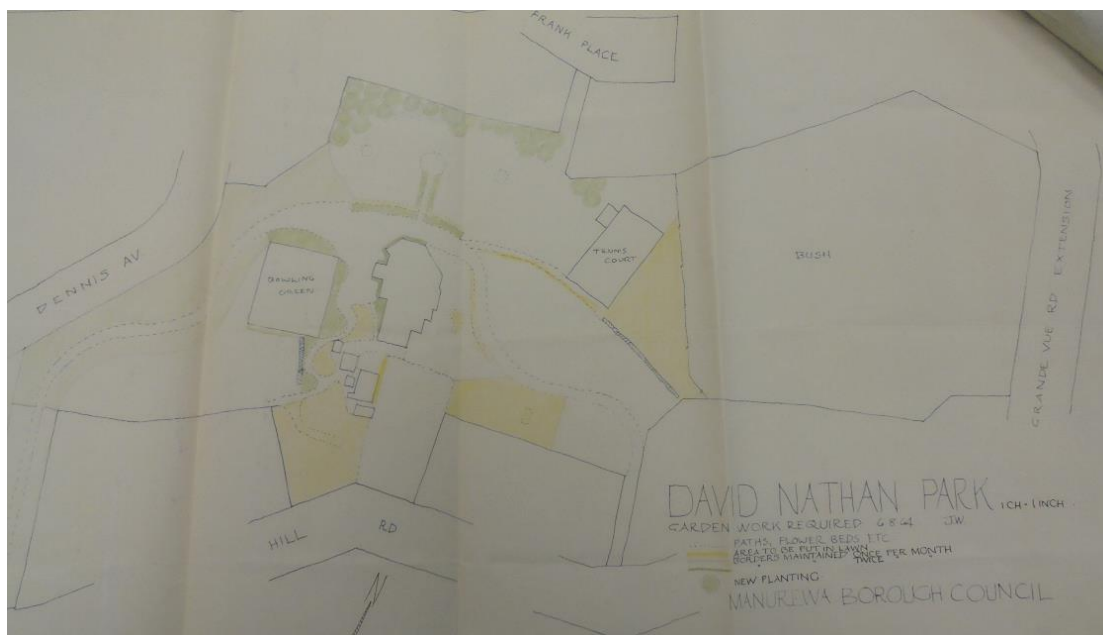
Figure 38: 1964 Site Plan showing Garden Work Required at David Nathan Park, Hortus Contractors. Auckland Council Archives South. Garden areas shown in yellow were to be changed to lawn, including a rockery adjacent to the tennis court. MBC 004 Item No 100, Record ID 692049, Box No 7, Record No 16-8-1.

In the same year Hortus Contractors recommended sowing parts of the grounds in grass to facilitate maintenance. A rock garden area behind the tennis court was to be removed and the area sown in grass because it required a lot of labour.<sup>183</sup>

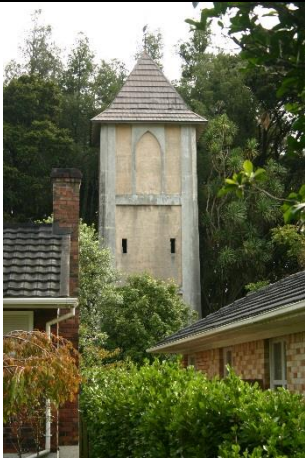
The water tower was also designed by Patterson, based on the form of a Norman church tower. It is built of reinforced concrete and was constructed at a similar time to the house. It provides evidence of how water was sourced and stored on the property prior to municipal water supply in 1937. Drawings for Roof replacement dated 1976.	High
3	Theatre Building to south

A drawing prepared by Manukau City Council Engineers Department in 1976 shows the proposed replacement of the water tower roof with a pre-built timber-framed roof clad with galvanised metal roof tiles and copper spouting. The existing roof was to be demolished using a cherry picker, and the pre-made replacement roof installed and the weathervane reinstated.

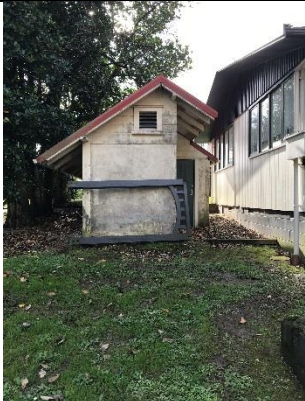
Thought to have been built at a similar time to the original house in the 1910s as a dairy. It is the earliest building on the property and is associated with farming activities and food production. It is the only surviving building of the group structures including glasshouses and out buildings that was earlier located to the south of the house.	High

At the south of the house was a collection of glasshouses and other out-buildings. Mostly these structures have subsequently been removed, however the small gabled building to the west of the house remains and is thought to have been the dairy. (Refer Figure 21)

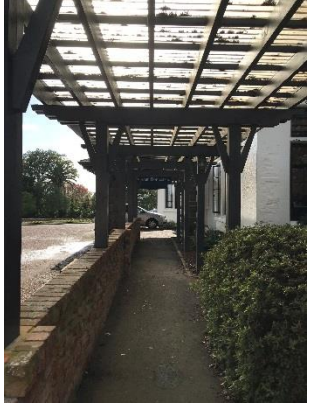
Built 2002 to provide a sheltered link from carpark to the main entrance of the homestead.	Nil/ Intrusive
6	Pergola by croquet lawn

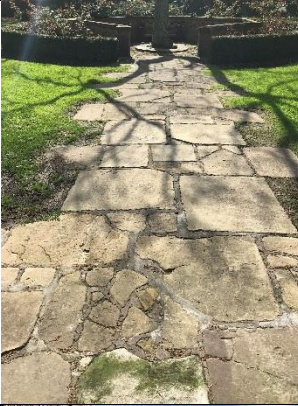
<p>Constructed with the octagonal garden c. 1925. Historic photos show naturalistic planting to the spaces between the stone flags, with flowering plants and a hedge to either side. (Fig 22:NZ Herald 24 November 1933, p.8)</p> <p>The existing central <i>Melia</i> tree is lifting the nearby paving and should be removed.</p>	High
26	Tennis Court with tennis court netting stone base walls

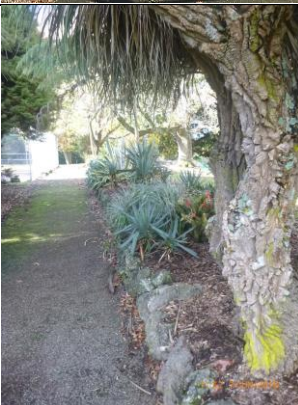
27	Garden rockery with succulents and bromeliads adjacent to Tennis Court

<p>There are descriptions of a rockery in the Nathan's garden dating from as early as 1928. (<i>New Zealand Truth</i>, Issue 1204, 27 December 1928, Page 15)</p>	High

A rock garden remains adjacent to a path on the south side of the tennis court, and rock walls are used around the south and west side of the tennis court. Descriptions of the garden from the 1930s noted rock gardens as a feature.

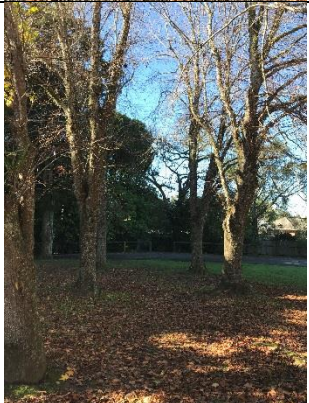
<p>Lime walk / pleached <i>Tilia cordata</i> trees (x6 trees)</p> <p>Parallel row of formerly pollarded <i>Tilia cordata</i> trees, on axis with path and with views towards the Water Tower.</p> <p>The spacing of the trees should be measured</p>	High
30	Metal drive to outbuildings

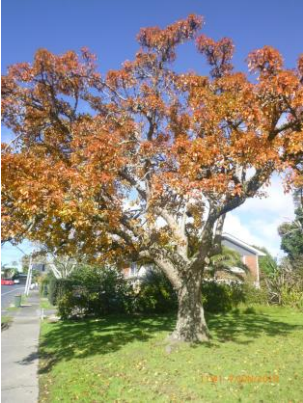
41	Single Pear orchard tree on far eastern boundary beyond bush, remnant of the orchard that extended towards motorway

Mature pear tree formed part of the Orchard located to the east of the bush. The tree has significance for potential propagation.	High
42	Potential ha-ha in front of property	(Not photographed/ on private property)	There may have been a ha-ha along the north edge of the garden to control grazing animals. Archaeological investigation recommended along full boundary required as crosses many private boundaries	Possible archaeological significance
43	Location of garden rooms and lily pond

An orchard was located to the east of the bush, in an area which is evident in the 1959 aerial photo. (Figure 36) A mature pear tree that formed part of the orchard remains evident adjacent to the bush near Grande Vue Road.

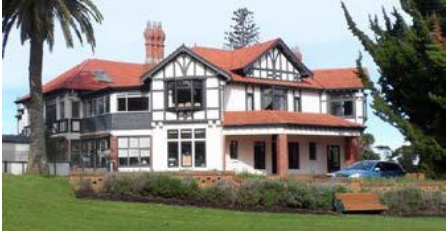
High
East Elevation	<p>Originally open at ground level, the verandah has been enclosed to provide space for a crèche. Originally whitney-type joinery at first floor level were used to enclose sleeping balconies. Joinery has been replaced with aluminium at first floor and timber windows enclose the ground floor verandah. Egress stairs added</p>

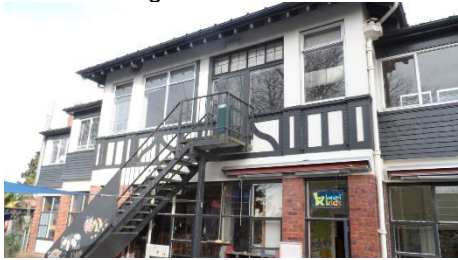
High  Nil/ intrusive
South Elevation	<p>Fire escape stairs c.1970 from First Floor Balcony</p> <p>This is the rear elevation of the house. It was simpler in its design and remains intact. It was originally screened from view by trees. It is now partially obscured by the adjacent theatre building of 1966.</p>

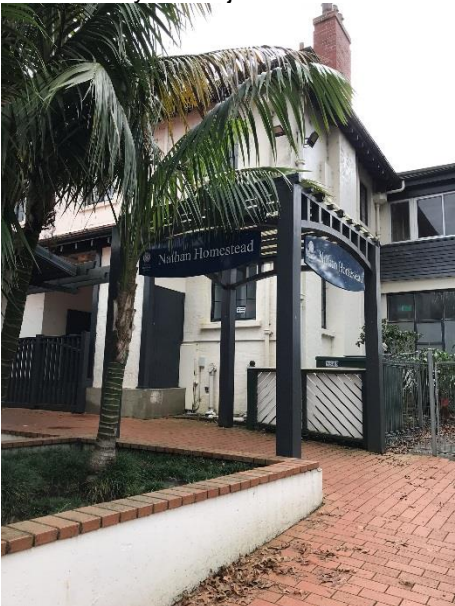
West Elevation	<p>The main entrance is positioned on the west side of the house, sheltered by the porte cochere.</p>	High

<p>Modifications have been made, such as the use of mirrored glass to protect the fragile historic glass which sits behind.</p>

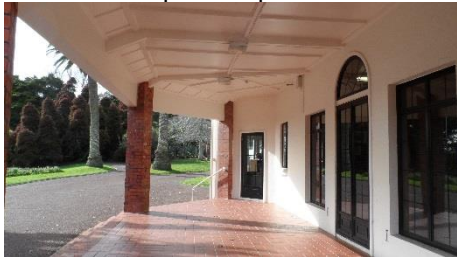
High
Porte Cochere	<p>Original Porte cochere over entrance with stone columns and pilasters and timber rafters</p>

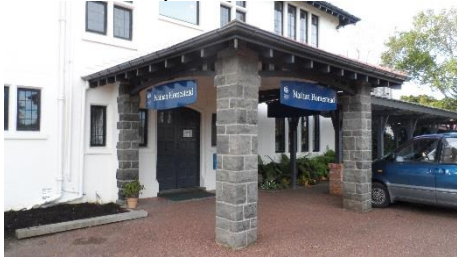
<p>Signage has been removed to better showcase the portico.</p>	High
East fire escape	<p>Steel and concrete fire escape stairs constructed for Manukau City Council c. 1970</p>

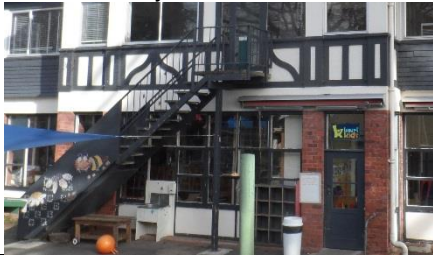
Nil/Intrusive
West Fire Escape	<p>Steel and concrete fire escape stairs constructed for Manukau City Council c. 1977 (Rigby James &amp; Partners Architects)</p>	Nil/Intrusive

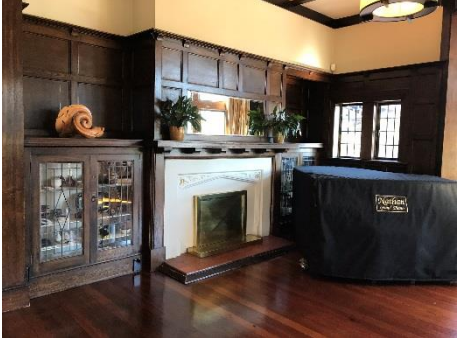
<p>High</p>
<p>Dining Room, now Meeting Room</p>	<p>The former Dining Room retains original ceiling, flooring (carpeted), wall panelling, fire place with mirror above, and trim. Refurbished in 2017. (Mirror is not original.)</p>	<p>High</p>

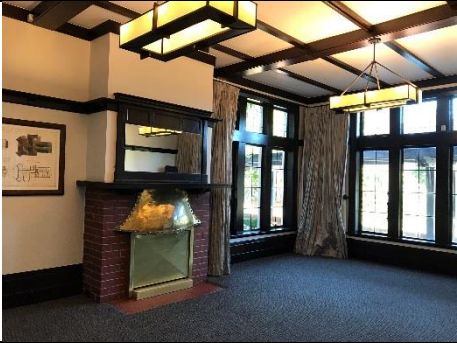
<p>Drawing Room, now Office</p>	<p>The former Drawing Room retains original ceiling with decorative plaster detail, flooring (carpeted), wall panelling, fire place and trim. Refurbished in 2017.</p>

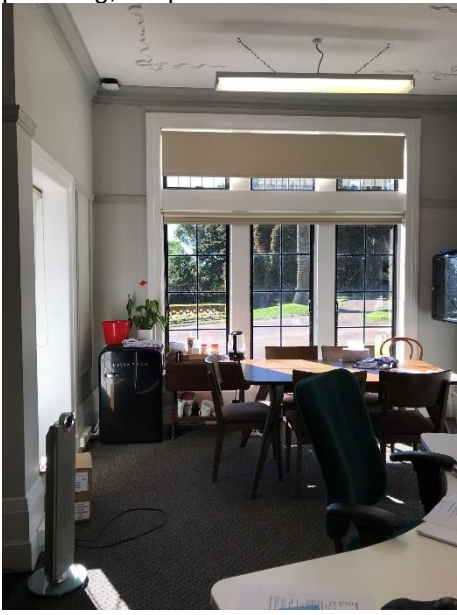
<p>High</p>
<p>Former Study (Now part of Creche)</p>	<p>Original plan form remains. Adjacent space which was originally the verandah is now enclosed. Original ceiling, flooring (covered), trims and door joinery are generally intact. There have been changes to built-in furniture and the fire surround.</p>

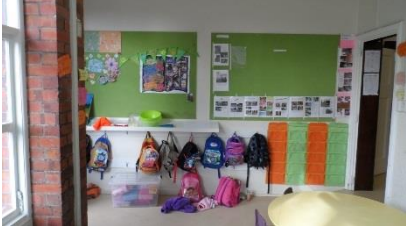
<p>High</p>
<p>Former Laundry, cloakroom and store now creche toilet</p>	<p>Changes have been made to the former Laundry, cloakroom and store cupboard to provide toilets for the creche, retaining some original walls.</p>		<p>Some</p>
<p>Former Verandah (now Creche)</p>	<p>Although enclosed, the verandah plan form, brick columns and tiled floor remain.</p> <p>Part of the verandah on the east side of the building that was enclosed c. Nov 1977 (Rigby James and</p>		<p>High</p>

<p>Partners drawing Auckland Council Archives South).</p>

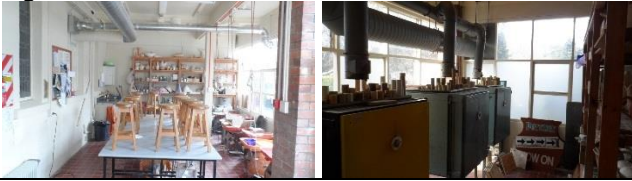
<p>Verandah, now studio</p>	<p>Although enclosed, the verandah plan form, brick columns and tiled floor remain.</p> <p>Part of the verandah on the east side of the building was enclosed c. Nov 1977 (Rigby James and Partners drawing Auckland Council Archives South). Infilling with windows has detracted from the significance of the verandah</p>

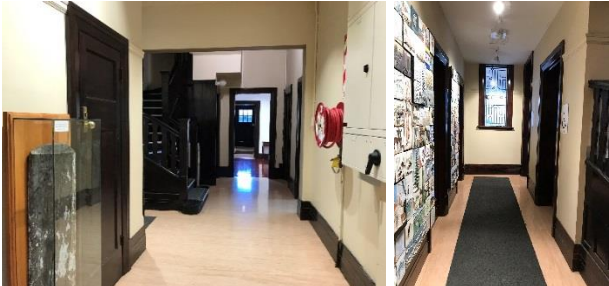
<p>High</p>
<p>Halls to Service Wing</p>	<p>The halls remains largely intact with original ceiling, walls, door joinery skirtings and trim. Lead light window to wall at end of east hall.</p>

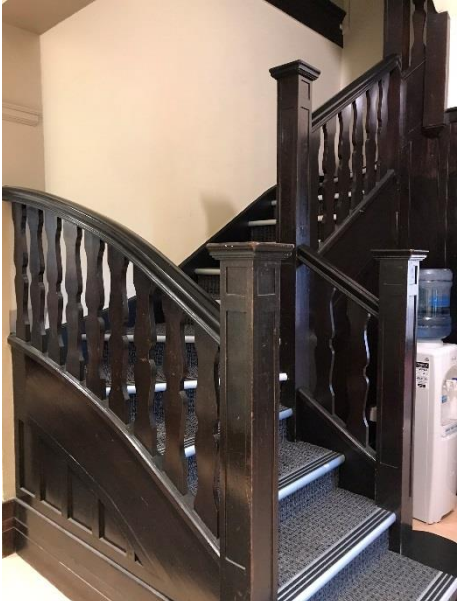
<p>High</p>
<p>Secondary Stair</p>	<p>Original secondary stair connecting the maids' rooms upstairs to the ground floor service rooms. Refurbished with new carpet in 2017.</p>

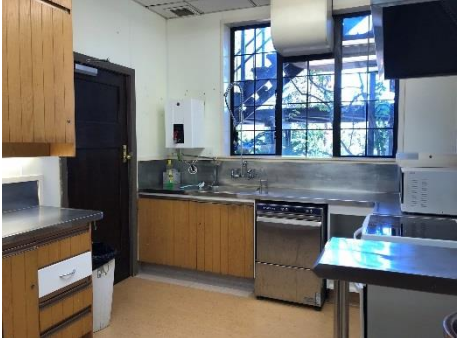
<p>High</p>
<p>Former Butler's Pantry, now Kitchen</p>	<p>The original plan remains intact. Kitchen fittings and units are all contemporary.</p>	<p>Moderate</p>

<p>Ceilings and walls are lined to meet building code requirements. Extract vent goes through window to exterior.</p>

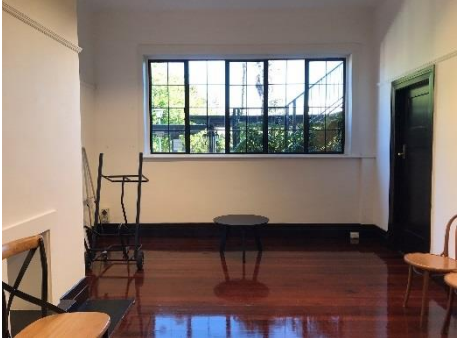
<p>Former Kitchen, now cafe</p>	<p>Original plan form remains intact. Original ceiling, fireplace, flooring and trim remain. No early kitchen fittings remain. The space was refurbished in 2017.</p>

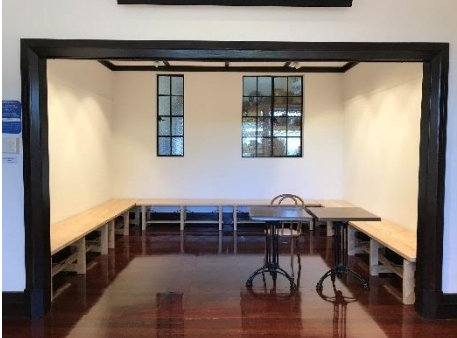
<p>Moderate</p>
<p>Former Scullery and Store, now café seating</p>	<p>A wall has been removed to connect the former scullery and storeroom. The narrow window on the east wall, indicates the extent of the storeroom. The connected space retains flooring and trim. Refurbished in 2017. The ceiling was lowered to allow for plumbing to toilets above. The new ceiling was made to match that in the Sitting Room.</p>

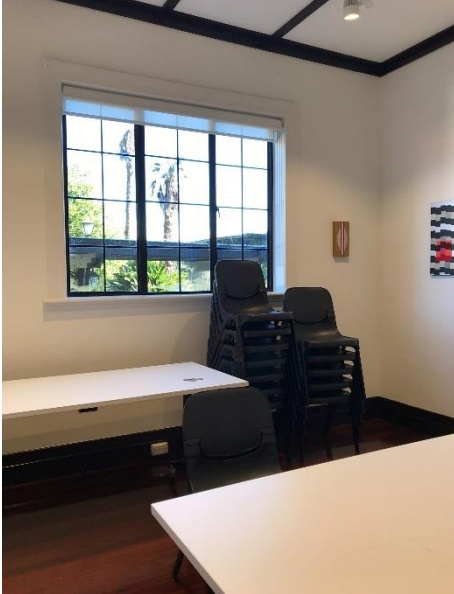
<p>Moderate</p>
<p>Former Maids' sitting room, now gallery</p>	<p>The original plan form remains intact, together with original ceiling, flooring, fireplace and trim. Refurbished in 2017.</p>	<p>Moderate</p>

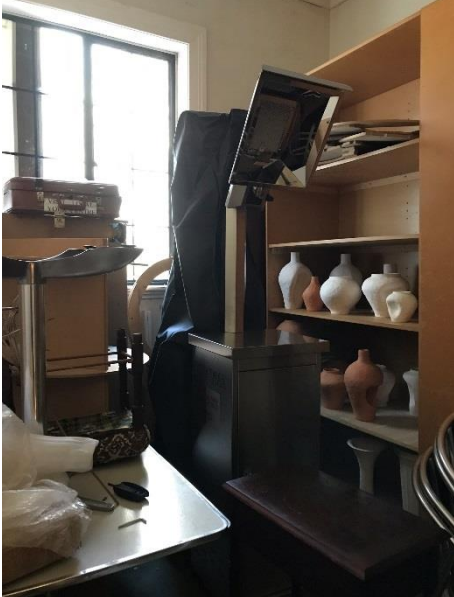
<p>Former Ironing Room now Store</p>	<p>Plan form remains intact. Original steel window remains, as well as ceiling detail and trim</p>

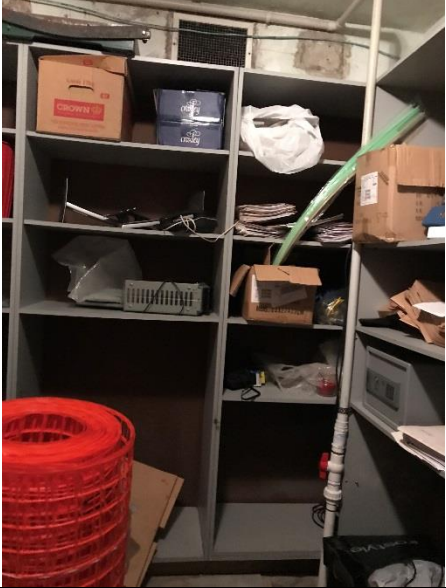
<p>Basement Strong Room</p>	<p>Original Strong Room as shown on original plans.</p>

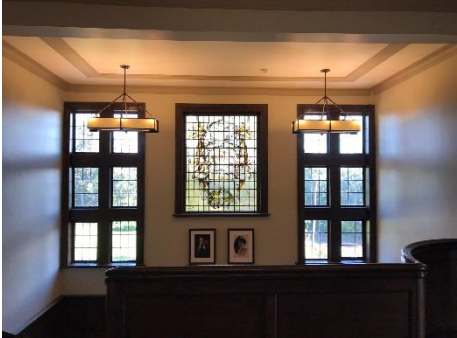
<p>High</p>
<p><b>FIRST FLOOR</b></p>			
<p>Main stair</p>	<p>Original main stair with timber panelled dado and balustrade, original ceiling and windows. The stair way was refurbished in 2017. The painted glass window was originally from a church in Holland, and dates from 1681.</p>

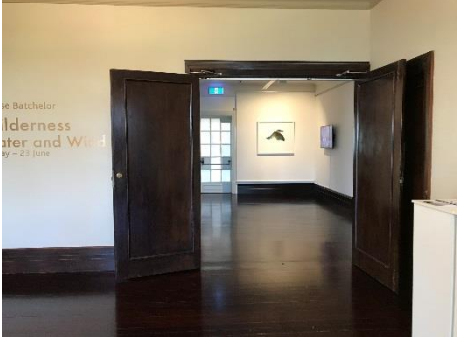
<p>High</p>
<p>Landing</p>	<p>The plan form of the landing remains. Doors have been modified. Original ceilings remain with coved plaster cornice. Refurbished in 2017</p>		<p>High</p>

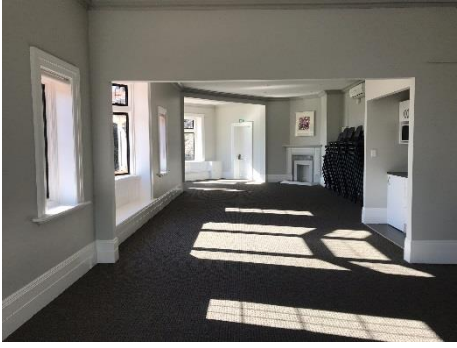
<p>Northern Room Formerly the Guest bedroom, Boudoir and Bedroom</p>	<p>Now an interconnected space across the north end of the upper floor, this area was originally divided into bed rooms on either side of a central boudoir. The space retains some original ceilings with decorative plaster detail, fireplaces and trim. A built-in seat and small cupboards remain in the east bay. In 2017 the space was refurbished. A small kitchen has been installed.</p>

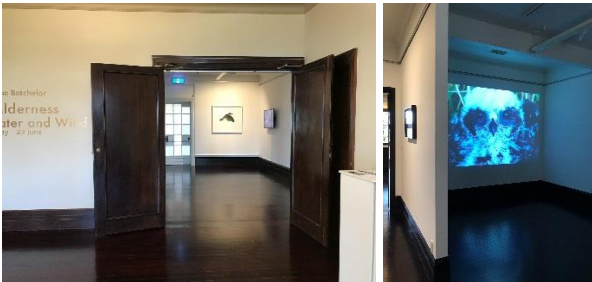
<p>Moderate</p>
<p>Former Bathroom and Dressing Room 1 now Exhibition Room 1</p>	<p>Walls have been removed to connect the former bathroom and dressing room, to create an exhibition space, with a wider door opening made to link the space to the main landing. Timber floors, skirtings and trim remain together with evidence of original wall locations. Refurbished in 2017.</p>

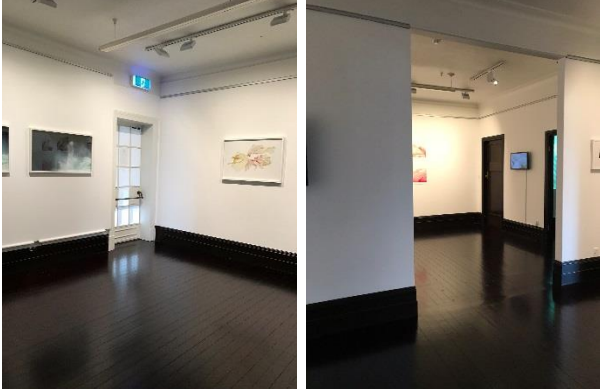
<p>Moderate</p>
<p>Former Dressing Room 2 now exhibition room 2</p>	<p>Plan form is largely intact, with an opening formed to the adjacent gallery space. Windows to the adjacent Sleeping porch and covered. The glazed door remains.</p>		<p>Moderate</p>

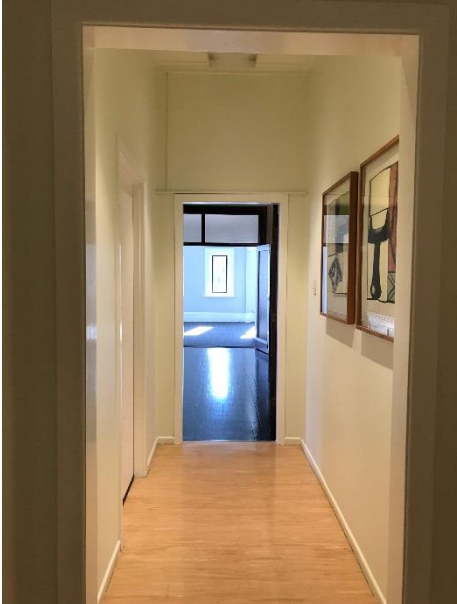
<p>Exhibition Room 3</p>	<p>The original plan has been modified in this area to form Exhibition Room 3.</p>	<p>Some</p>
<p>Former Dressing Room 3 now Meeting Room</p>	<p>Some modification to the plan has occurred forming the corridor past this room where wardrobes were originally located.</p>	<p>Some</p>
<p>Corridor to service wing</p>	<p>The plan form has been modified to form a corridor leading from the Landing to the Hall through part of a former dressing room, therefore ceiling, walls and trim not original. Repainted in 2017.</p>

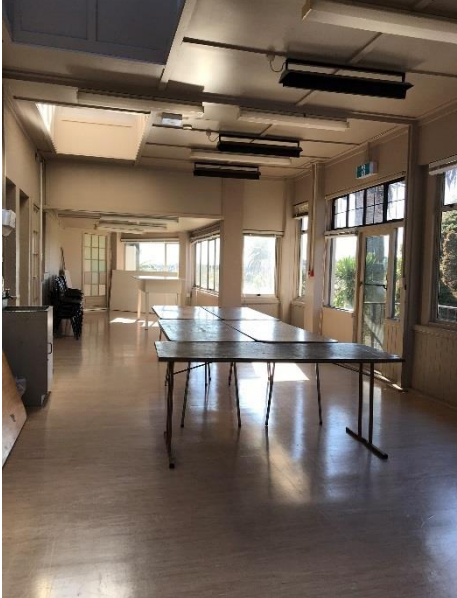
<p>Some</p>
<p>Former Sleeping Balconies, now Studio space</p>	<p>Originally detailed with whitney windows and a dividing wall. Earlier dividing walls have been removed. Original plasterboard and batten ceilings and skylights remain along with T&amp; G wall lining below windows. Aluminium joinery has replaced earlier windows. Vinyl floor covering. The original steel joinery is largely intact where the porch meets the house. Significance derives from original function, a distinctive feature of 1920's houses for health benefits of fresh air.</p>	<p>Moderate</p>

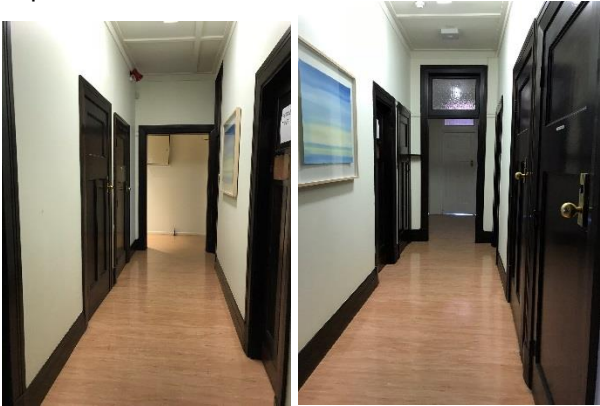
<p>Moderate</p>
<p>Hall</p>	<p>Original hall remains with ceilings, doors and trim largely intact. A former maid's bedroom is now part of the wider south end of the hall. A kitchenette reconfigured in 2017 required reducing size of cupboards.</p>

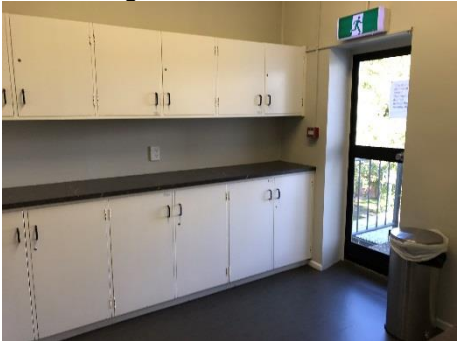
<p>Former Bathroom now Kitchen</p>	<p>The kitchen, renovated in 2017, is where a bathroom was originally located. The room has contemporary cupboards and fittings. A glazed door leads to the west fire egress stair.</p>

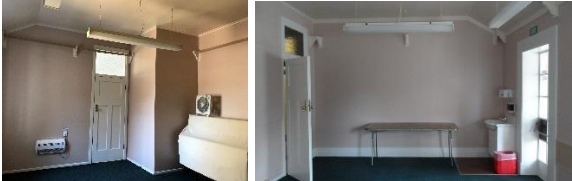
<p>Some</p>
<p>Former Linen Cupboard and Toilets</p>	<p>Two small offices are located where the Linen cupboard and adjacent toilet were.</p>	<p>Some</p>
<p>Former Bathroom and maid's room, now Workroom</p>	<p>Original bathroom, cupboards and maid's bedroom 5 have been altered to form a workroom</p>	<p>Some</p>
<p>Former Maids' rooms 1 and 2 (now Fibre Studio)</p>	<p>Two of the former maids' bedrooms on the east side of the house have been combined into one studio space. Wall layout altered, original trims mostly intact.</p>
