# DAVID NATHAN PARK AND HOMESTEAD

## CONSERVATION PLAN

# David Nathan Park and Homestead Manurewa, Auckland

Prepared by  
Matthews & Matthews Architects Ltd  
P O Box 108 166 Symonds Street,  
Auckland

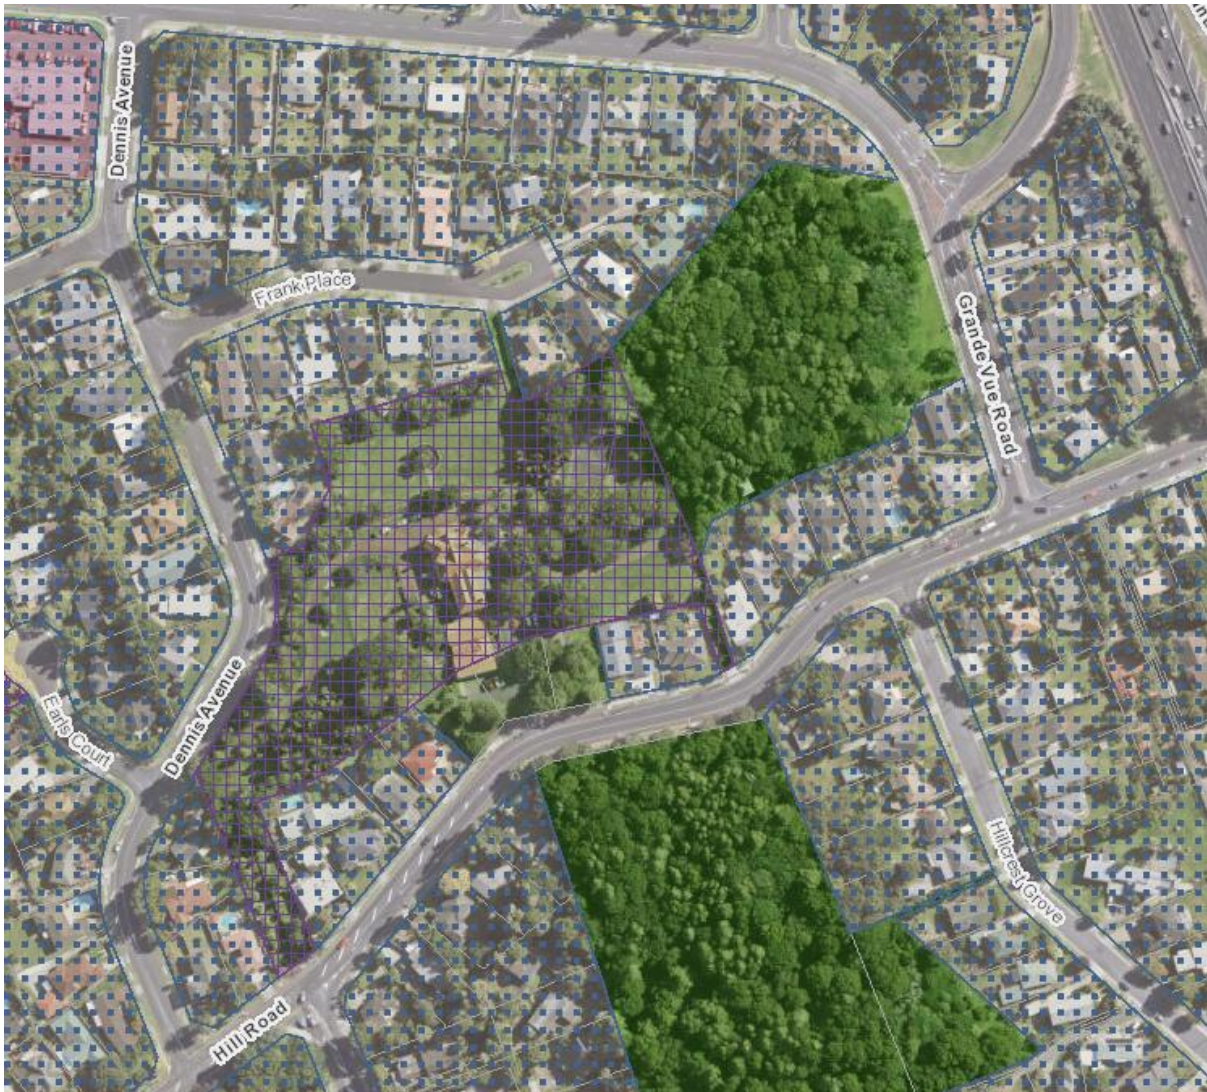
Map showing the Scheduled Extent of Place, Auckland Unitary Plan maps.

It sits within a historic heritage Extent of Place overlay area in the AUP Maps, which applies to much of David Nathan Park. The water tower is located outside the scheduled extent of place, which does not apply to the area of bush within David Nathan Park.
