Puketāpapa Coastal Tracks

Assessment Report

Prepared For: Auckland Council By reNature Limited Job #23200

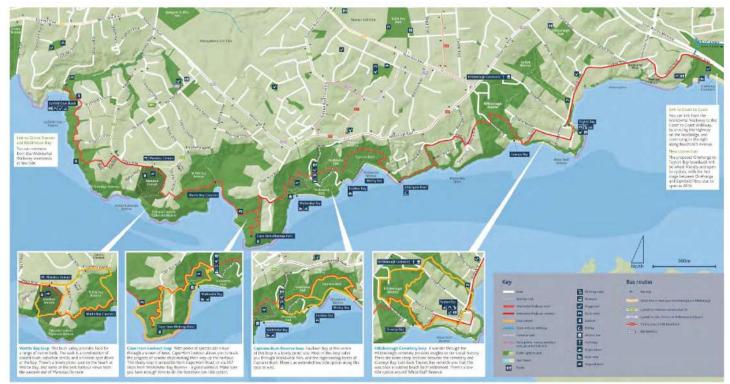
Figure 1: Map of the Waikowhai walkway (https://ourauckland.aucklandcouncil.govt.nz)

The Waikōwhai Walkway provides coastal track experience for users along the northern shore of the Manukau Harbour. The Puketāpapa Coastal track sections relevant to this report include the reserves within the Puketāpapa Local Board area, from Manukau Domain in the west to the Onehunga Foreshore in the east, covering approximately 5km of the shoreline with over 10km of track (Figure 1).

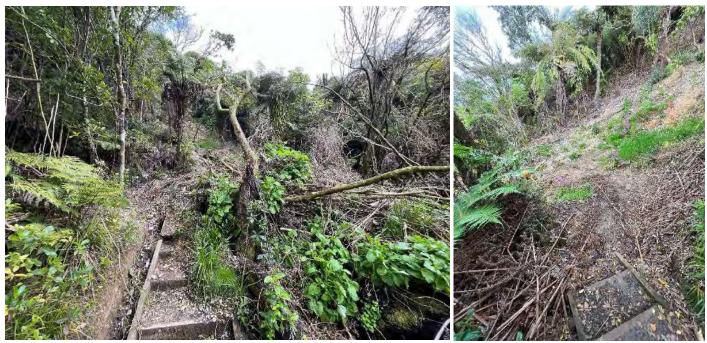
Figure 2: Manukau Domain - upper slip

The Manukau Domain coastal walkway sections consist of approximately 400m of track, steps and boardwalk structure. Most of the track network is in Good to Average (grade 2 – 3) condition. Two slip events have rendered a section of track and boxed steps non-existent (Figure 2) and damaged a boardwalk (Figure 3) that is now in a Poor condition (grade 4).

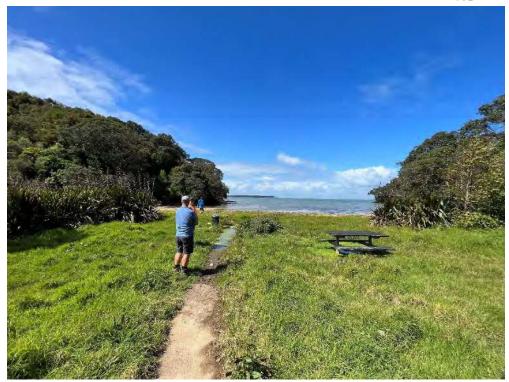
Figure 10: Wattle Bay - Flooded picnic area

The Wattle Bay coastal walkway sections consist of approximately 2,400m of track, concrete path, steps, boardwalk structures, timber bridges, etc. Most of the track network is in Good to Average (grade 2 – 3) condition. Numerous landslips, ranging in size from small to large, occur throughout the park and along the track alignment. The damage caused by these slip events range from minor obstructions to complete destruction of track sections. Evidence of this damage is displayed in Figure 4 to Figure 10. In addition, the movement of material has altered the course of some overland flow paths resulting in increased stormwater damage in some locations and soaking the lower picnic area so that it can no longer function as a picnic amenity (Figure 10).

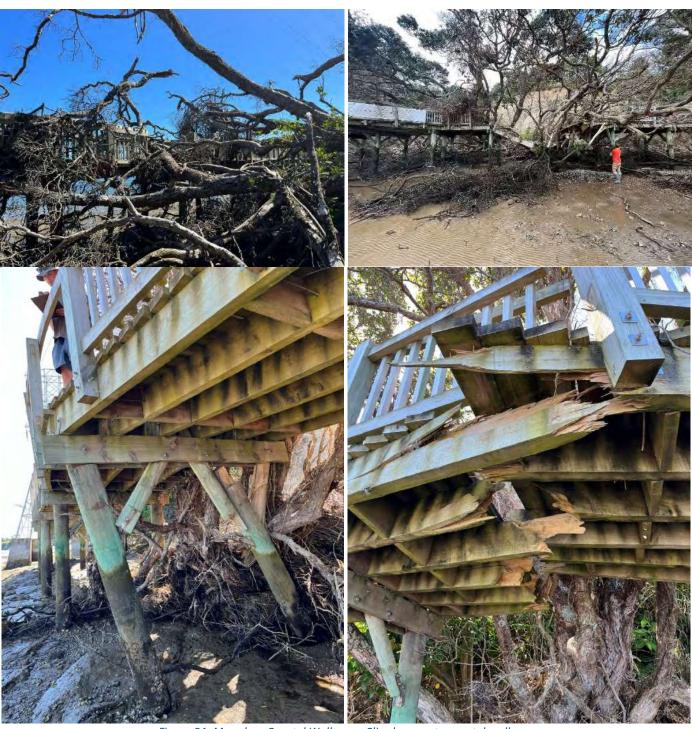
Figure 31: Manukau Coastal Walkway - Slip damage to coastal walkway

The Waikowhai Boardwalk is an approximately 2.5m wide by 420m long coastal boardwalk connecting Bamfield Reserve to Onehunga foreshore. Several slips along the adjacent coastal cliffs have resulted in significant damage to the boardwalk structure effectively rendering the structure unusable (Figure 31).

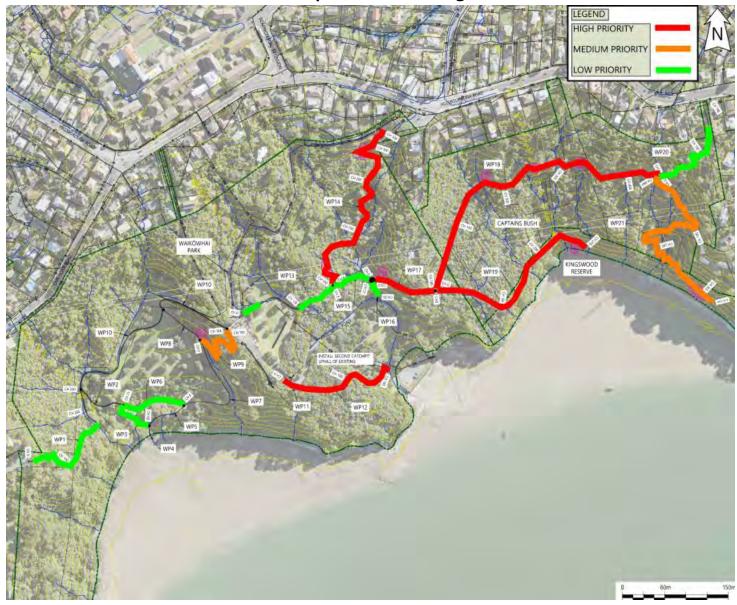
Waikōwhai Park, Captains Bush & Kingswood Reserve

The Waikōwhai Park, Captains Bush, and Kingswood Reserve coastal walkway sections consist of approximately 3,400m of track, concrete path, steps, boardwalk structures, timber bridges, etc. Most of the track network is in Good to Poor (grade 2 – 4) condition. Numerous landslips, ranging in size from small to medium, occur throughout the reserves and along the track alignment. The damage caused by these slip events range from minor obstructions to complete destruction of track sections. Evidence of this damage is displayed in Figure 11 to Figure 18.

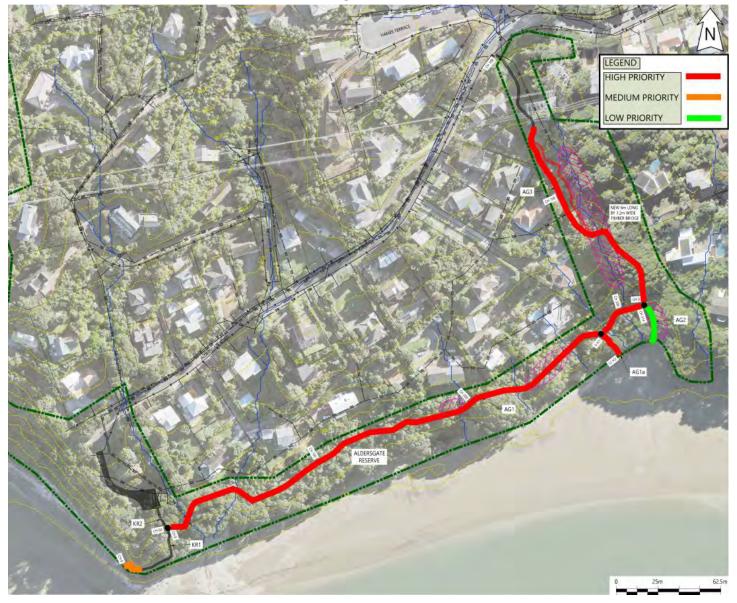
The Aldersgate Reserve coastal walkway sections consist of approximately 550m of track, concrete path, steps, boardwalk structures, timber bridges, etc. Most of the track network is in Average to Very Poor (grade 3 – 5) condition. Significant land movement and scouring along the stream and valley that runs from Aldersgate Road to the coast has resulted in major damage to the entire track network along this section. The remaining track section connecting to Kingswood Reserve is predominately affected by a major slip with other minor damage/obstructions occurring due to failed retaining walls and smaller slip events. Evidence of this damage is displayed in Figure 19 to Figure 21.

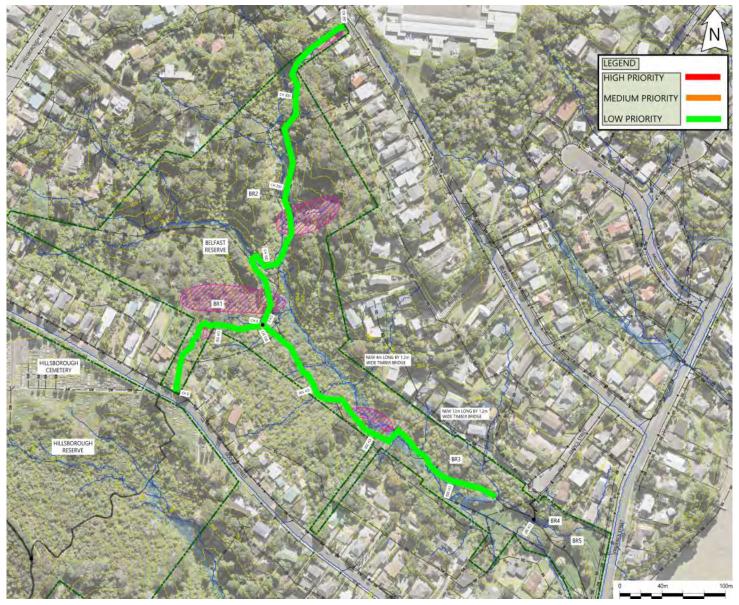
The Belfast Reserve walkway sections consist of approximately 950m of track, steps, boardwalk structures, timber bridges, etc. Most of the track network is in Average to Poor (grade 3 – 4) condition. Several large land slips and scouring have resulting in significant damage to components of the track alignment resulting if complete closure of the reserve to the public. Evidence of this damage is displayed in Figure 27 to Figure 30.
