Devonport-Takapuna Local Board Workshop Programme

Devonport-Takapuna Local Board Workshop Record

KENNEDY PARK WWII TUNNEL

CONDITION ASSESSMENT
&
PROPOSED MAINTENANCE

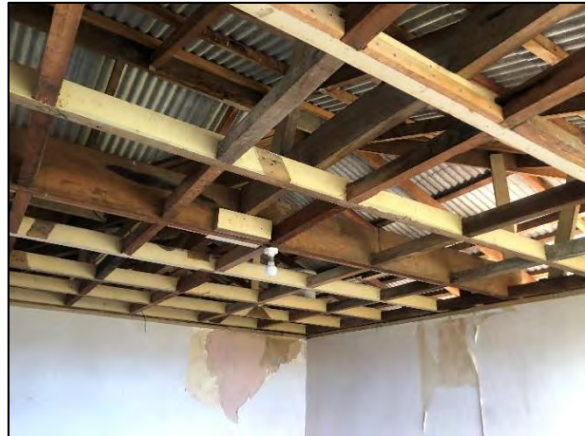
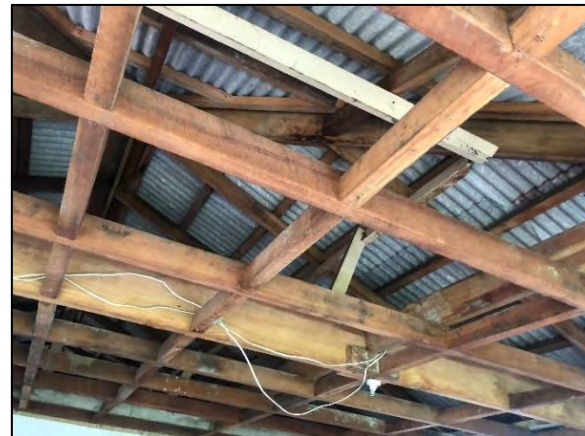
Areas of roof and ceiling framing. Note original timbers and later recycled material.

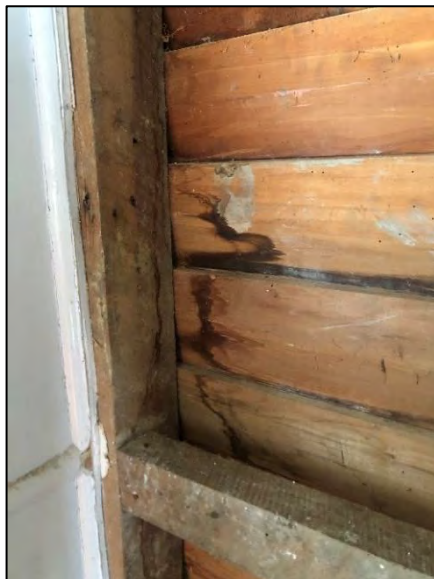
Some areas had building paper under the weatherboards, although it was missing in other areas, suggesting that the building may have been partly reclad in its life. Some additional framing had also been added.

External wall framing. Note water staining on weatherboards.

Wherever there is evidence of decayed weatherboards, the timber framing behind should be checked.

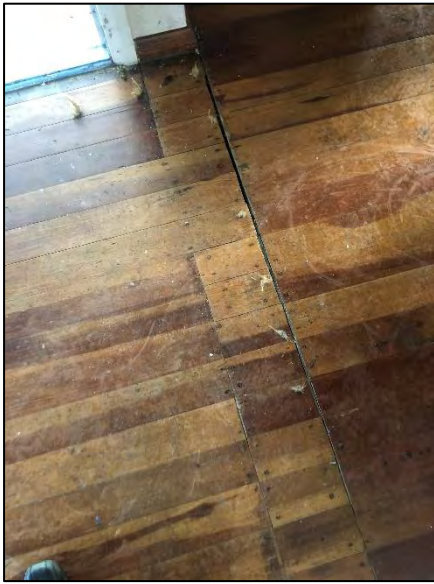
The floors comprise tongue and groove boards and generally appear to be in good condition. The timber is believed to be matai. A saw cut in the floor may have originated when the building was relocated, although the floor boards on either side of the cut do not match.

Matai tongue and groove floor boards. Note cut line.

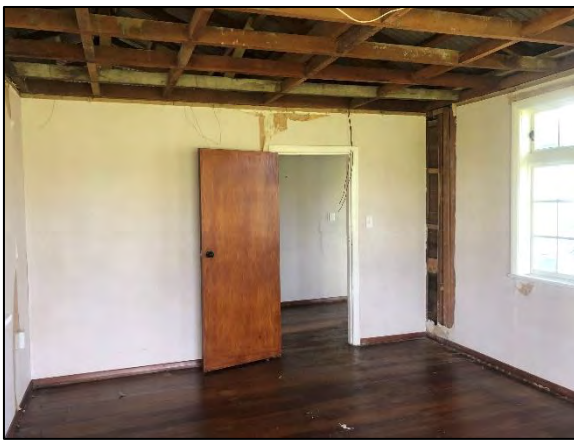
The internal doors throughout the building appear to be hollow core, sheathed with rimu faced plywood. Some of the doors have been damaged and are showing signs of wear and tear. Borer is also present in some of the doors. The internal trim is also rimu, generally with a bullnose profile. Borer has also attacked some of the internal trim.

Interior of living area. Note plywood faced door and bullnose architraves and skirting.

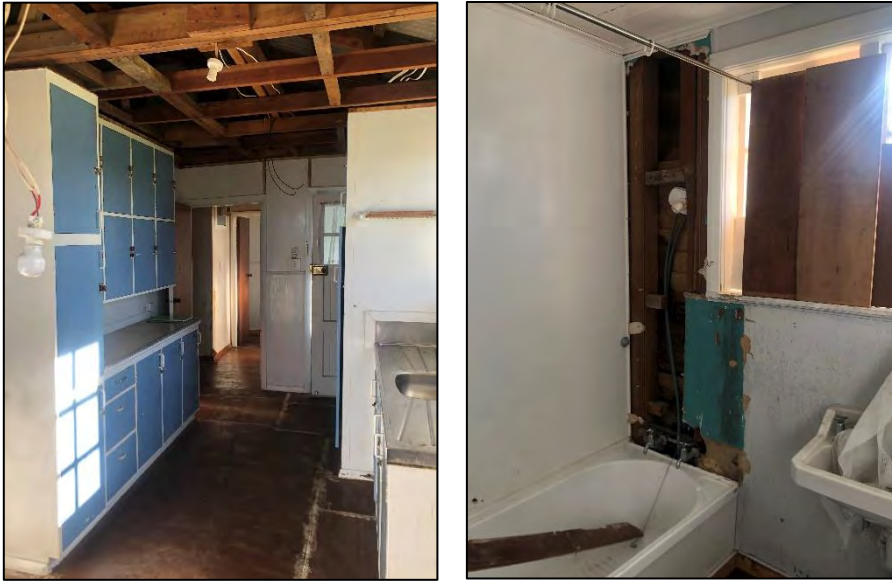
Internal fixtures and fittings include cupboards and a stainless steel sink bench in the kitchen. The bathroom contains a bath, a shower and a basin. The building has a separate toilet, the seat of which has broken. The figures and fittings, with the exception of the toilet seat could be described as being "serviceable".

Fittings in kitchen (left) and bathroom (right).

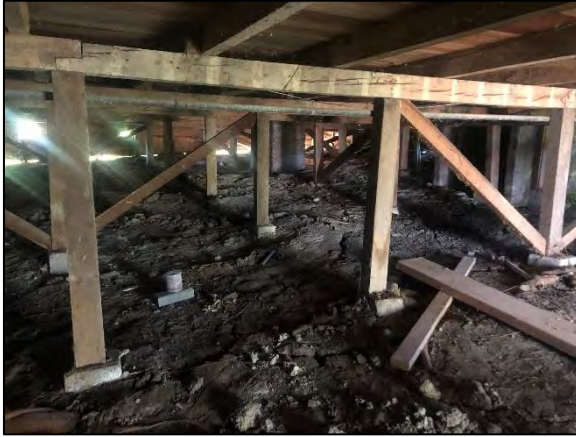
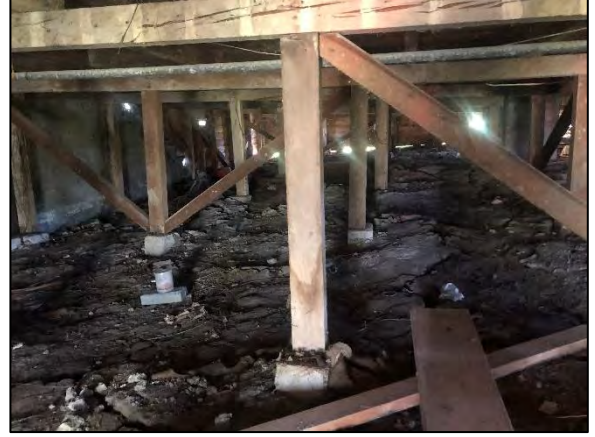
The subfloor area includes concrete piles timber jackstuds, braces, bearers and floor joists. It is likely that the subfloor framing and concrete piles were renewed when the building was relocated. Within the building, there is some unevenness in the floor, suggesting that settlement of the piles has occurred. Some piles may also have rotated due to uneven vertical loading.

Two views of subfloor area. Note general lack of fixings.

The timber subfloor framing generally appears sound. In general, however, there is a lack of fixings between piles and jackstuds and jackstuds and bearers. The bracing requirements should be reviewed with additional braces provided if required.

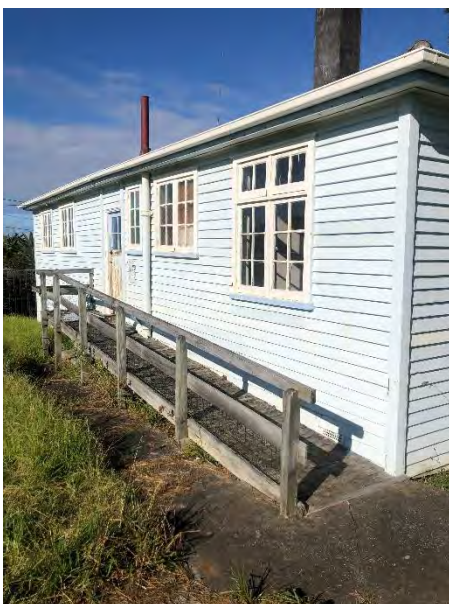
As the building is currently fenced off, the area within the fence appears unkept with grass and flora not being maintained. In particular, a Pōhutukawa tree that is not yet fully grown overshadows the western corner of the building.

At the back door, the steps remain although a timber ramp has since been constructed over them. The ramp has been poorly built and never painted and is in poor condition. At the front door, there is some evidence of the steps settling with a gap opening between the steps and the rest of the building.

There is a concrete path running between the front and back doors. The path has cracked and is uneven, largely due to the presence of a pine tree beside the house.

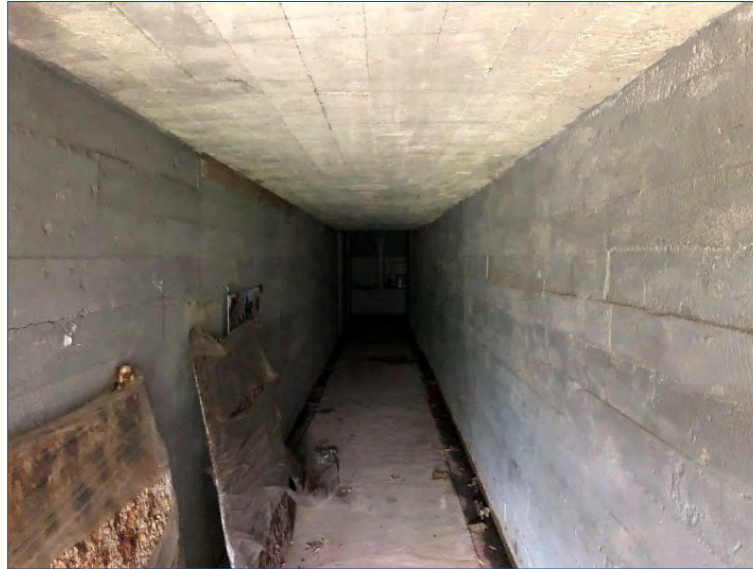
Figure 4: Western Entrance Tunnel

The tunnel floor was notably wet (flooded) at the time of our August observation but dry at other times, suggesting that it is susceptible to flooding following rain events. While leaked ground water is likely to contribute to moisture levels within the tunnels, the water at the floor of the entrance was of a volume attributable to flooding.

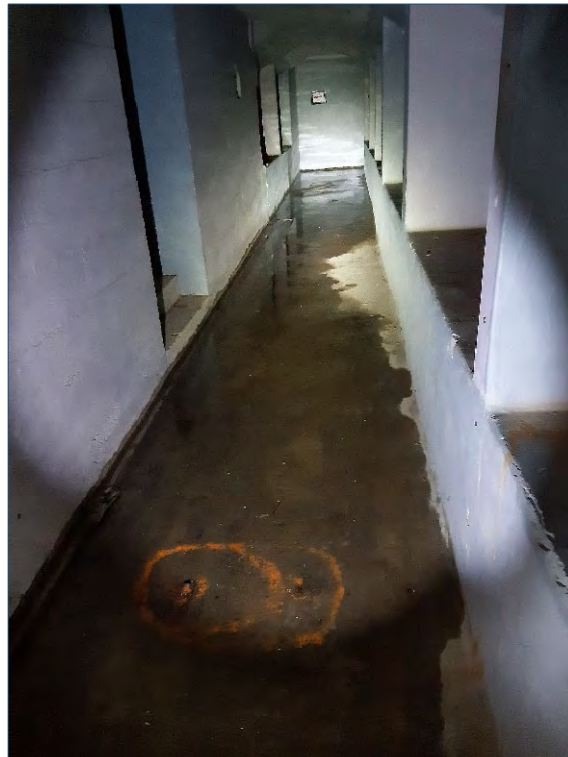
Figure 5: Ammunition Niche Corridor

The corridor floor has a gentle cross fall in its surface, sloping toward the rear western side, and drainage along the rear wall is limited to a narrow v-drain at the junction with the back wall. At the time of our August observation the corridor floor was wet, appearing to be in the drying stages of recent flooding.

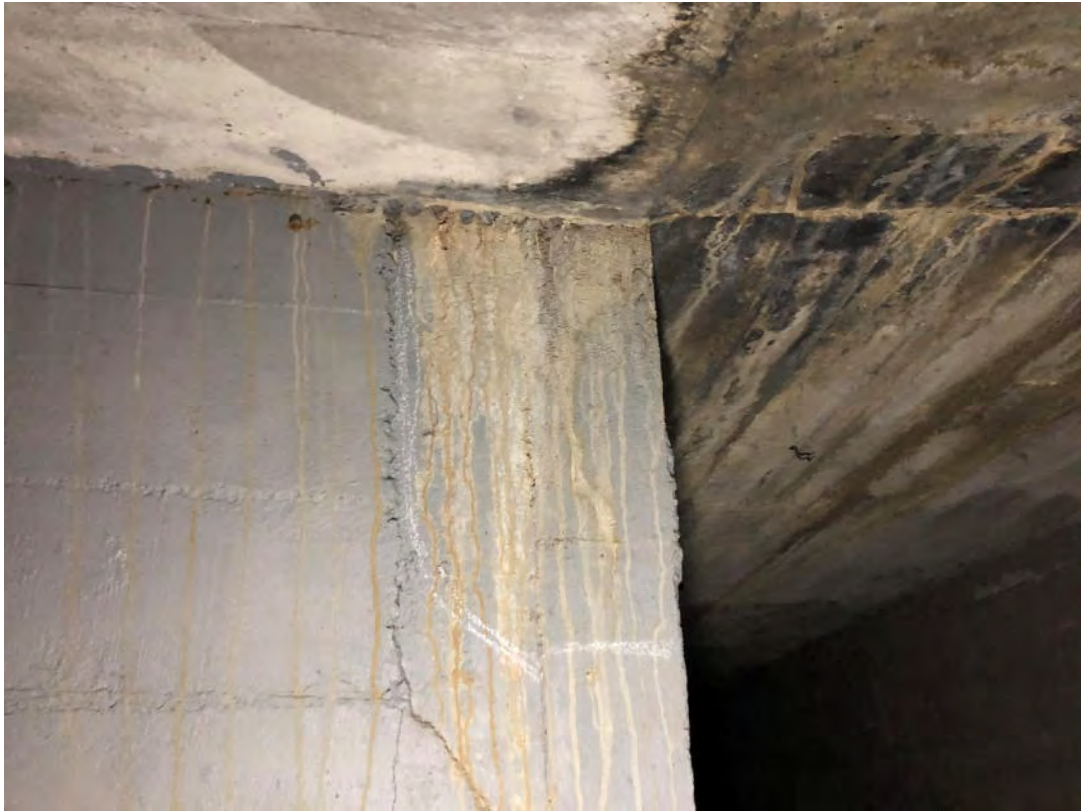
Photo 1: Rotten concrete at corner

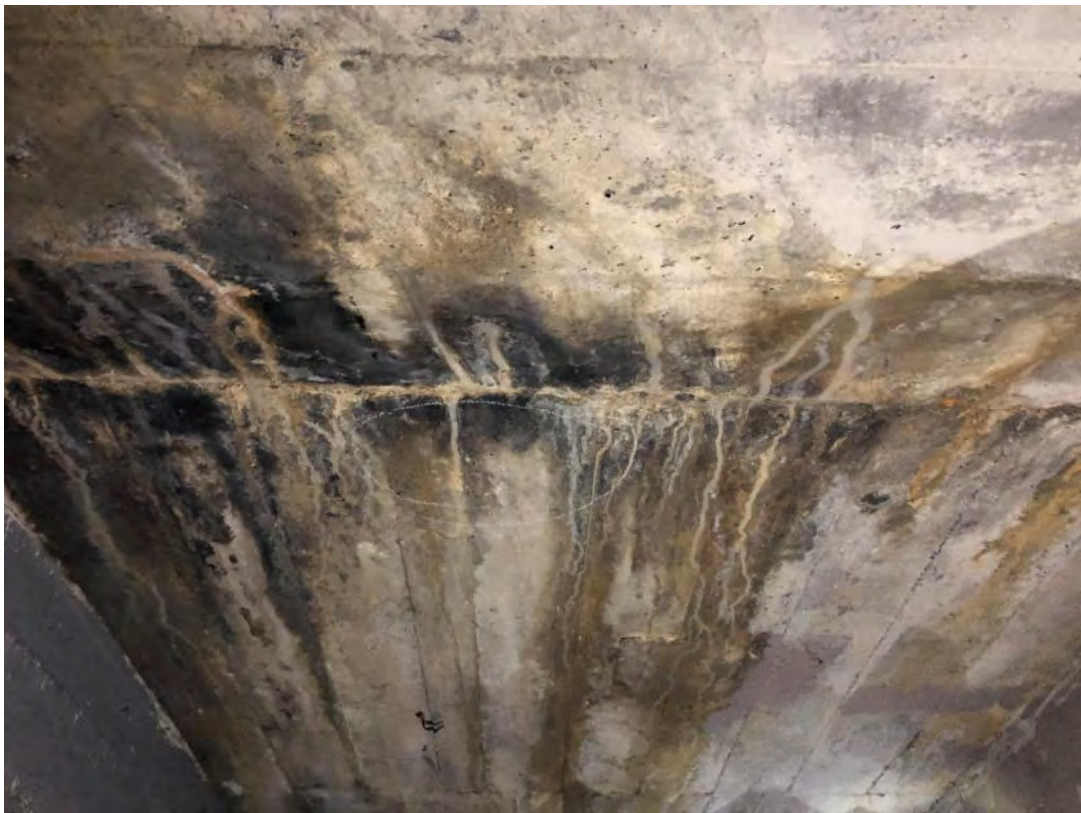
Photo 2: Water ingress and rotten concrete to soffit

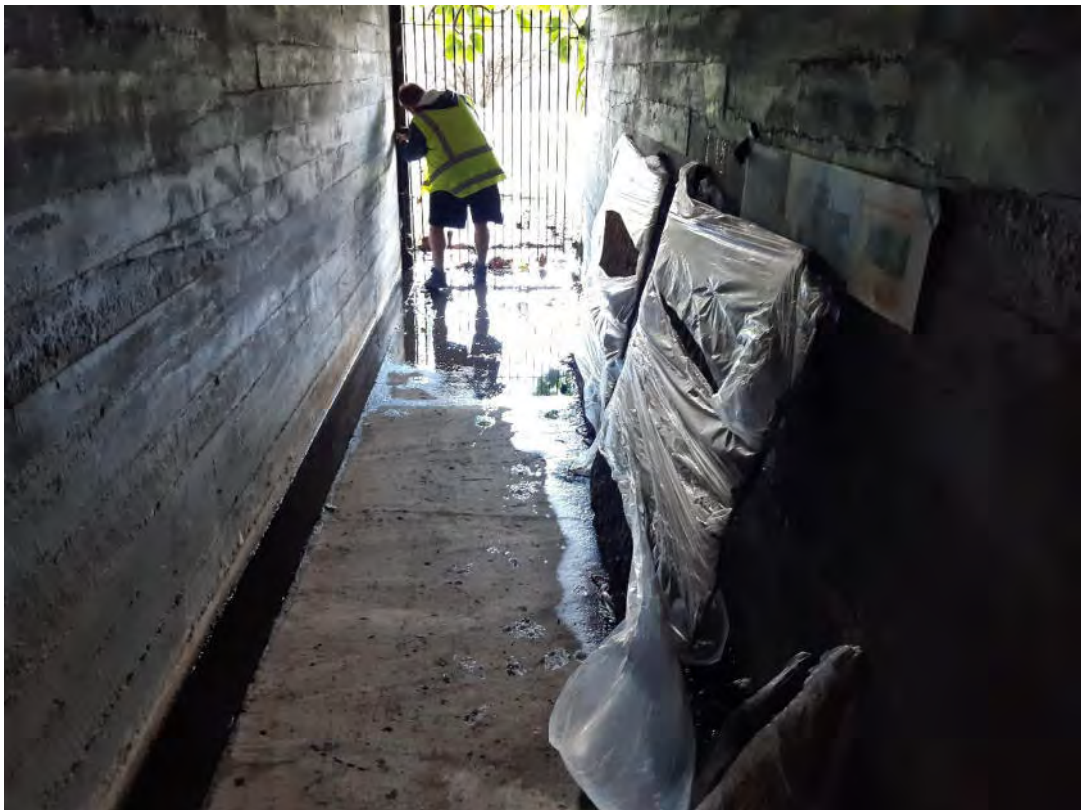
Photo 8: Flooded tunnel entrance

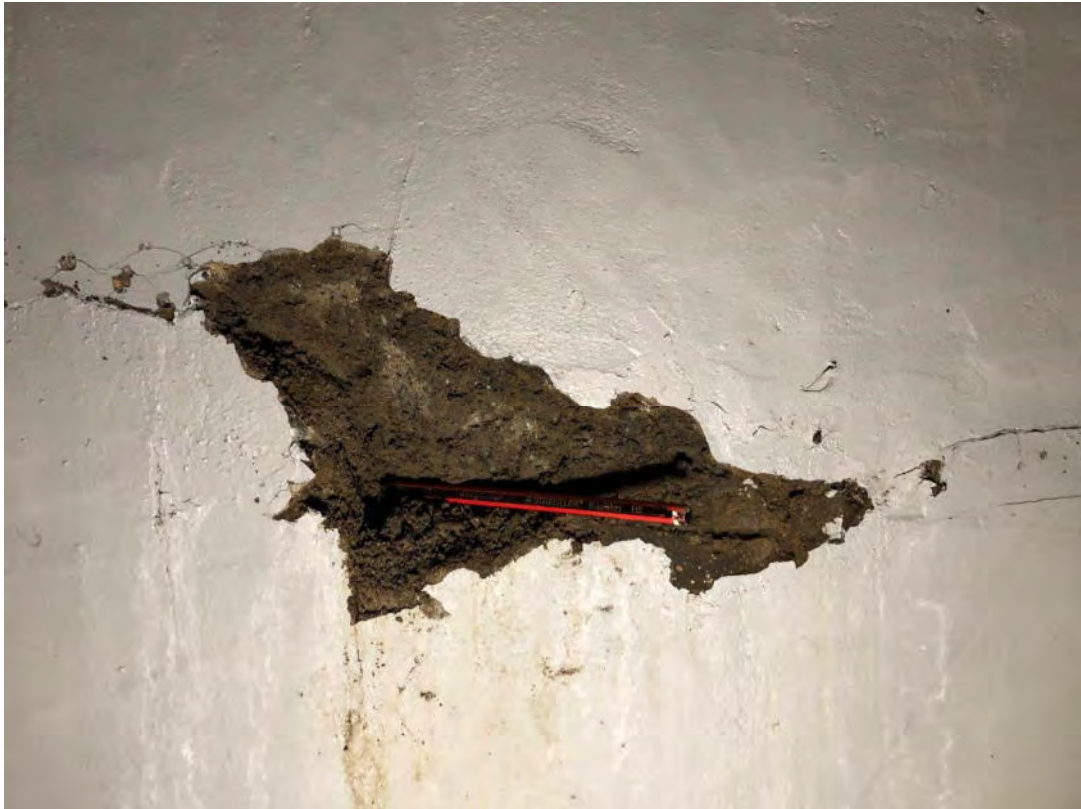
Photo 9: Rotten concrete with water seeping into service room
