Watercourse Assessment Report

Slippery Creek Catchment

Ingle, R., Rieger, A., Magee, J., Reeves, E., Macintosh, K., Lowe, M., Young, D.
Morphum Environmental Ltd

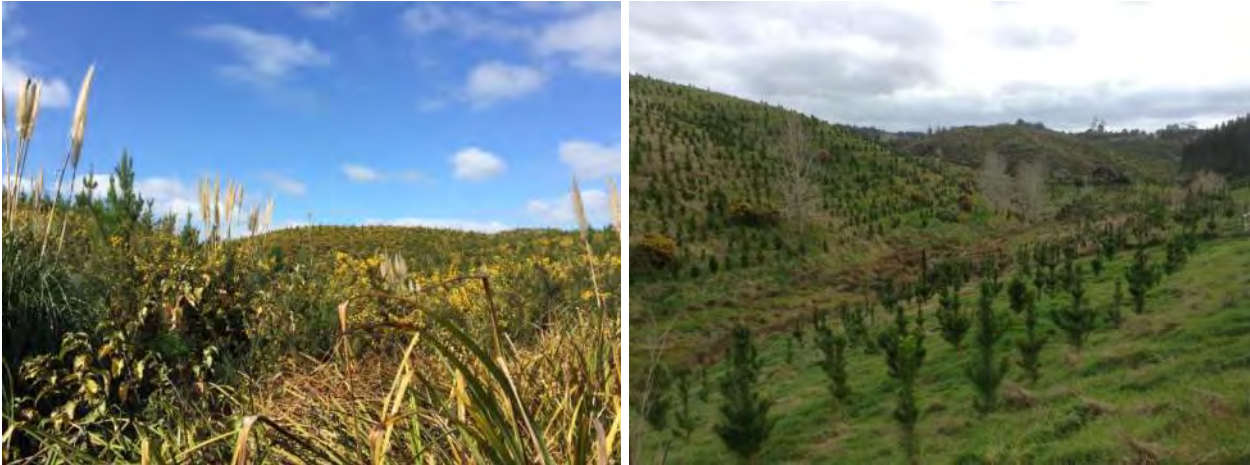
Reaches immediately downstream of pine plantations on Symonds Stream had high levels of fine silt and pine needle deposition on the floodplain from recent rain events that had occurred in the preceding weeks (see Figure 40). Some more recent plantings <5 years old also lacked riparian buffer strips such as HAY_TRIB6f (Figure 41). Conversely, a recent pine plantation had been established on HAY_TRIB6g which had also incorporated a 10 m wide planted buffer strip of indigenous shrubs and trees on each side of the channel which also formed an approximately 7 m wide riverine wetland dominated by *Carex spp.* (Figure 41).

Figure 41: New pine plantations at HAY_TRIB6f (left) and HAY_TRIB6g (right).

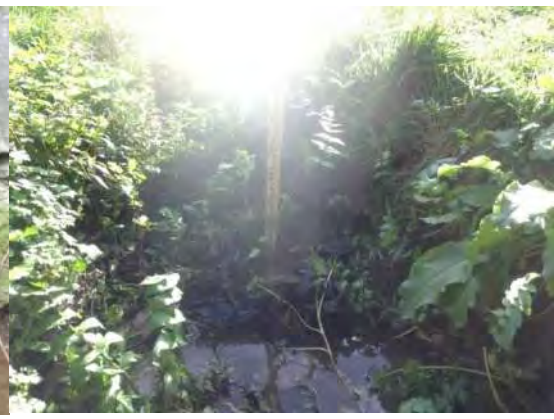
Appleby Road Drainage Improvement Project 25. Asset ID UNK_320 450mm incorrectly labelled as 900mm on project plan. Inlet ID UNK_143. Outlet ID UNK_046

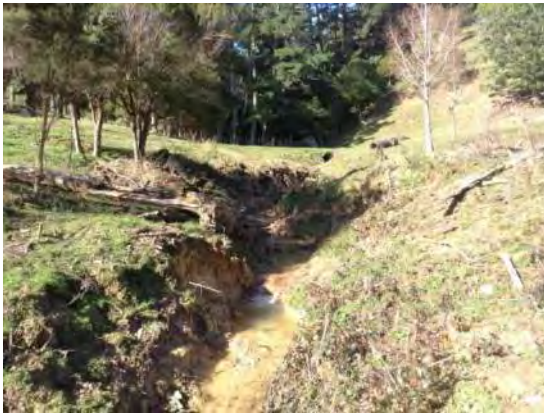
High sediment deposition on WAI_TRIB2_21

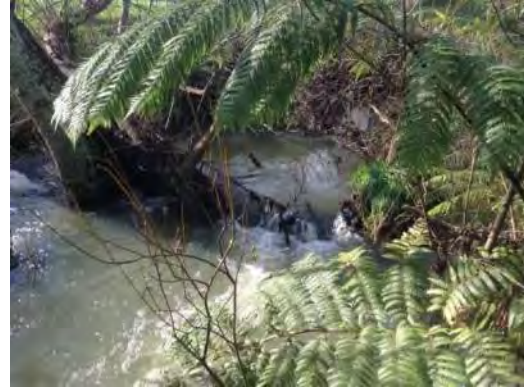
Willow in Stream bed altering hydrology on WAI_MAIN_1

- Manage willows to reduce erosion from flow diversion, debris jams, and improve fish passage to upstream high value habitat.
- Engage landowners to fence watercourses where moderate to severe stock damage has occurred to reduce further damage and ongoing sediment and faecal pollution downstream.

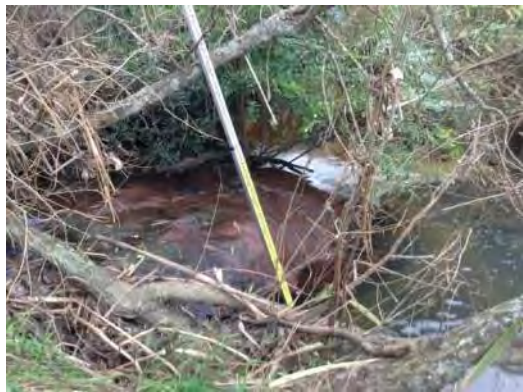
Willow in stream causing altered hydrology and partial barrier to swimmers on WAI_MAIN_6

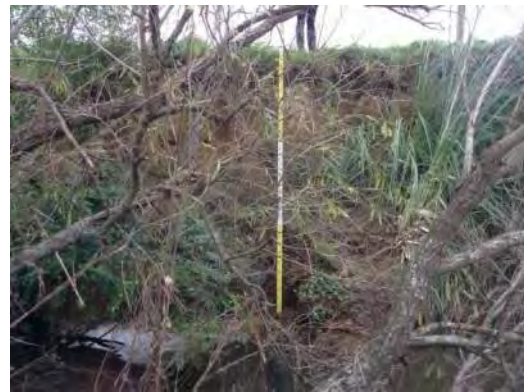
Cascade over Willow roots. Scoured pool immediately downstream with bank slip at SYM_MAIN_5

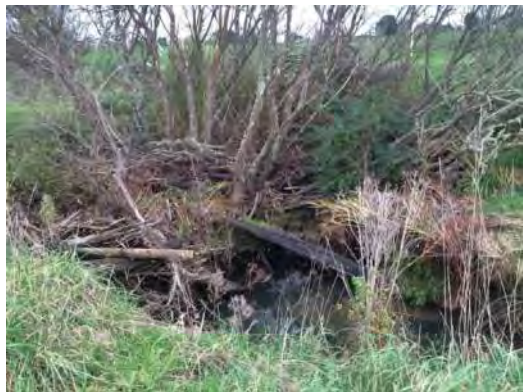
Landslip at SYM_MAIN_5

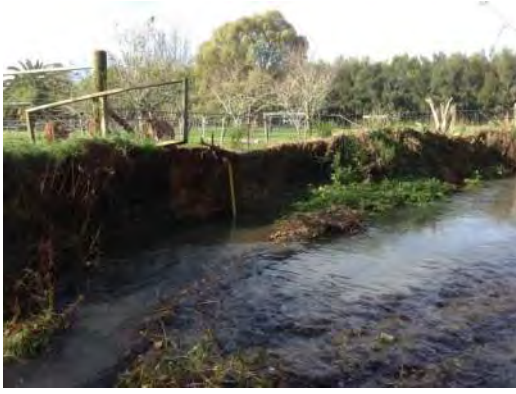
Erosion hotspot on true right bank on WAI_MAIN_10

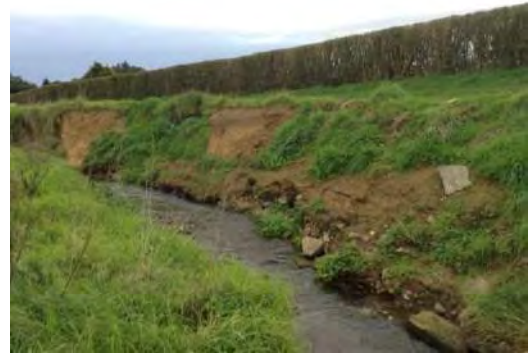
Erosion hotspot approximately 80 m2 on true right bank on WAI_MAIN_12

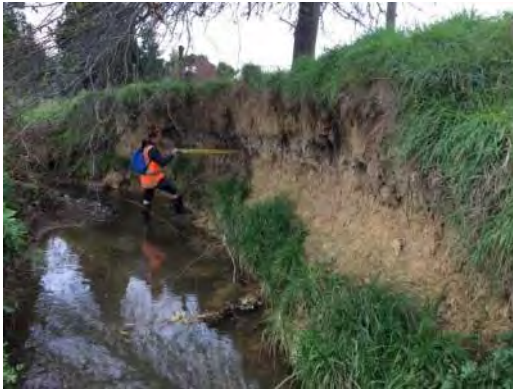
Undercut bank on true left bank on WAI_MAIN_14

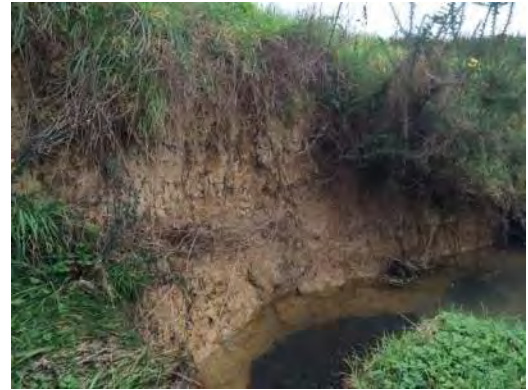
Erosion hotspot on true left bank

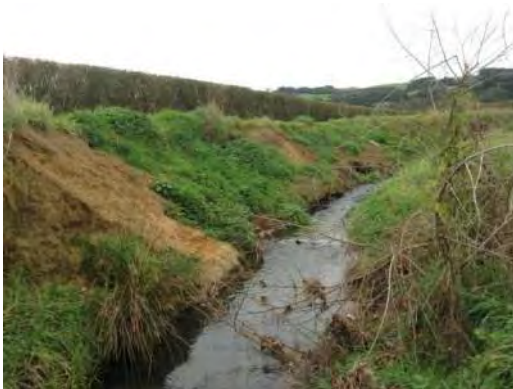
The true right bank on WAI_MAIN_12 has been widened and regraded. Pasture grasses on both banks.
