Watercourse Assessment Report

Slippery Creek Catchment

Ingle, R., Rieger, A., Magee, J., Reeves, E., Macintosh, K., Lowe, M., Young, D.
Morphum Environmental Ltd

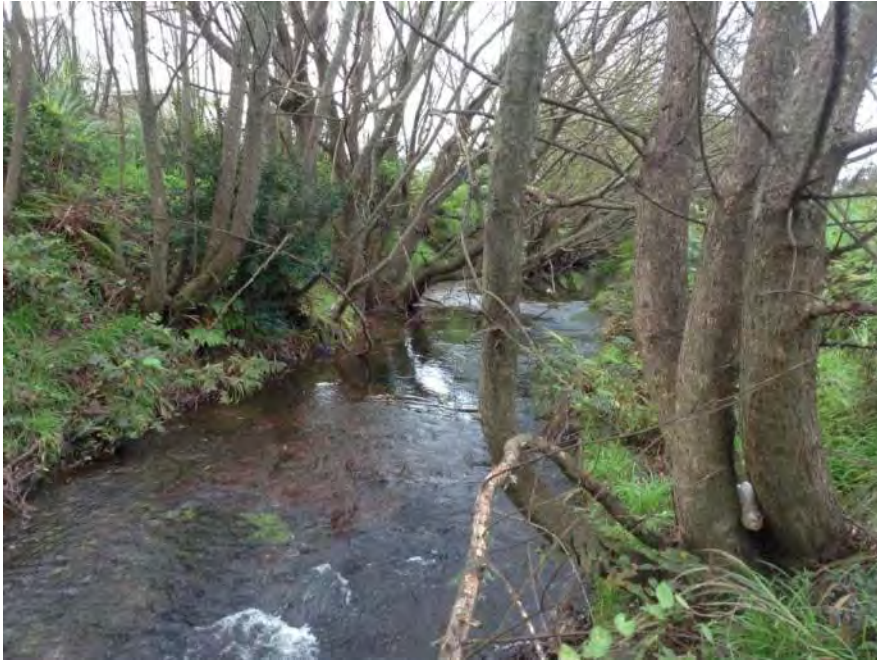
The main reaches of Hays Stream along the border of the industrial zone were dominated by mature willows with little to no understorey, with the ground cover dominated by pasture grasses and weeds (Figure 15).

Figure 15: Willow dominated riparian margins representative of HAY_MAIN_1-15

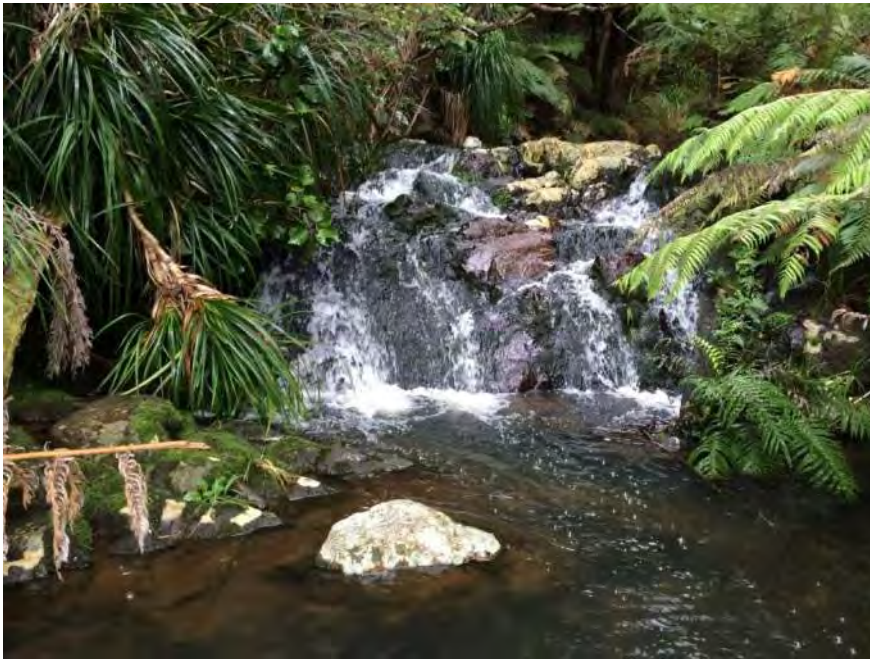
Figure 18: Bedrock cascade (HAY_TRIB6c_1).

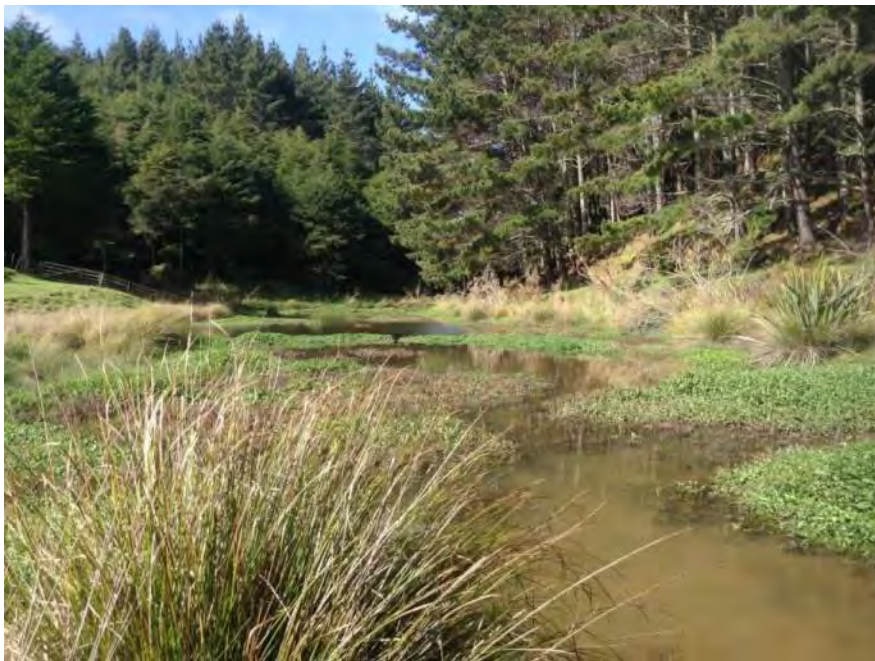
A farm pond (UNK_109) in the upper reaches of Symonds Stream (SYM_MAIN_FORK2_8) is providing important sediment retention for the downstream reaches of Symonds Stream (Figure 25). There is approximately 2,500 m of watercourse upstream of the pond and the dominant substrate type is silt/sand with most reaches having high sediment deposition. However, downstream of the pond, the dominant substrate is gravel and the reaches flow through mature native bush and provide suitable habitat for fish and invertebrates.

Figure 25: Farm pond (UNK_109) (SYM_MAIN_FORK2_8).

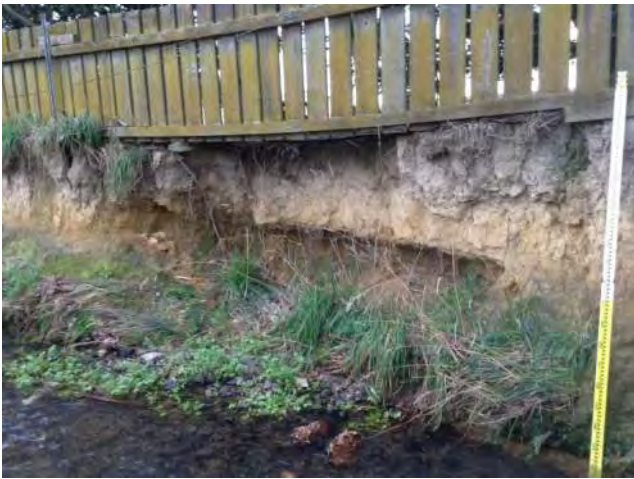
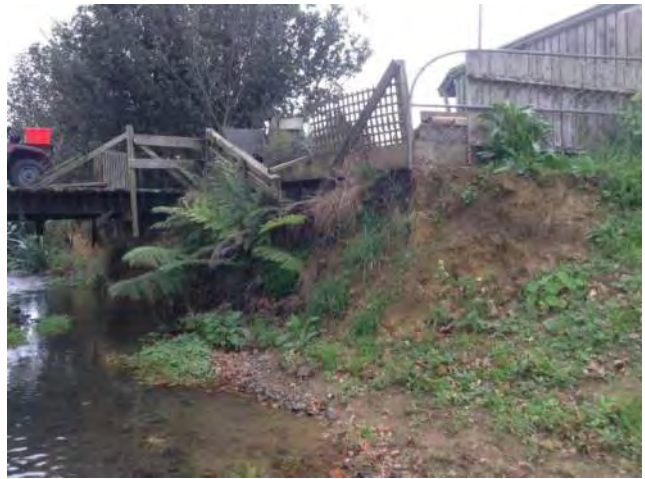
One erosion hotspot was identified on WAI_MAIN_11-12, within 10 m of a residential dwelling which was considered to present a moderate risk to the dwelling (Figure 33). Approximately 40 m², had undercut the fence of a property as well as a small bridge crossing. Ongoing erosion could cause the fence to collapse into the stream, and further investigation by a geotechnical engineer is recommended to define the nature and extent of any remediation works at this site. Works could include reinstating the bank to a more suitable grade, planting and installing rock at the toe of the bank for erosion protection. However, further investigations and specific design is required to ensure the most suitable option is implemented.

Figure 33: Erosion hotspot on WAI_MAIN_11/ WAI_MAIN_12

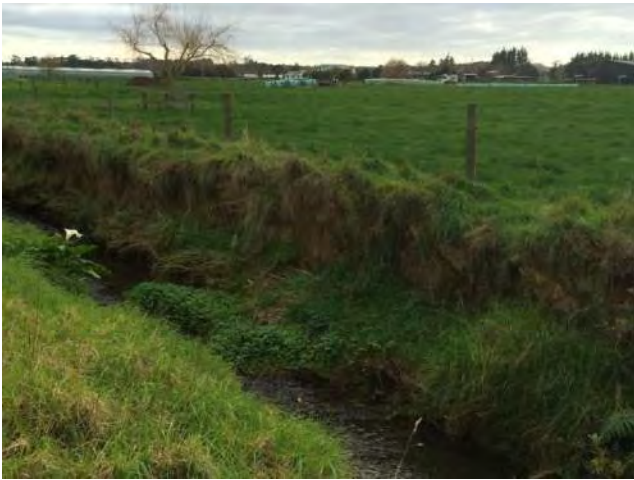
The largest erosion hotspot assessed (180 m²) was located along the true right bank of WAI_MAIN_13 on privately owned rural farm land (Figure 34). Although healed in some parts, the area included fresh erosion with mass wasting and unstable overhanging banks. Ongoing erosion at this site is likely. Previous straightening of the stream channel has occurred along these reaches; it is likely that some of the erosion could have been caused

Figure 34: Erosion hotspot on WAI_MAIN_13

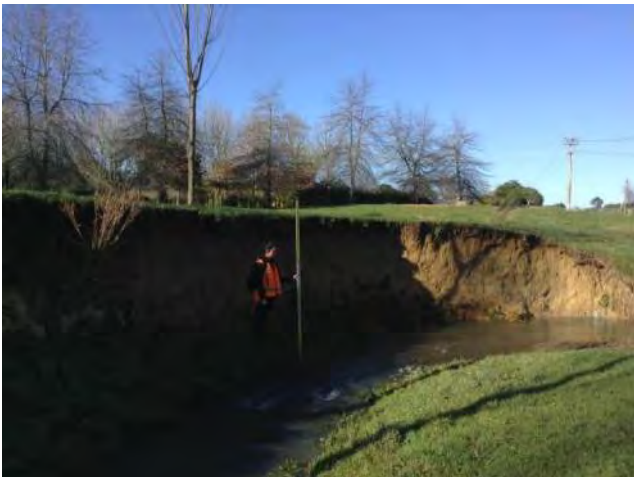
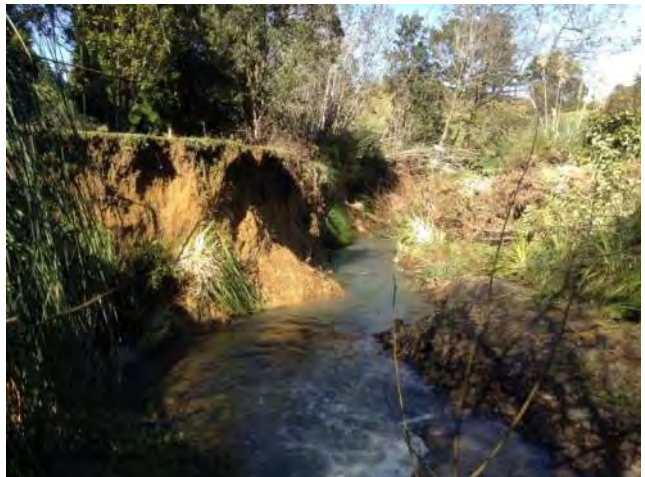
Nine disconnected erosion hotspots were assessed along Symonds Stream between SYM_MAIN_20 and SYM_MAIN_22 (Figure 35). Eight of these hotspots were considered to have poor upper bank stability due to high banks and steep bank angles, and poor riparian vegetation. Risk to buildings was identified as low to none as the reaches are through rural farm land. As such, regrading and planting of the banks may be a suitable option for remediation. Further details are provided in enhancement opportunity 5 in section 5.2.

Figure 35: Erosion hotspots on SYM_MAIN_20 and SYM_MAIN_1

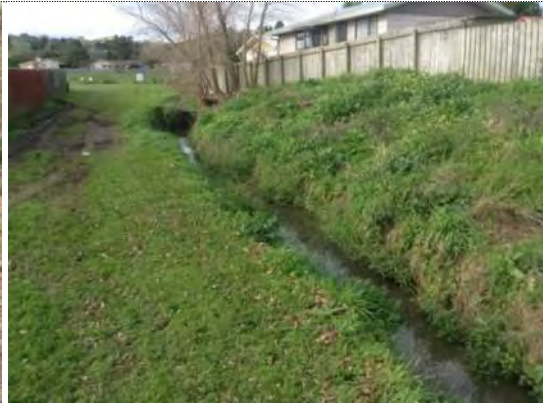
Planting site in 2015, no plants remain

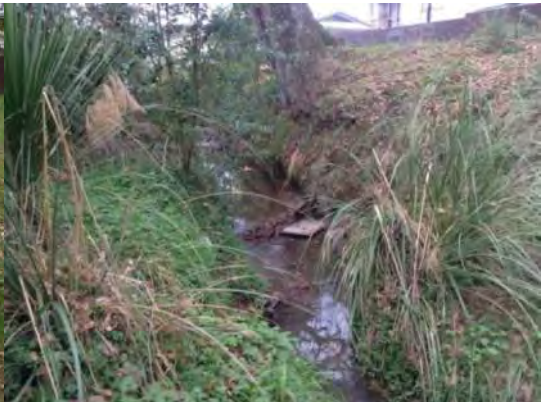
Planting site in 2015, with high plant losses

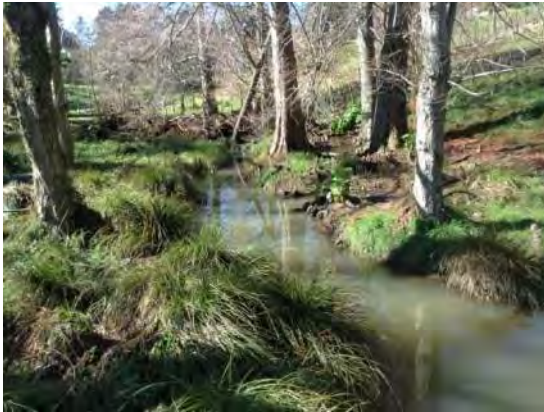
Erosion hotspot associated with farm pond UNK 130 on WAI TRIB2 19

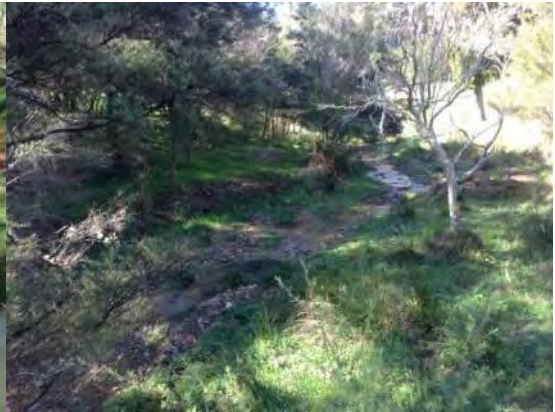
Carex grasses with stock access on WAI_TRIB2_20

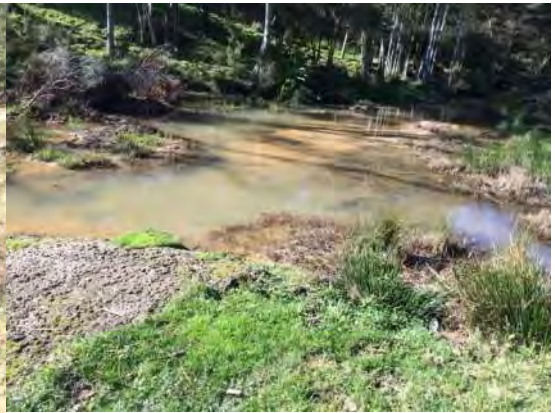
High bank erosion and sedimentation on WAI_TRIB2_22

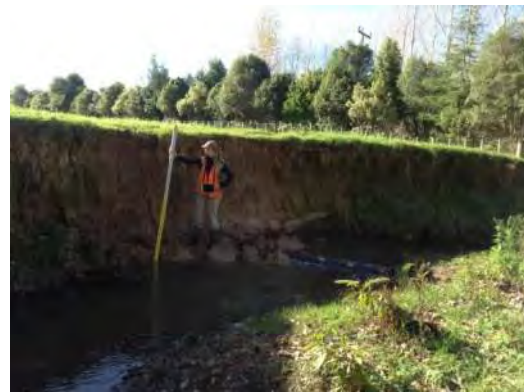
Large Willow in stream causing debris jam and obstructing flood conveyance on WAI_MAIN_9

- Manage willows to reduce erosion from flow diversion, debris jams, and improve fish passage to upstream high value habitat.
- Engage landowners to fence watercourses where moderate to severe stock damage has occurred to reduce further damage and ongoing sediment and faecal pollution downstream.

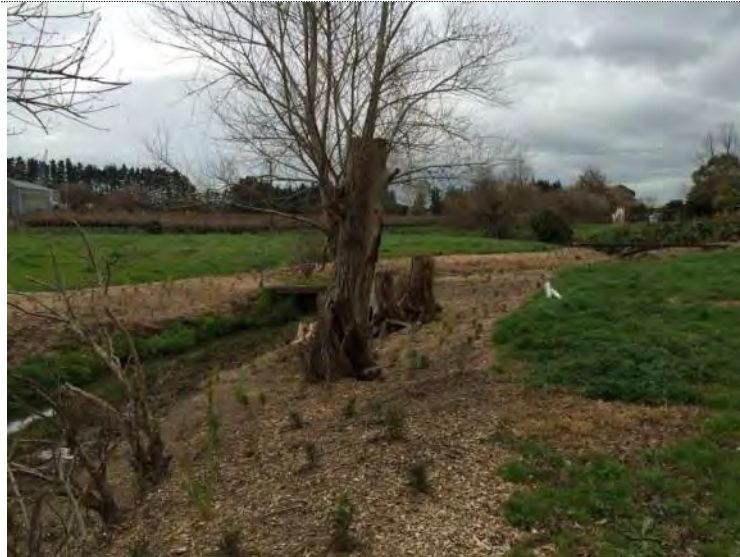
SLI_TRIB5_2 viewed August 2015.

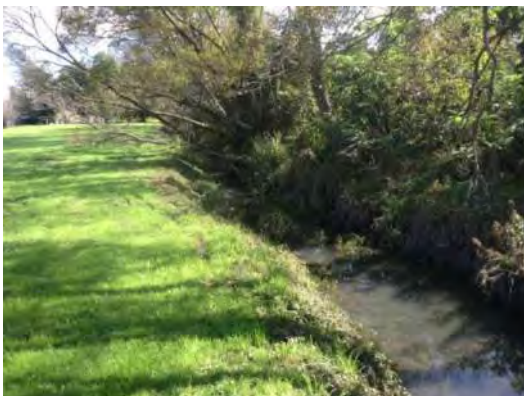
Erosion protection and structural repair required at outlet Asset ID 1115547

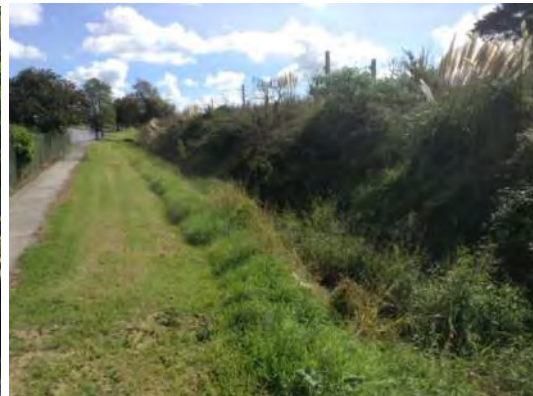
SLI_TRIB5_6 (5 m riparian margin TRB, enhancement on TLB), SLI_TRIB5_7 (low growing veg only for sight lines).

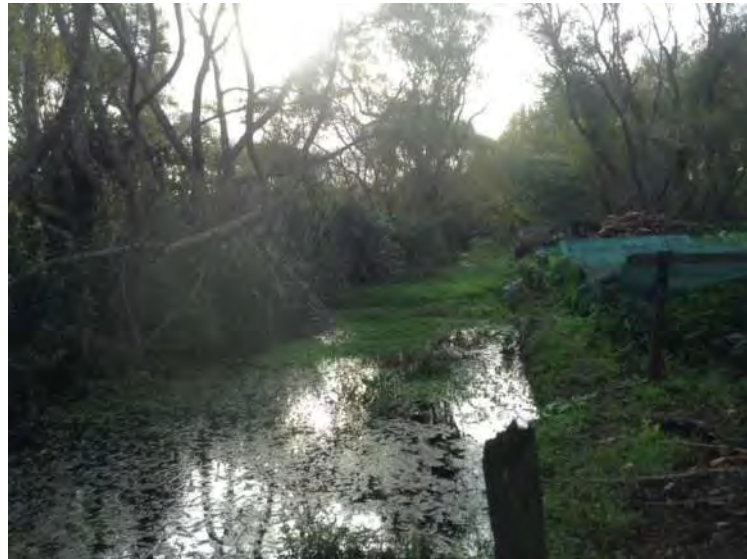
Parker Street proposed wetland upstream of SLI_TRIB6_2. ICMP Project 22

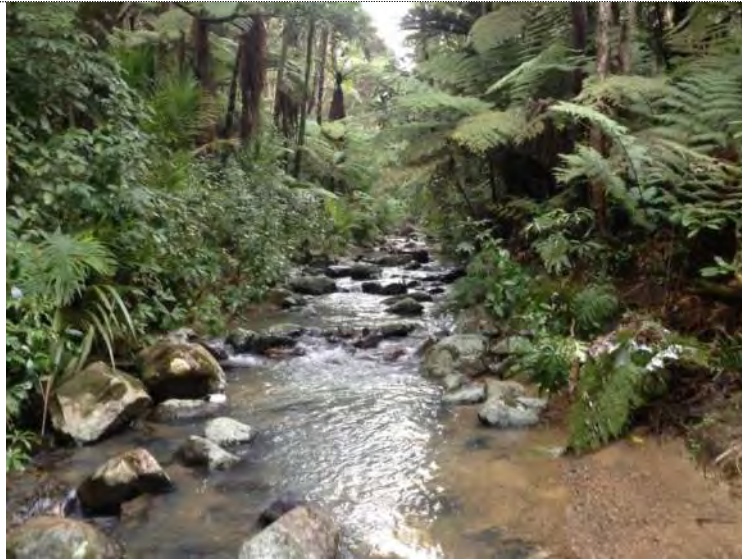
Regenerating native bush on Symonds Stream SYM_MAIN_26

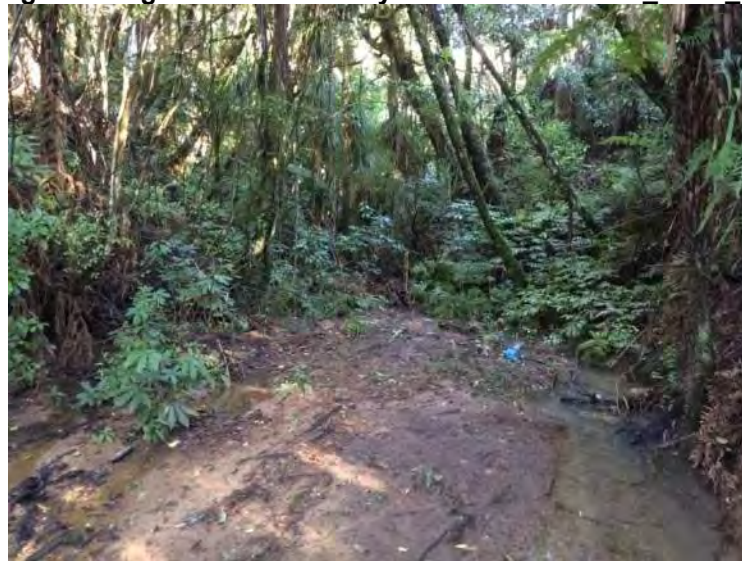
Regenerating native bush upstream of the enhancement opportunity SYM_TRIB3_3
